INTERNATIONAL TRUCK AND ENGINE CORPORATION

VIN 1HTWCAAN87J470169

7400 SBA 4X2

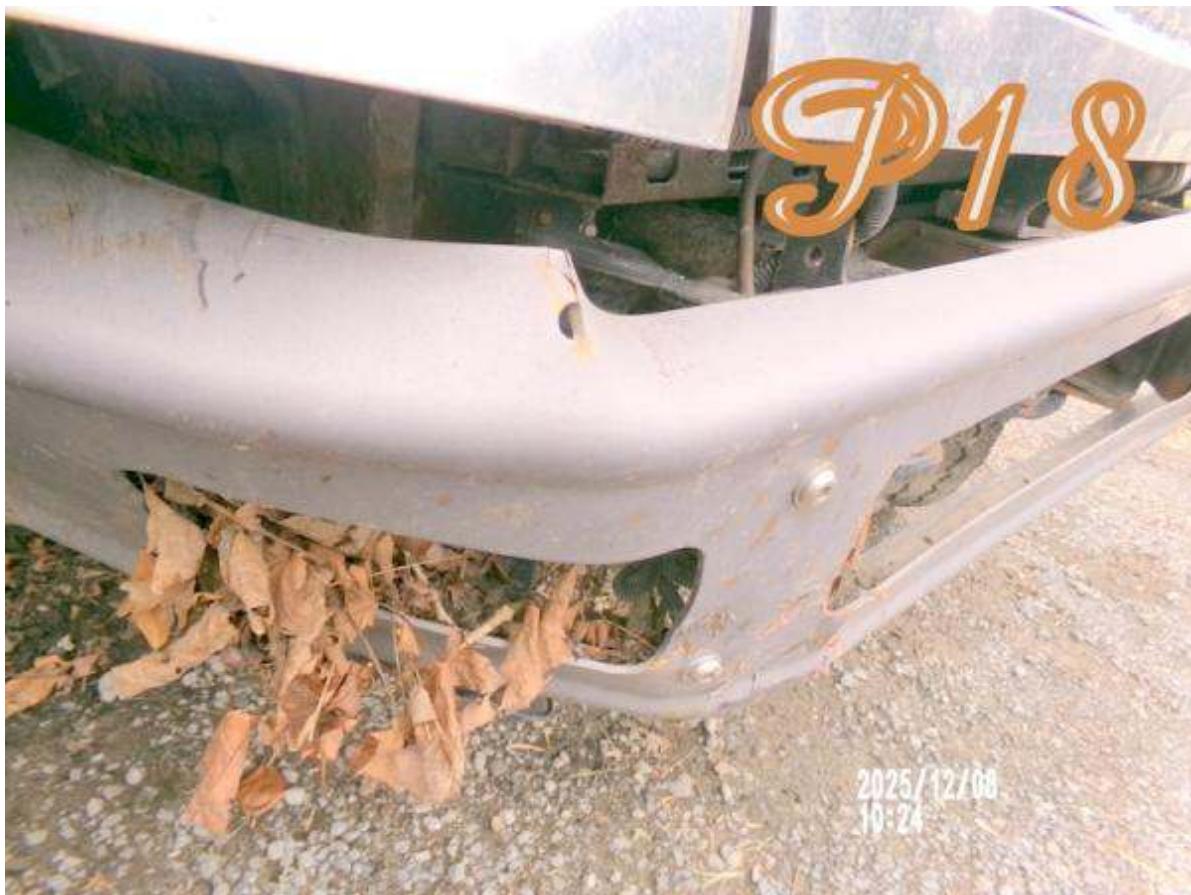
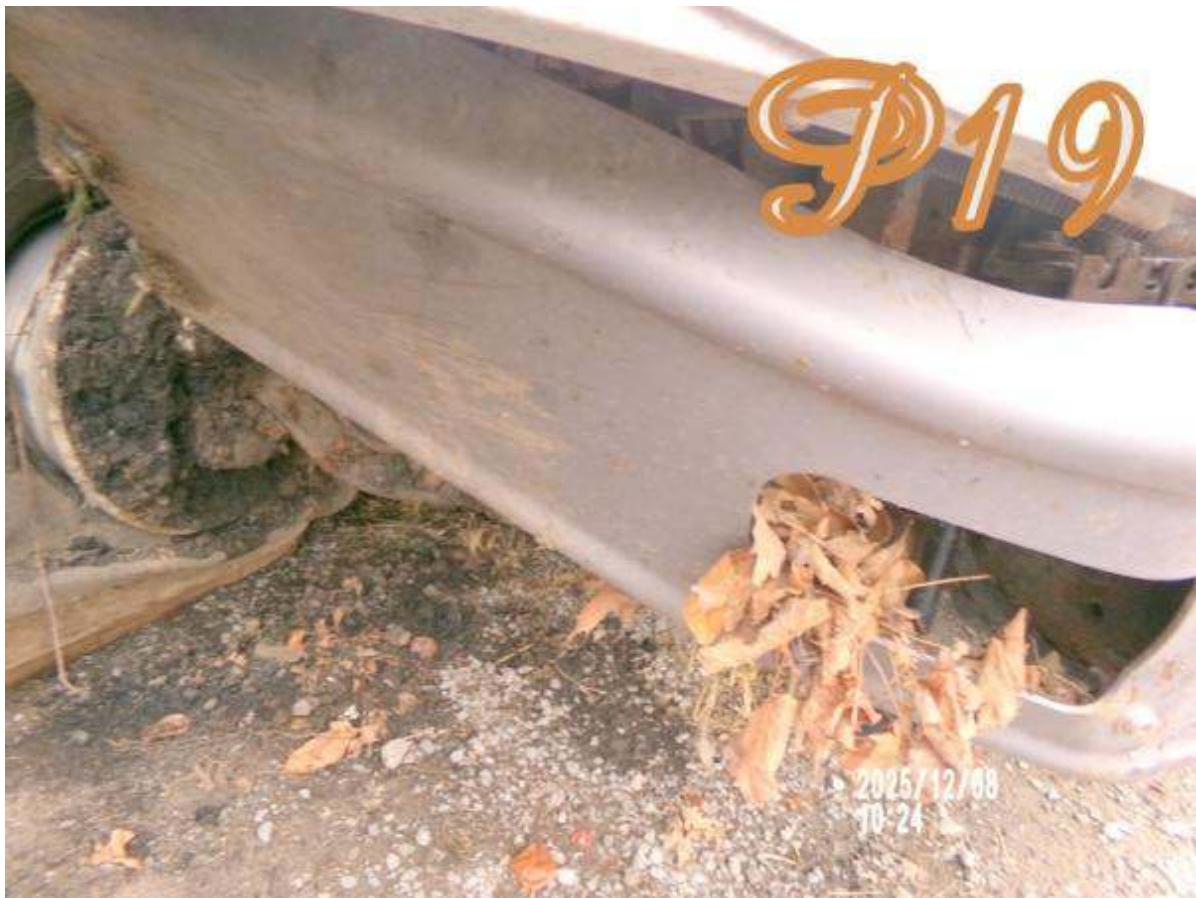
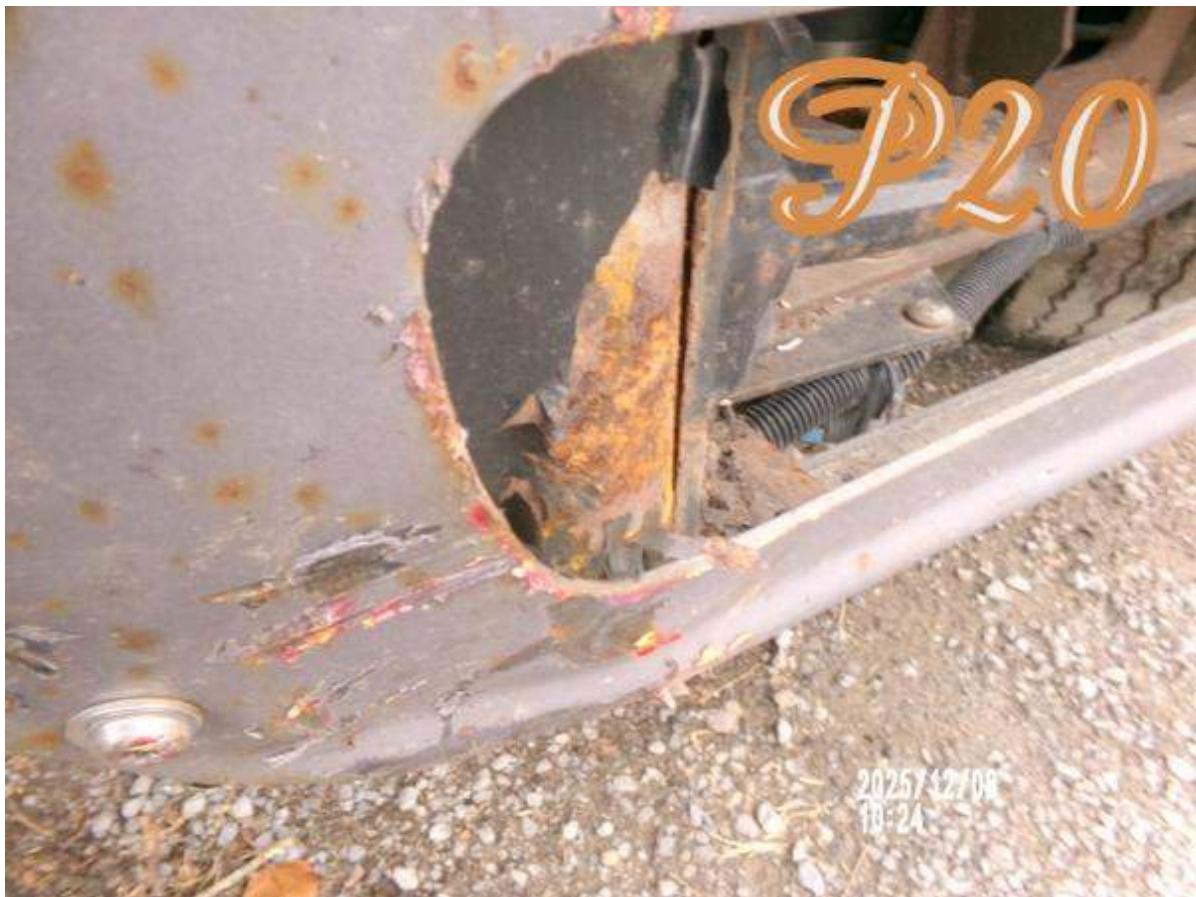
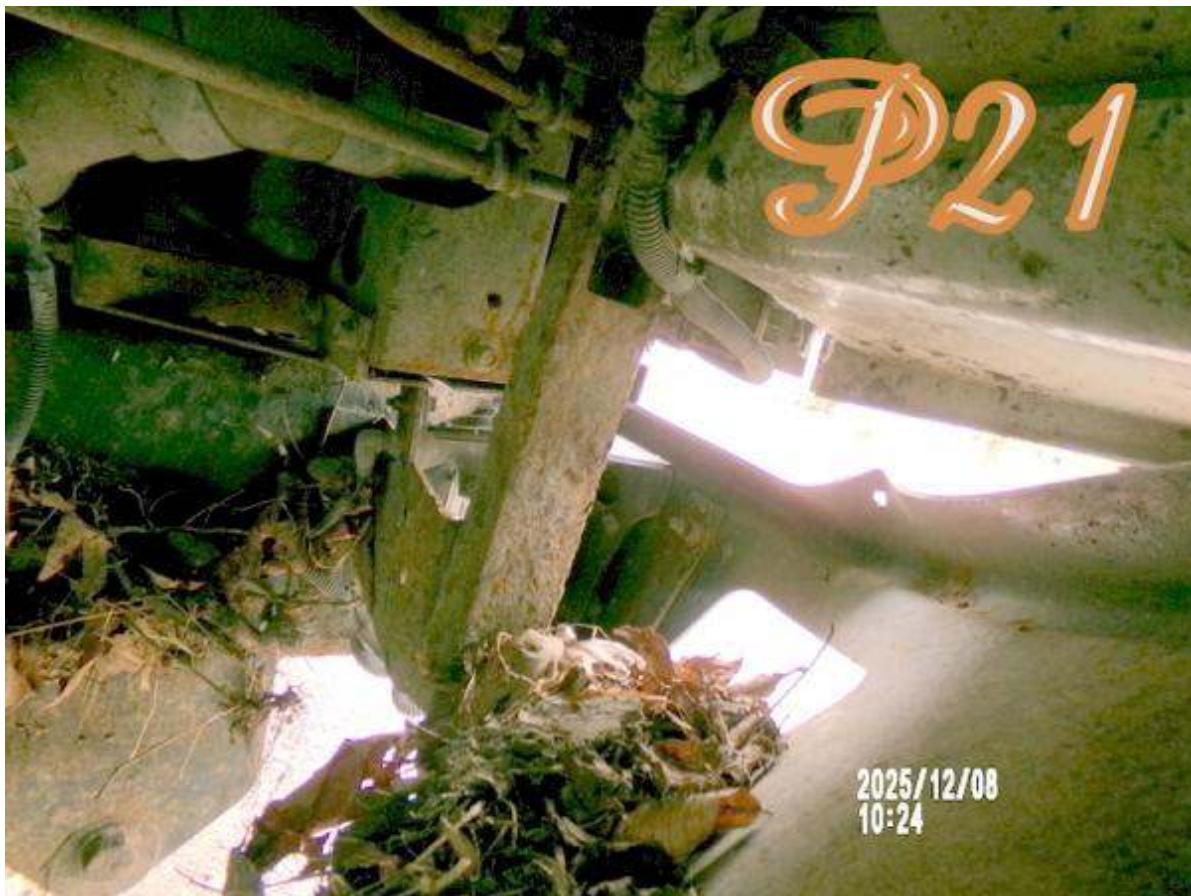
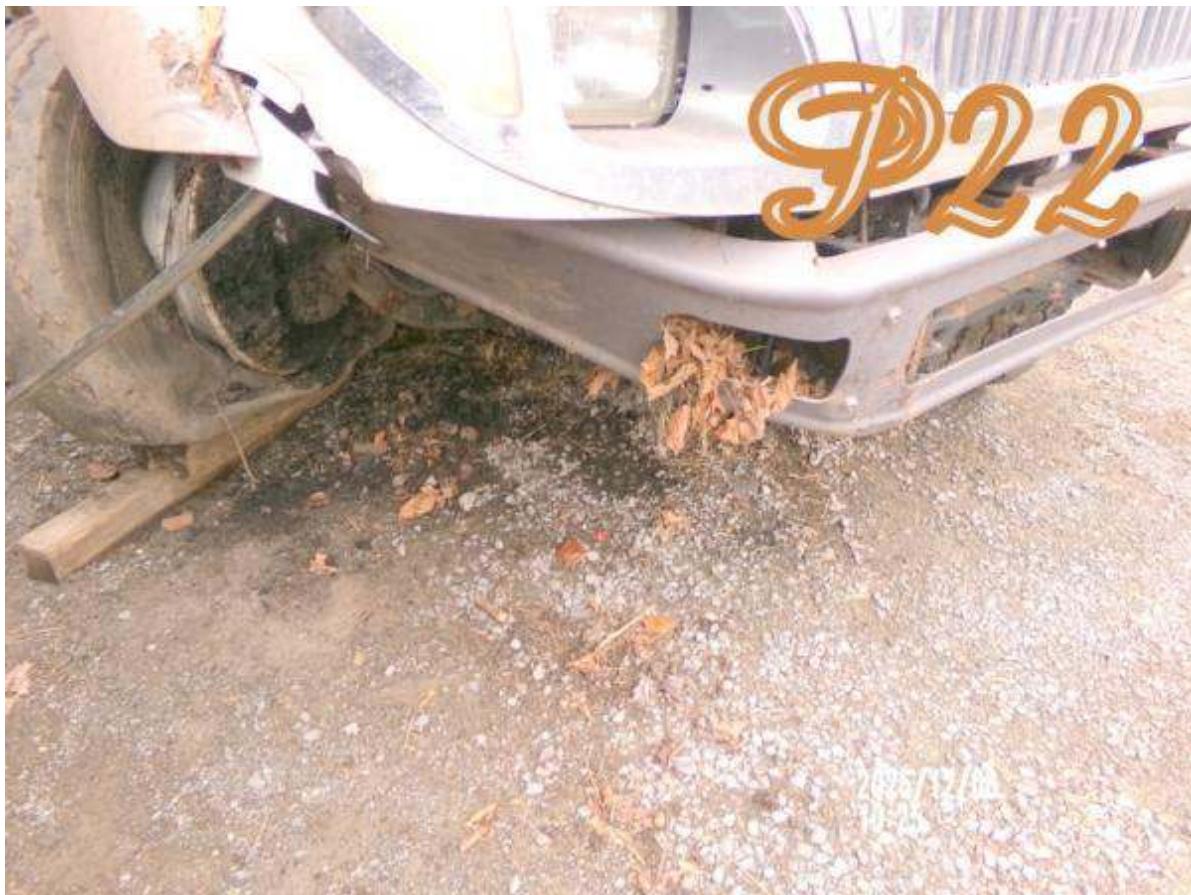
DAMAGE BUMPER FT

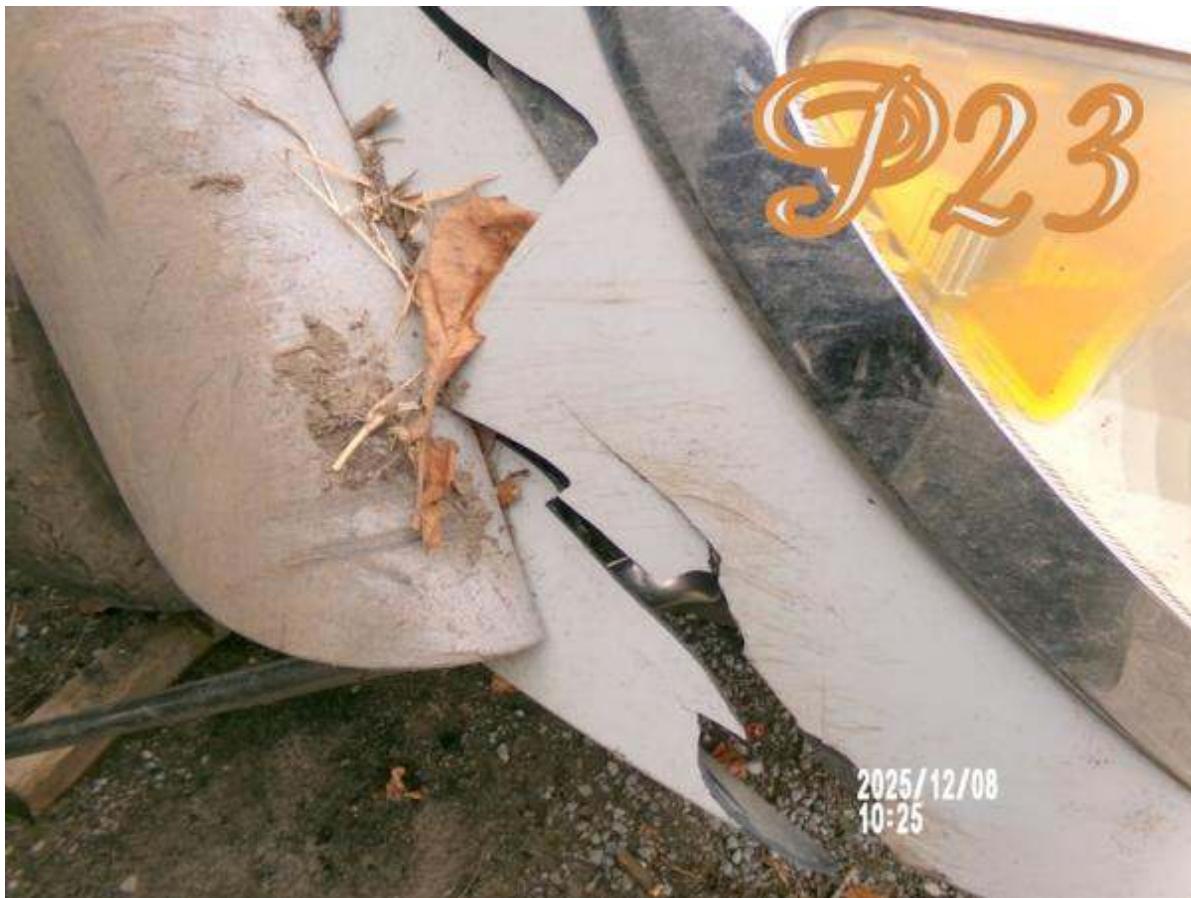
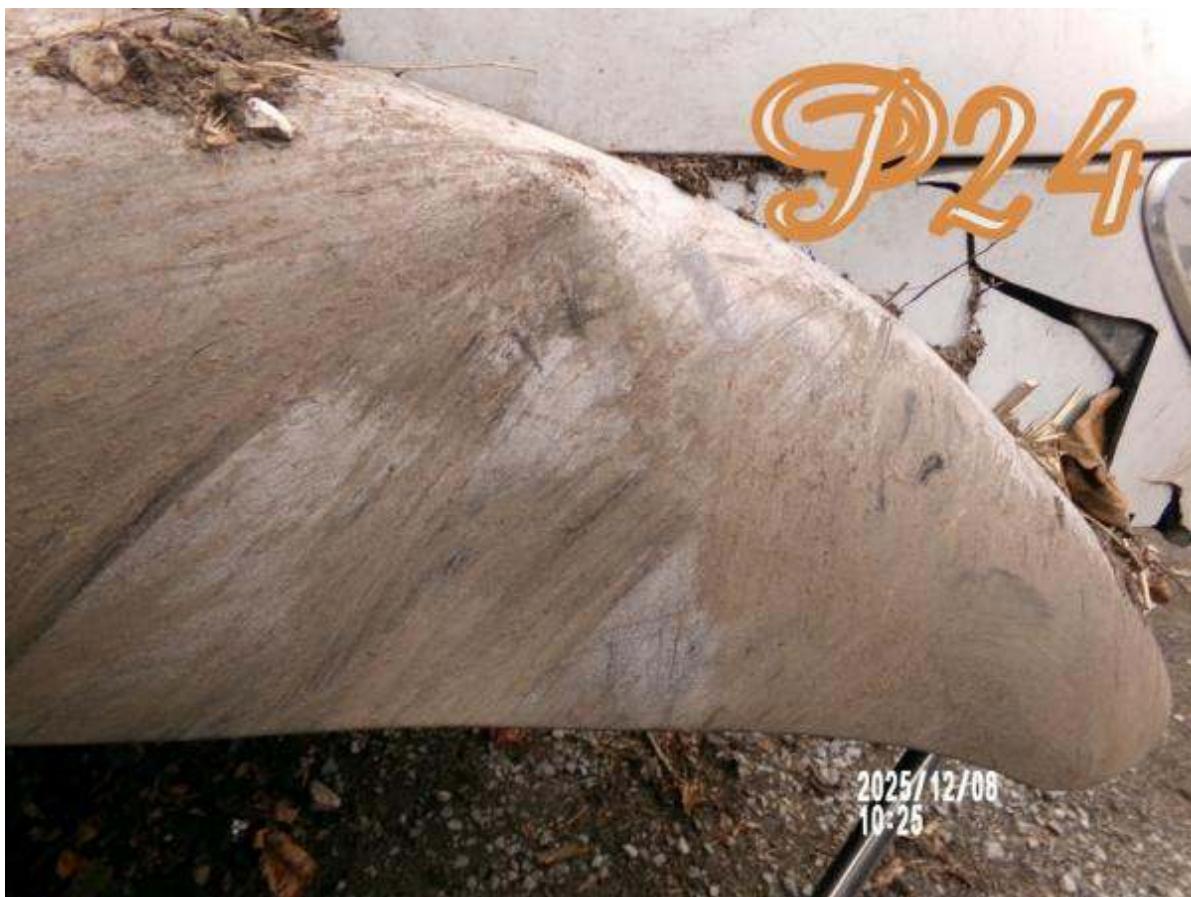
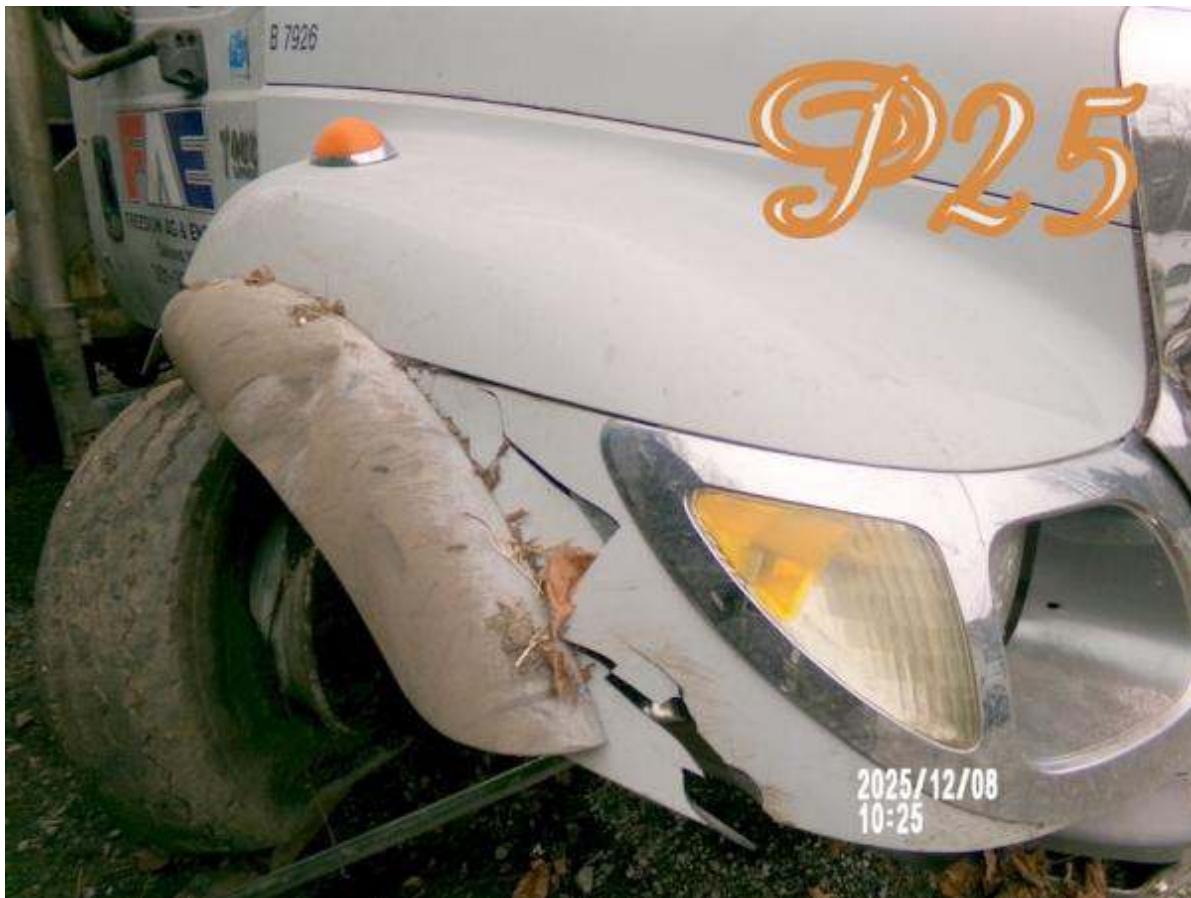
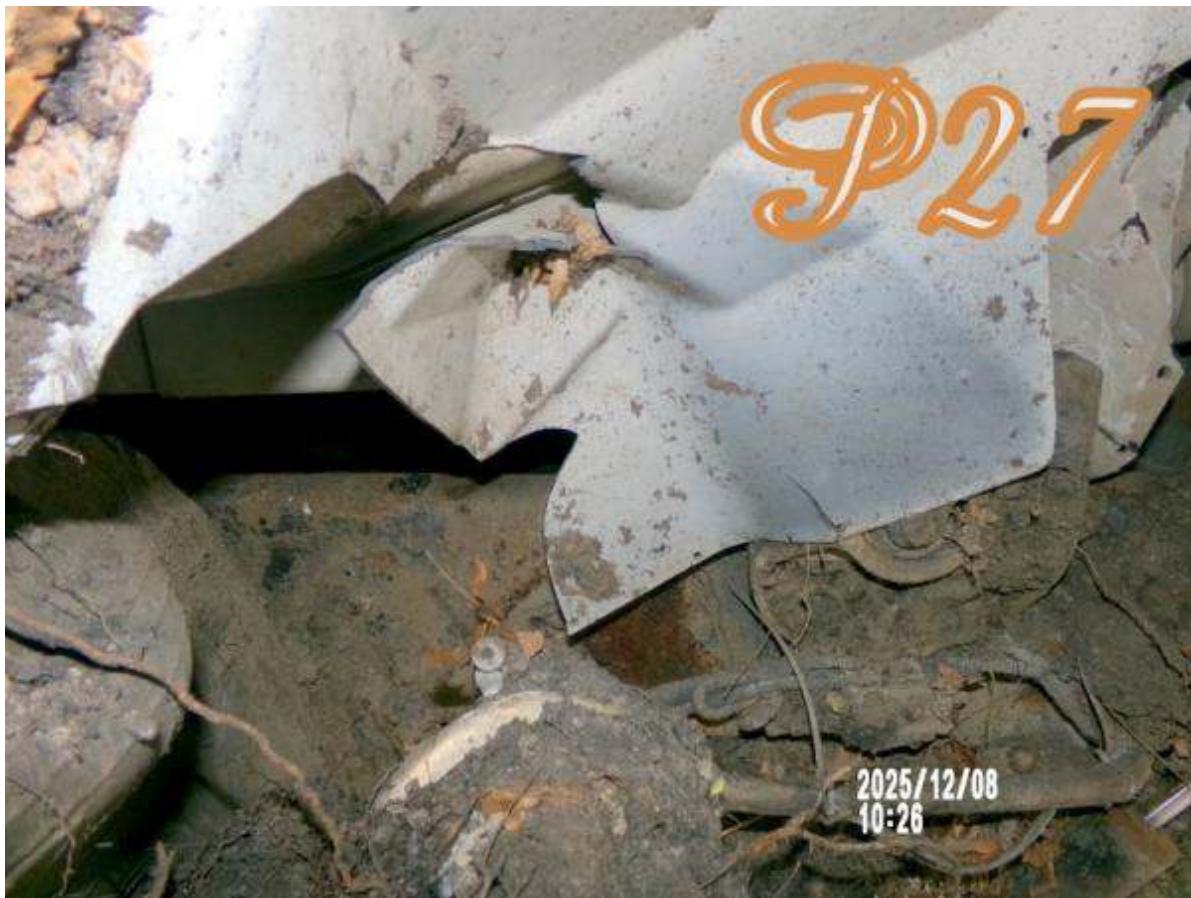
DAMAGE HALF FENDER LS FENDERS

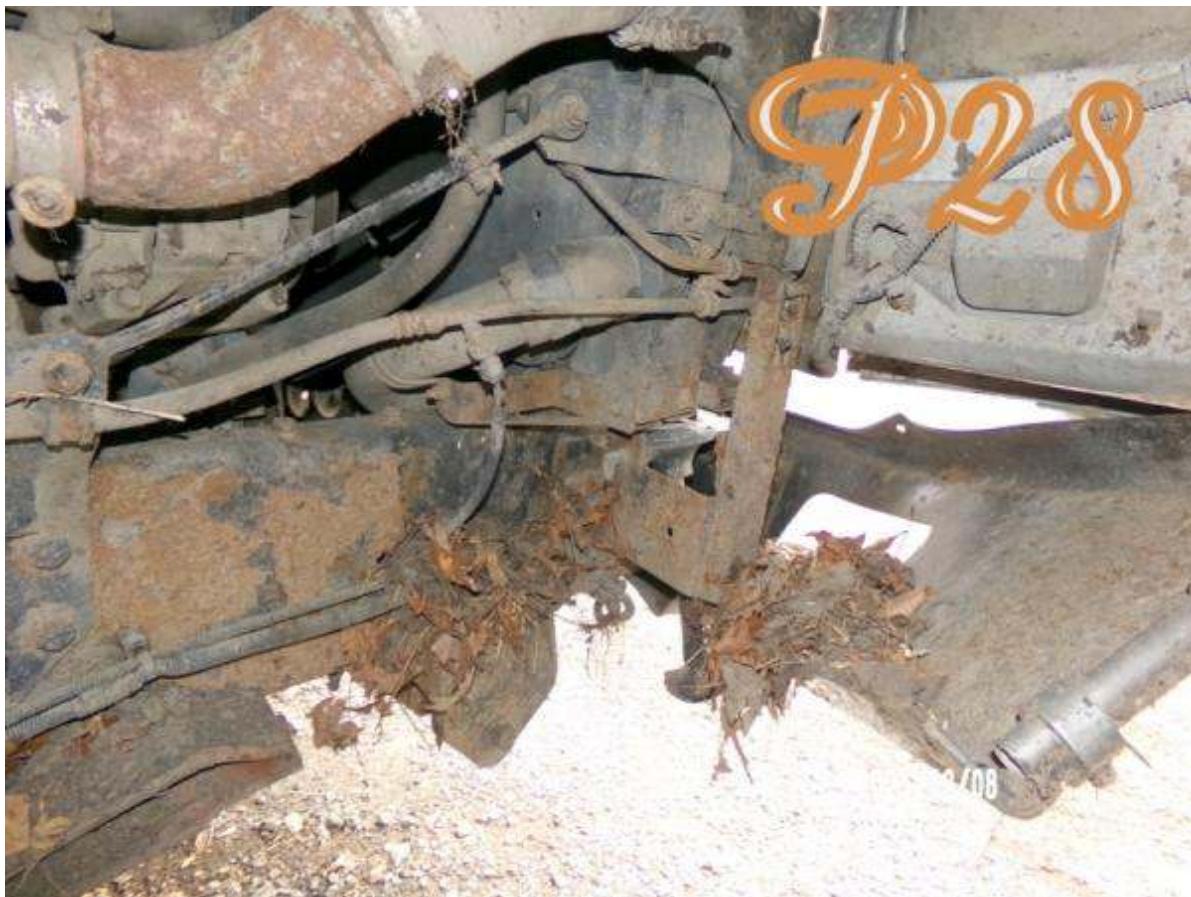
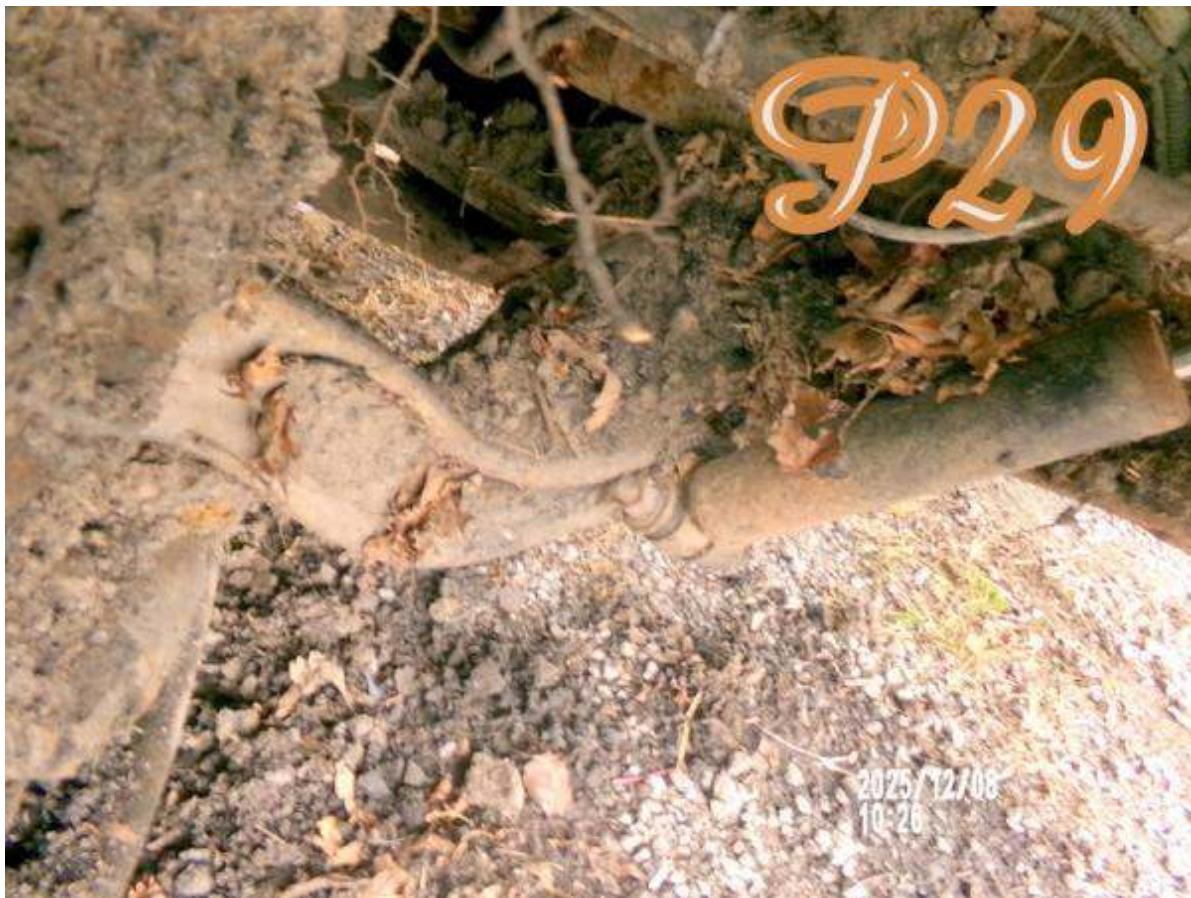
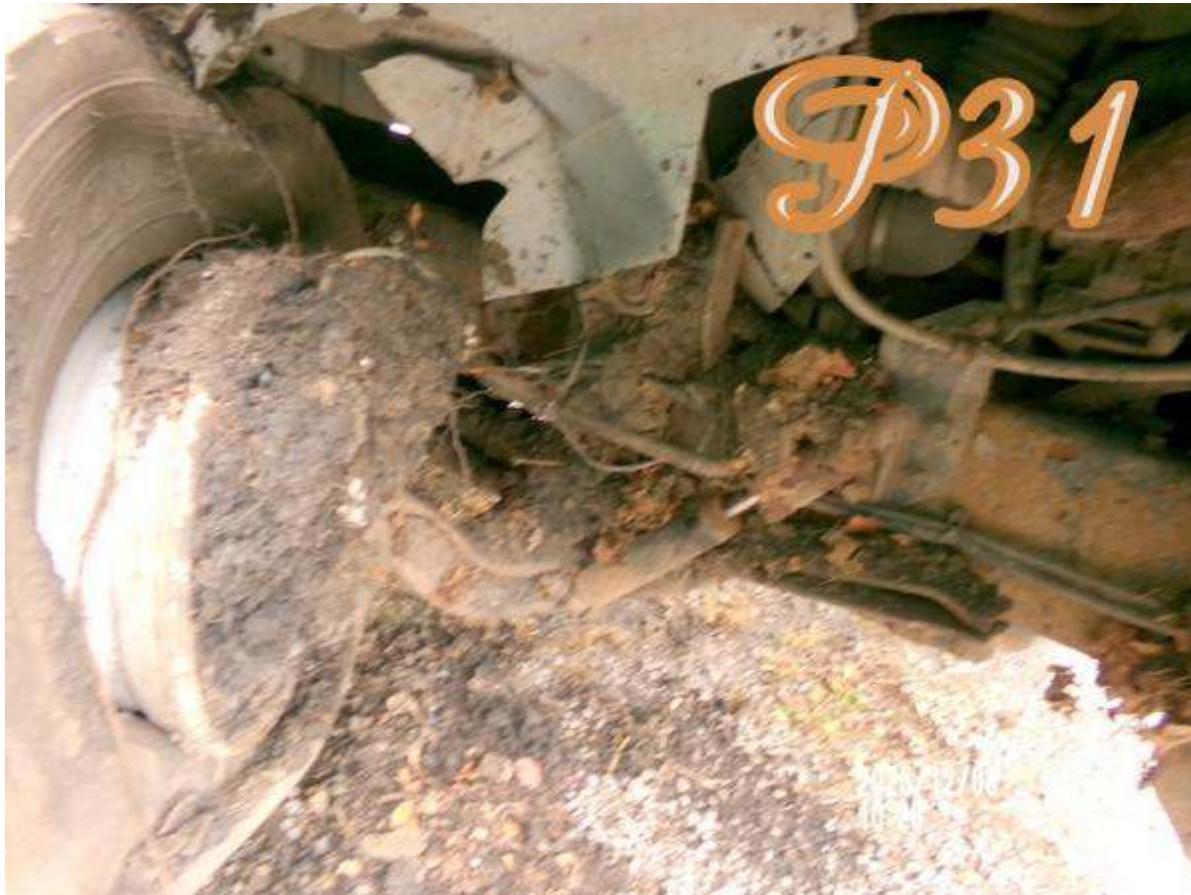
DAMAGE AXLE FT

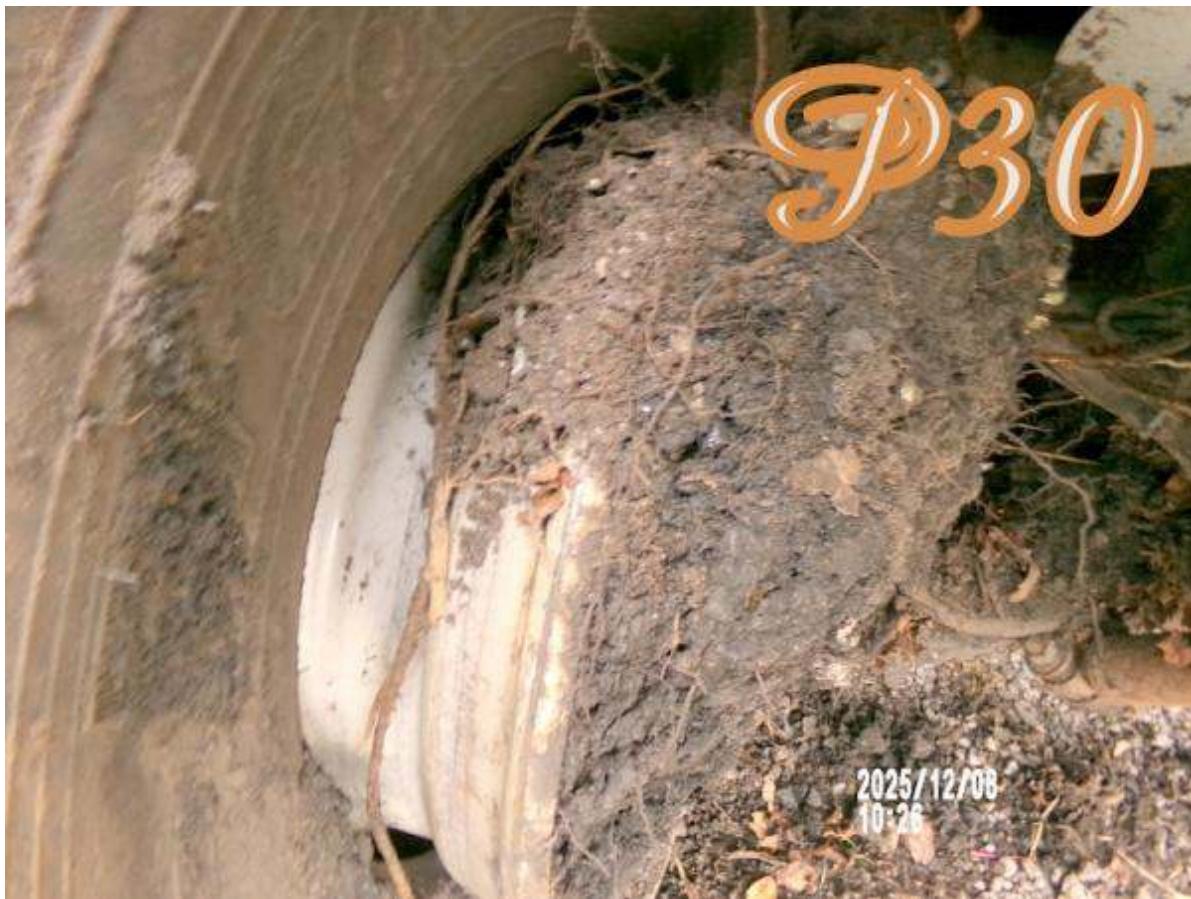
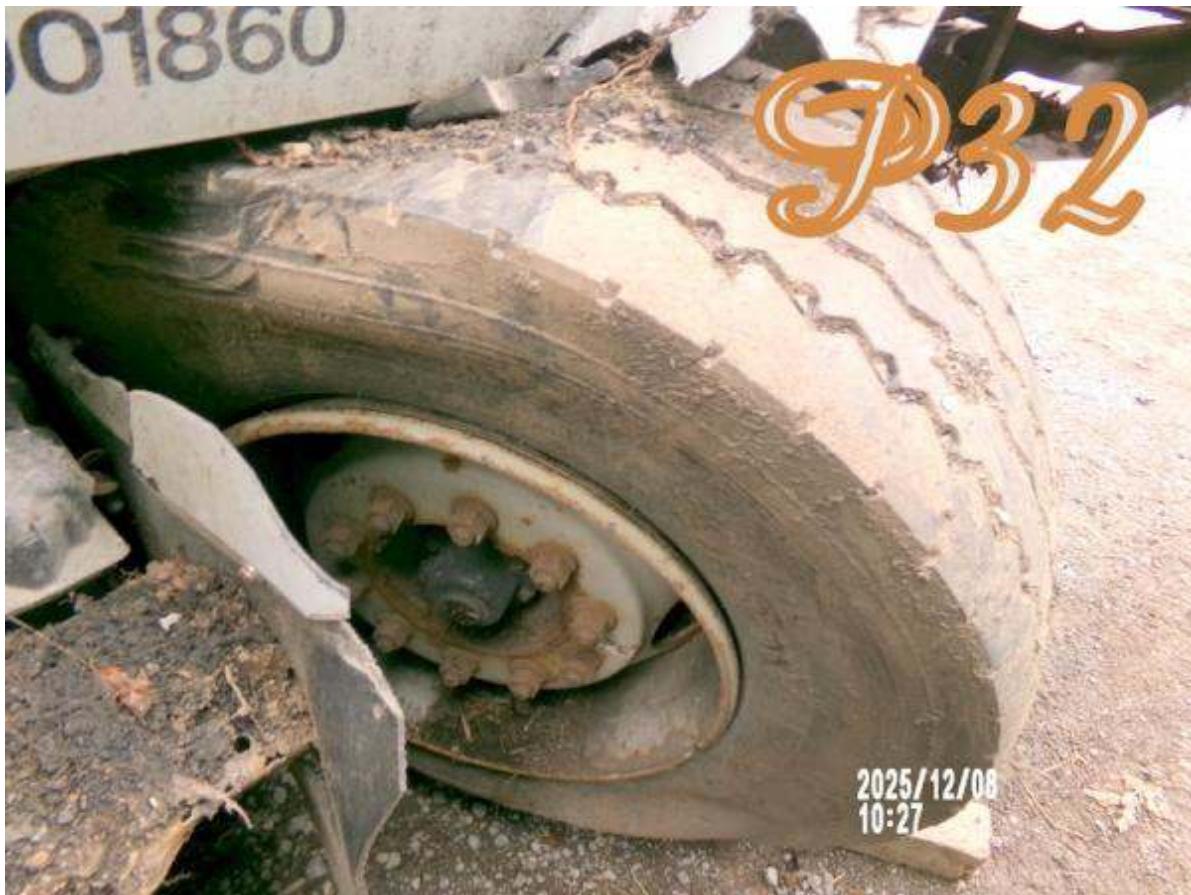
DAMAGE WHEEL/TIRE RS FRONT WHEELS

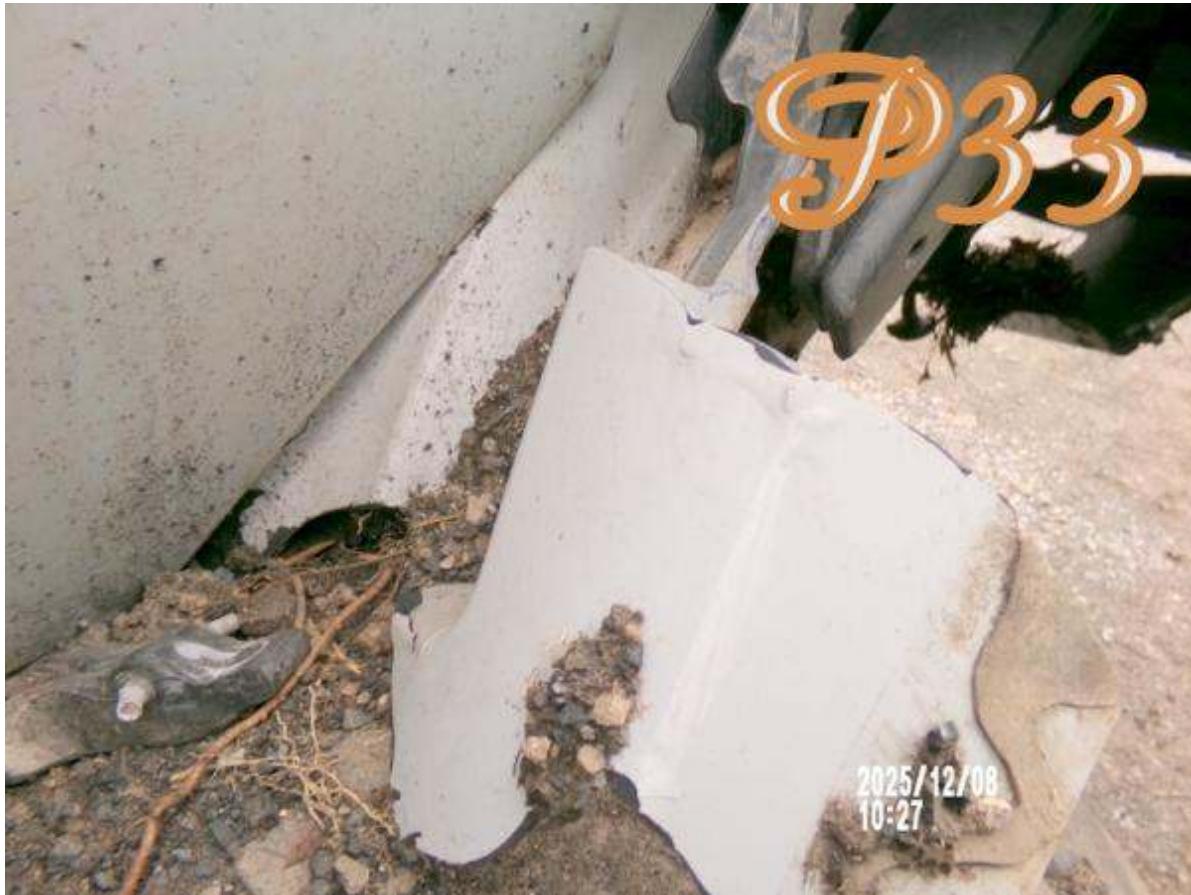
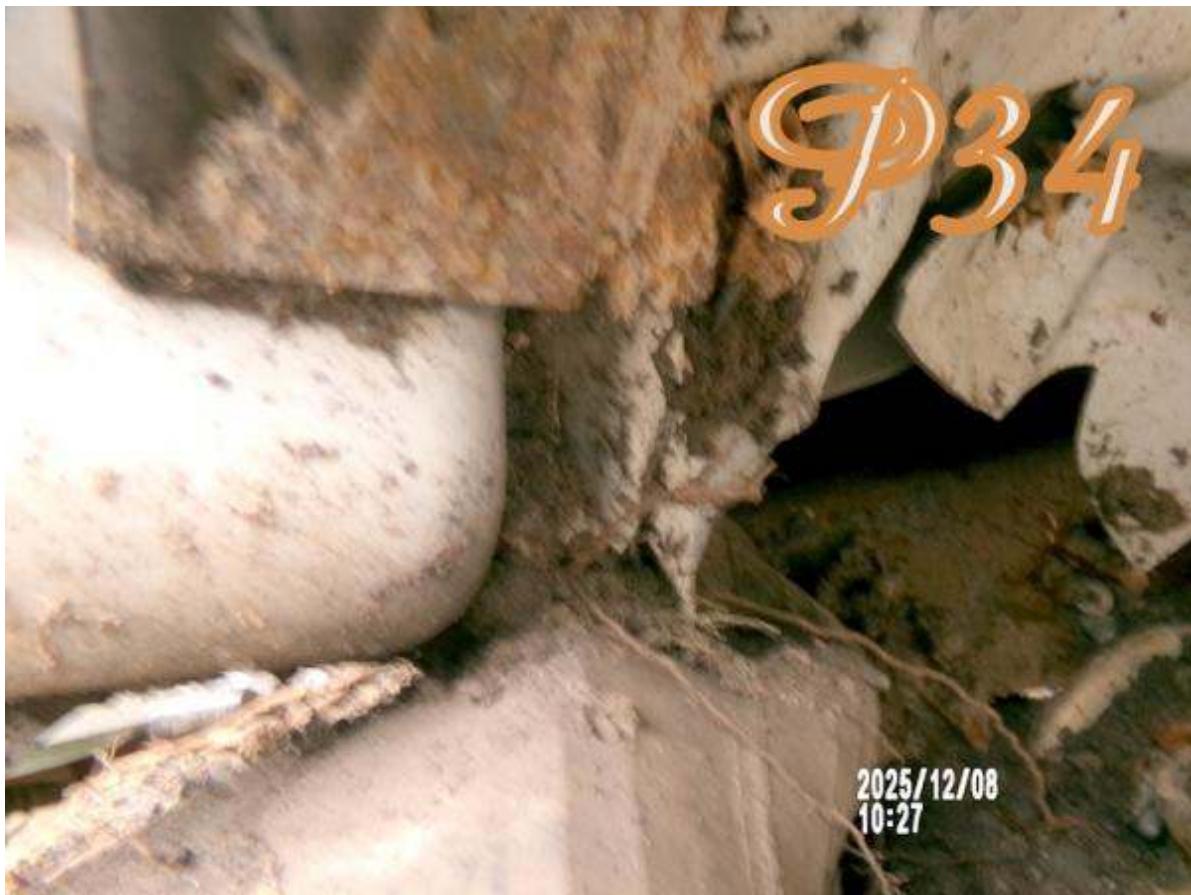
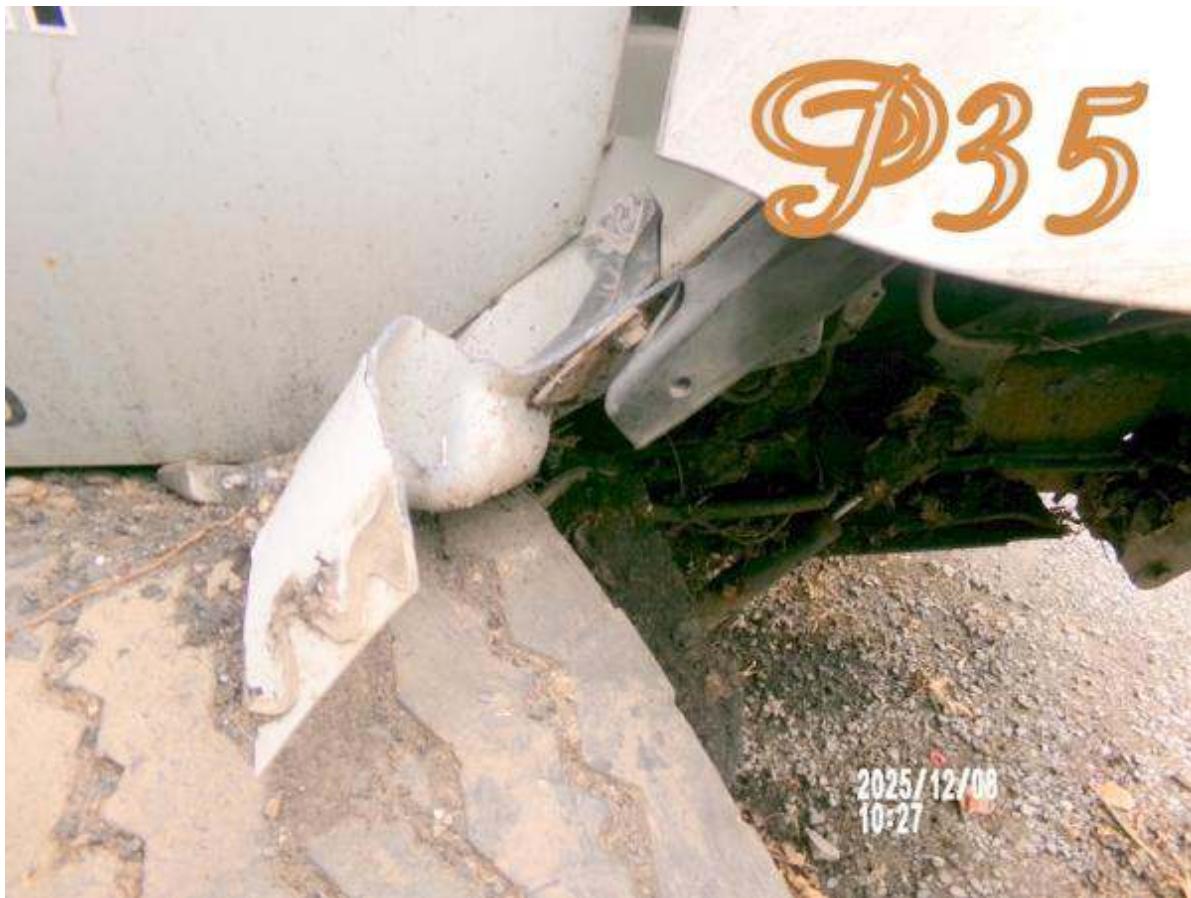
DAMAGE PANEL DOOR FRAME RS CAB

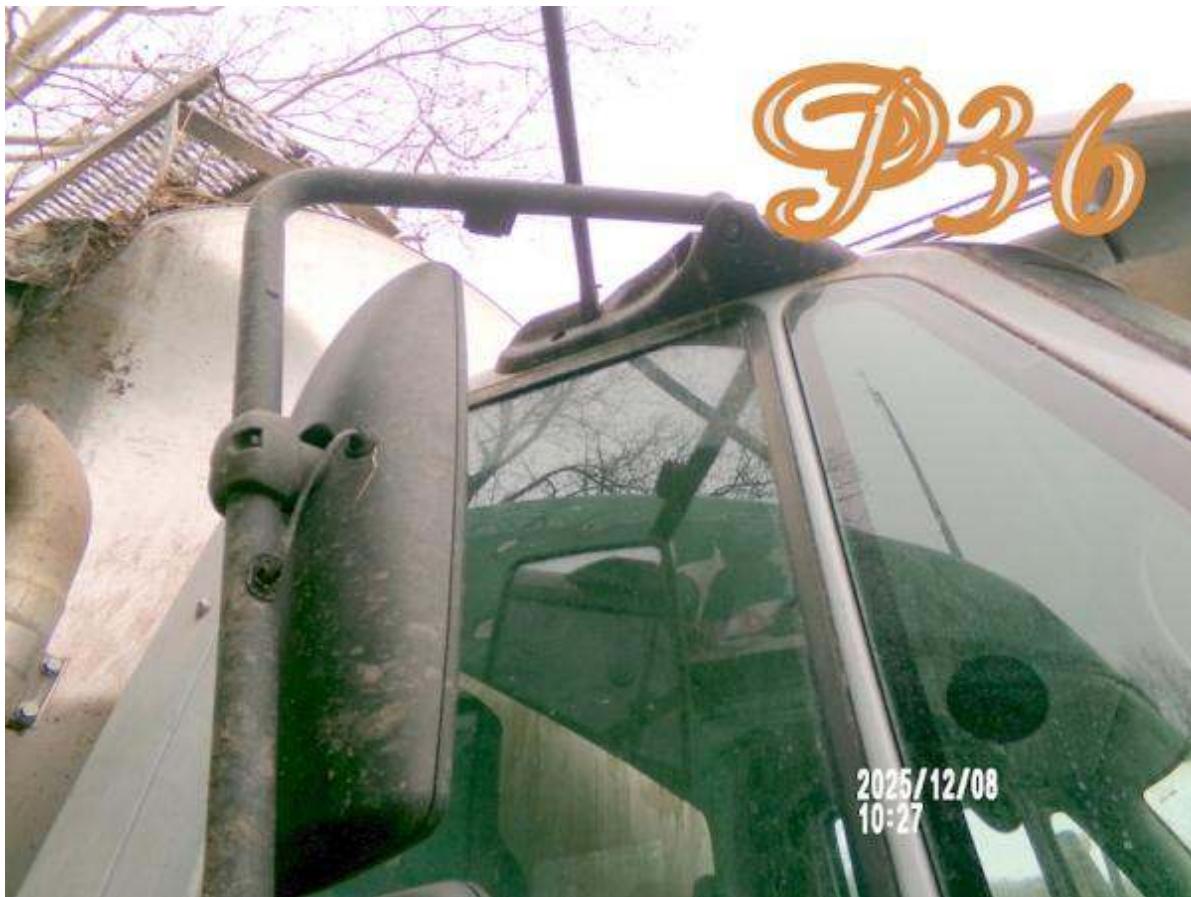
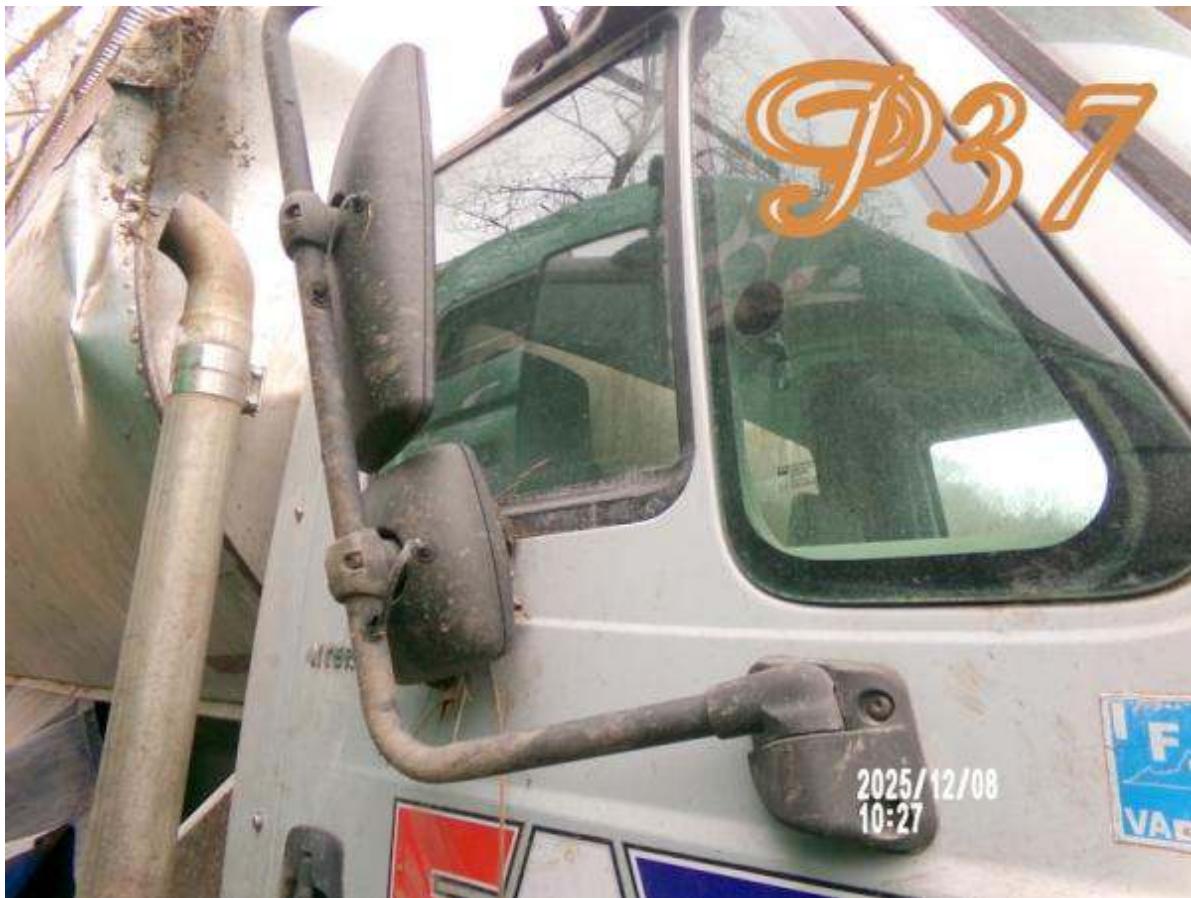
DAMAGE MIRROR RS DOORS
