INTERNATIONAL TRUCK AND ENGINE CORPORATION

VIN 1HTWCAAN87J470169

7400 SBA 4X2

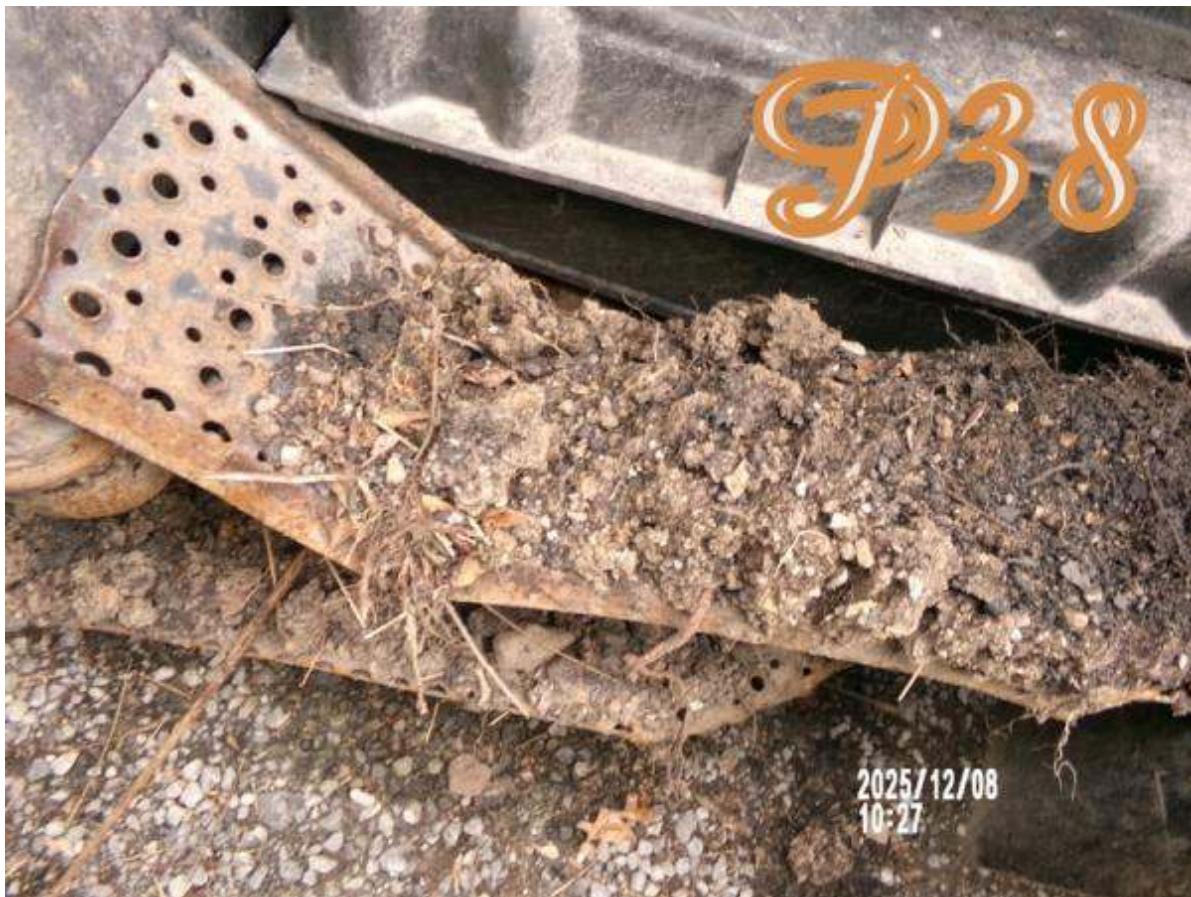
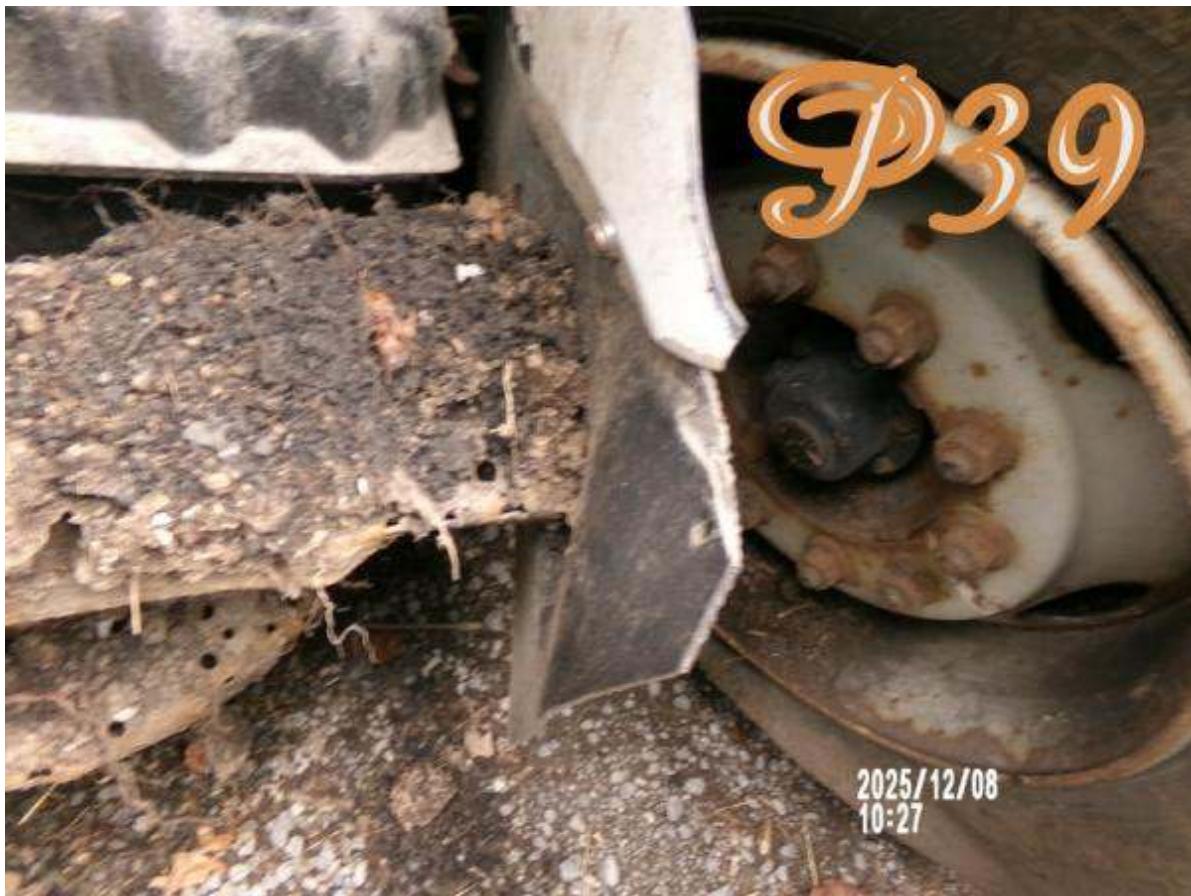
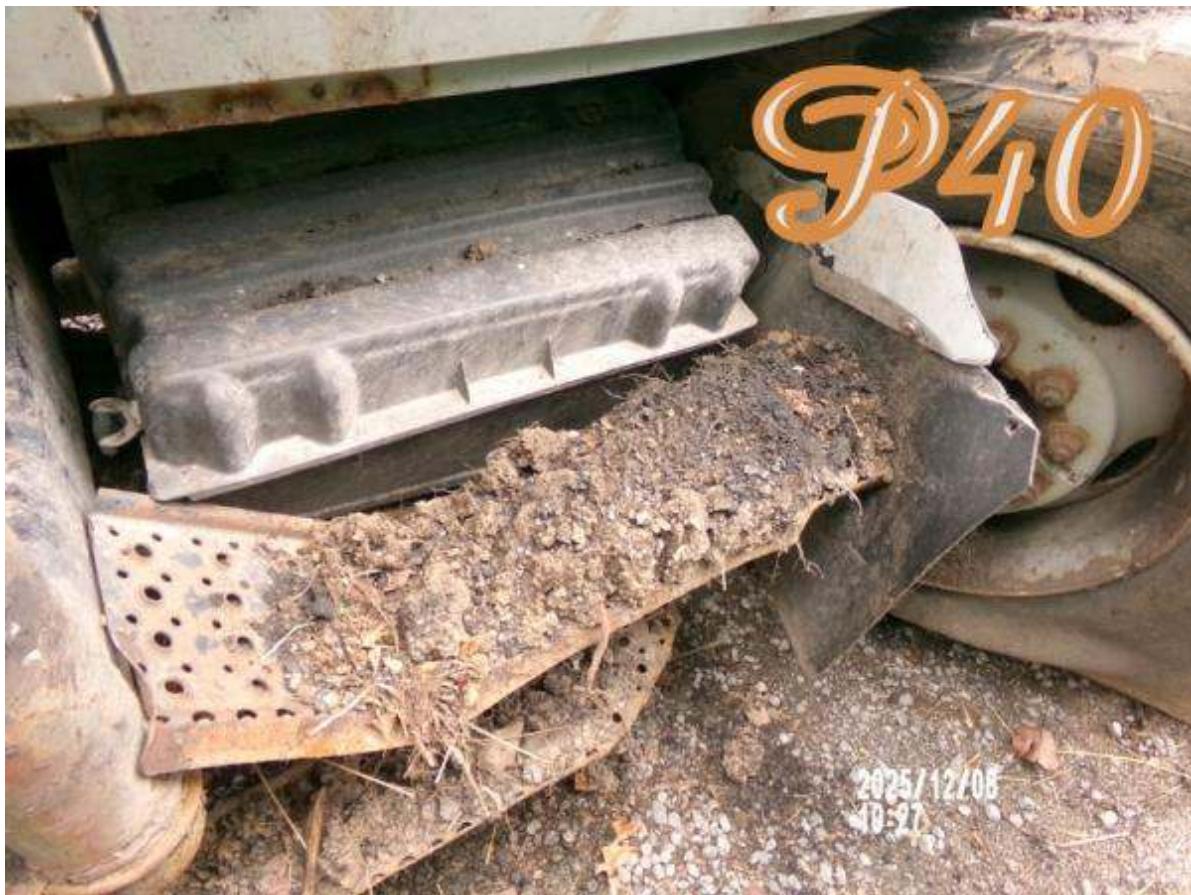
DAMAGE STEPS ATS ONE BOX

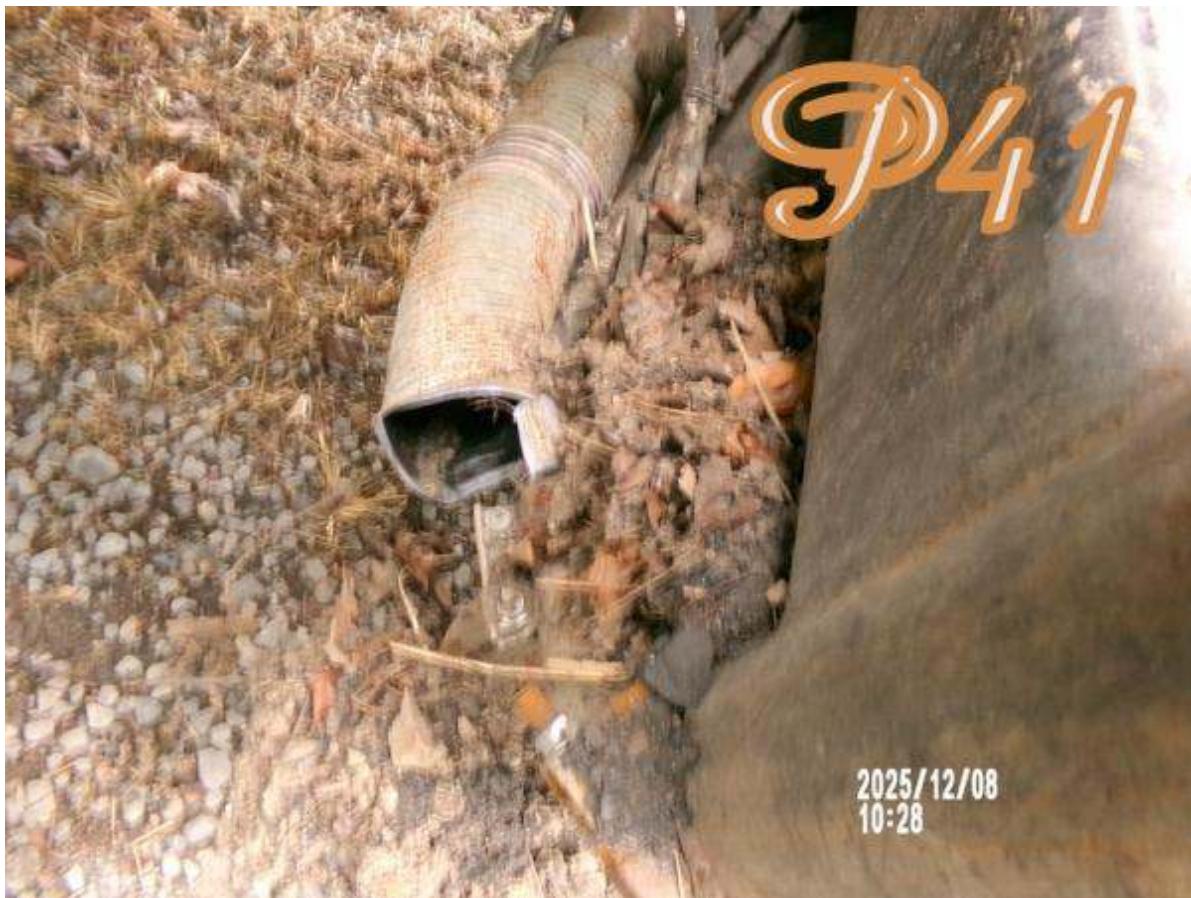
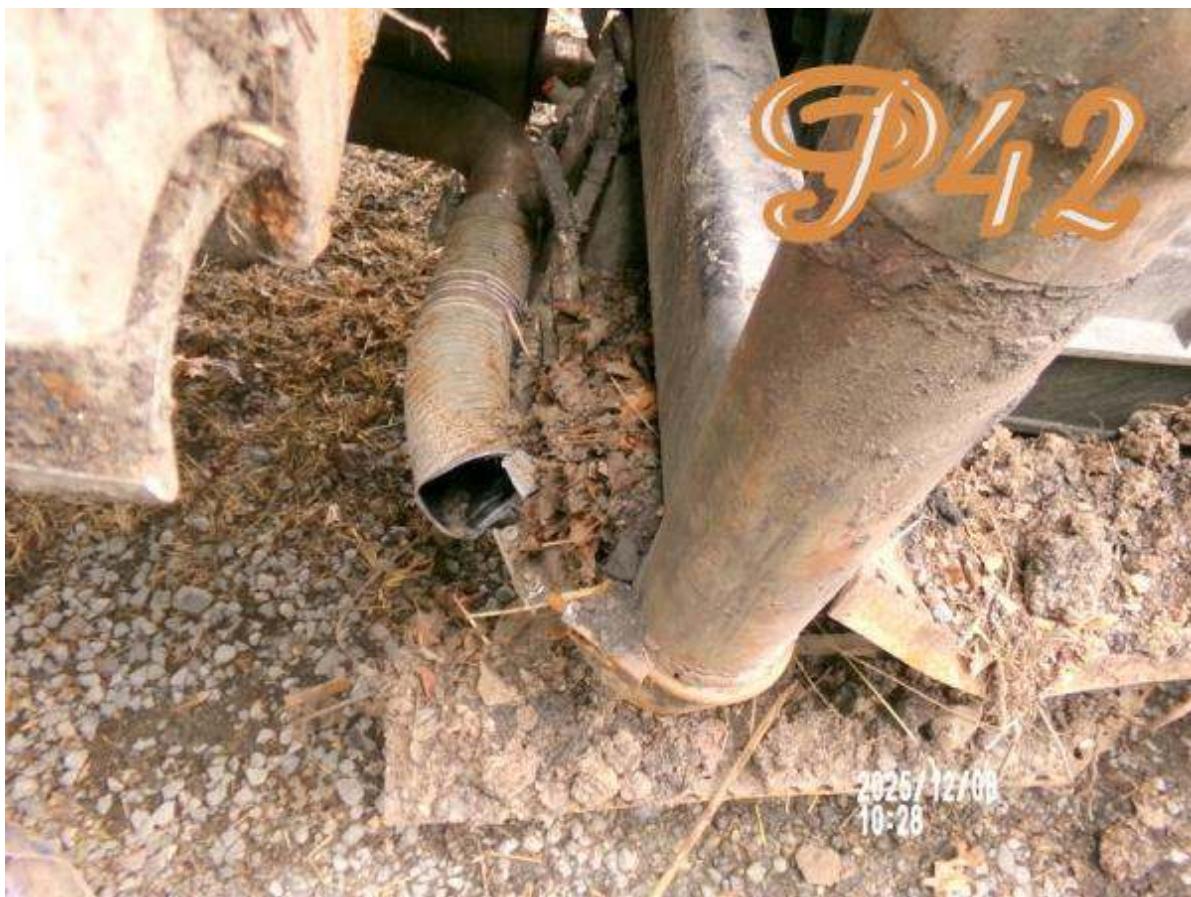
DAMAGE EXHAUST

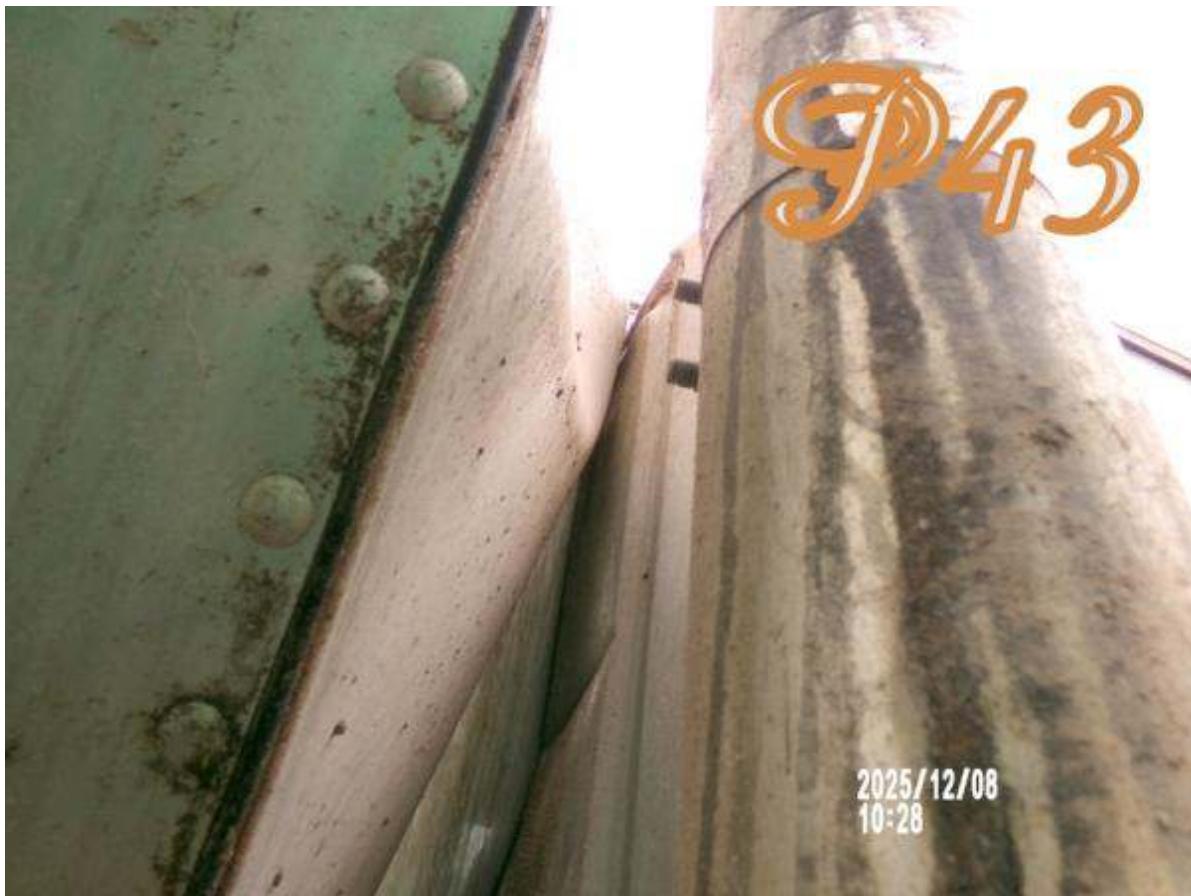
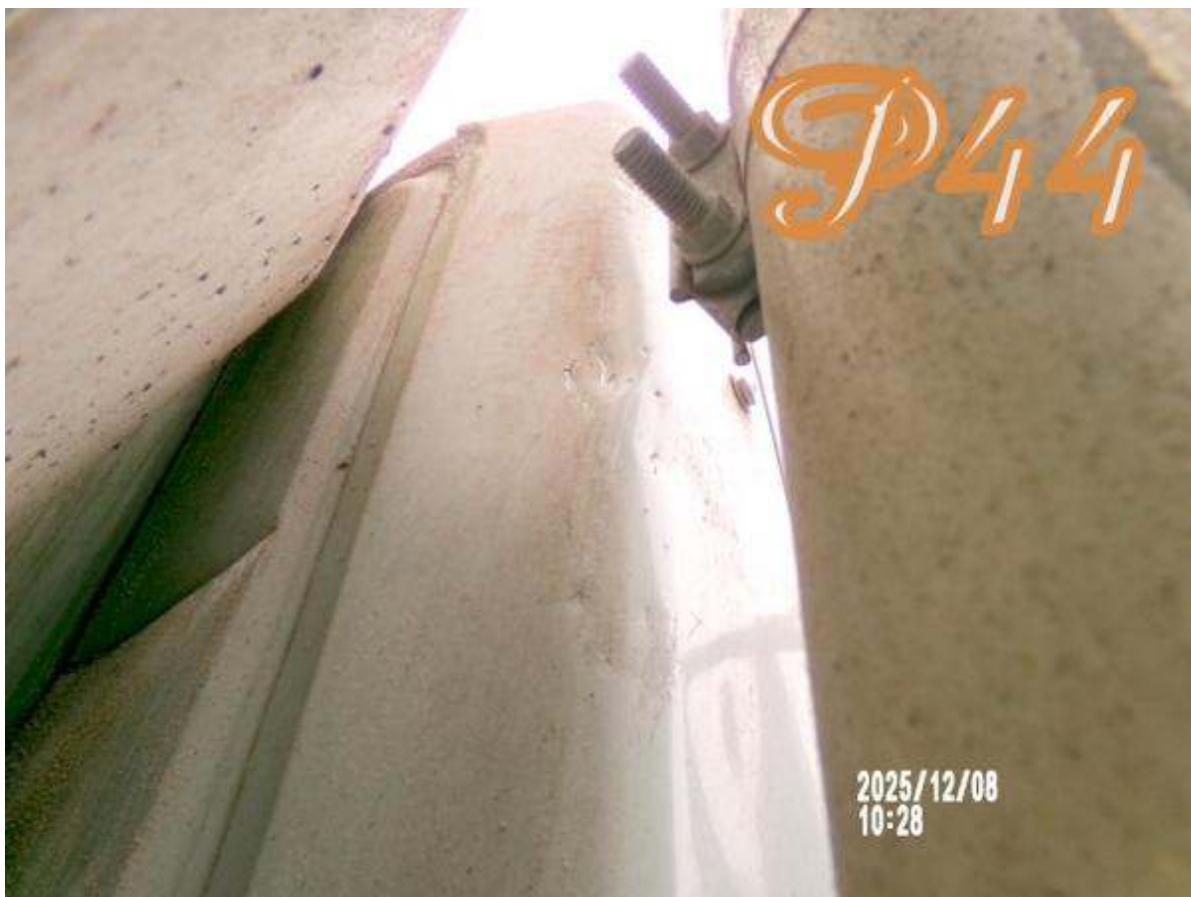
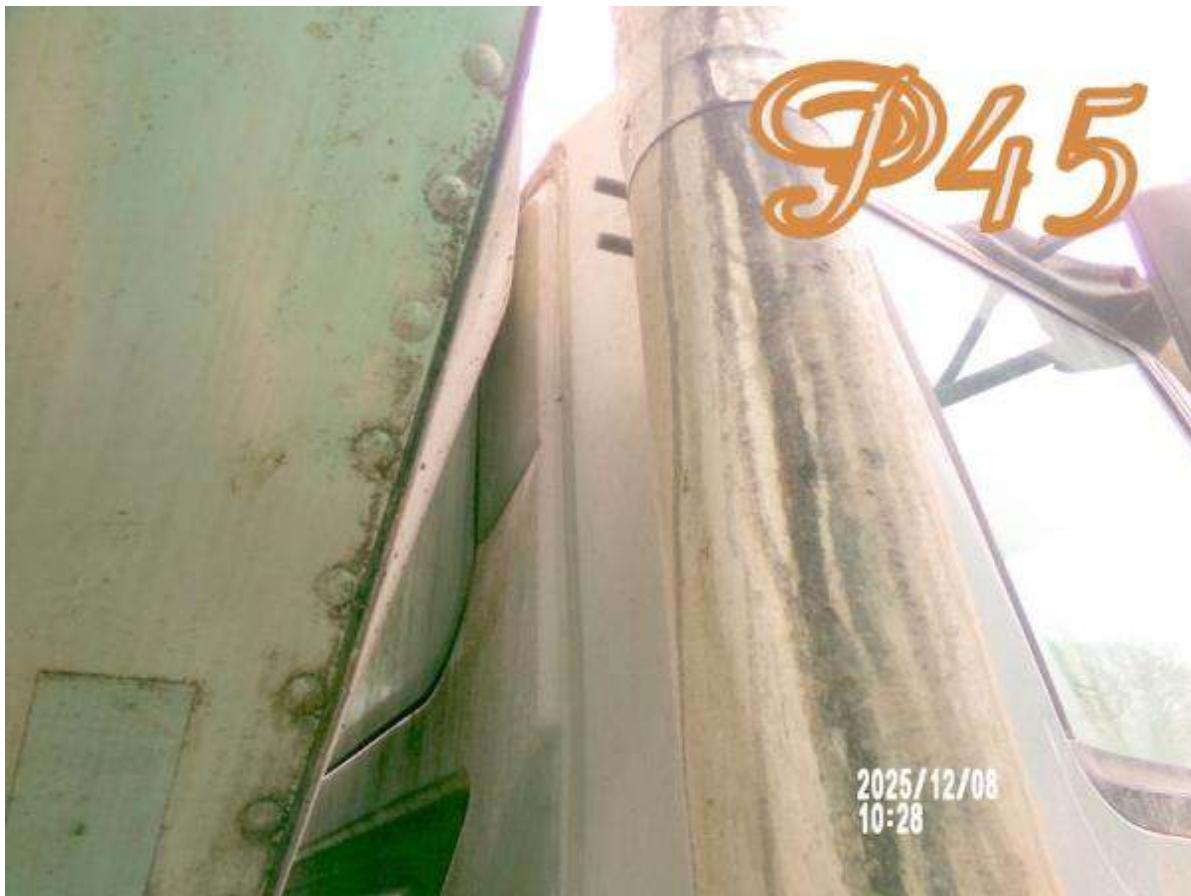
DAMAGE PANEL BACK/CORNER RS CAB

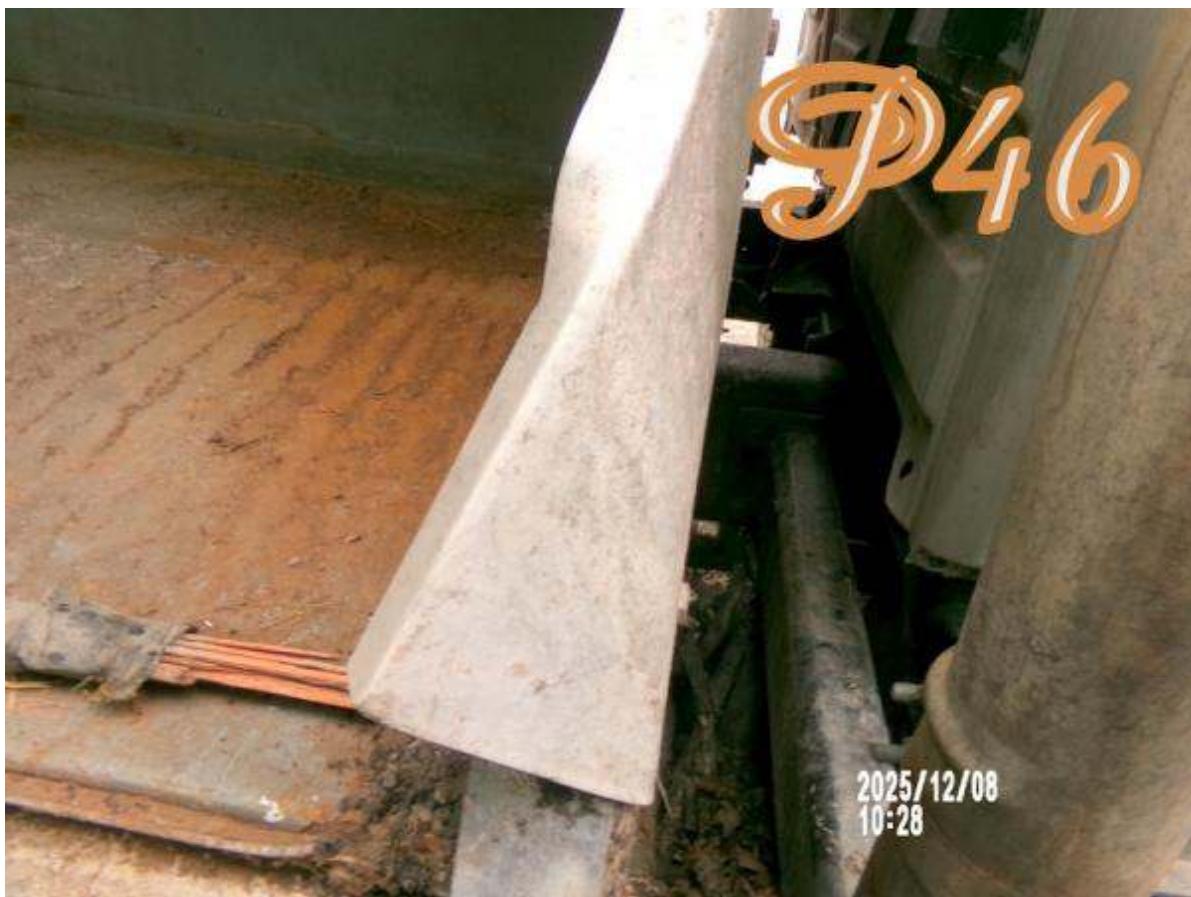
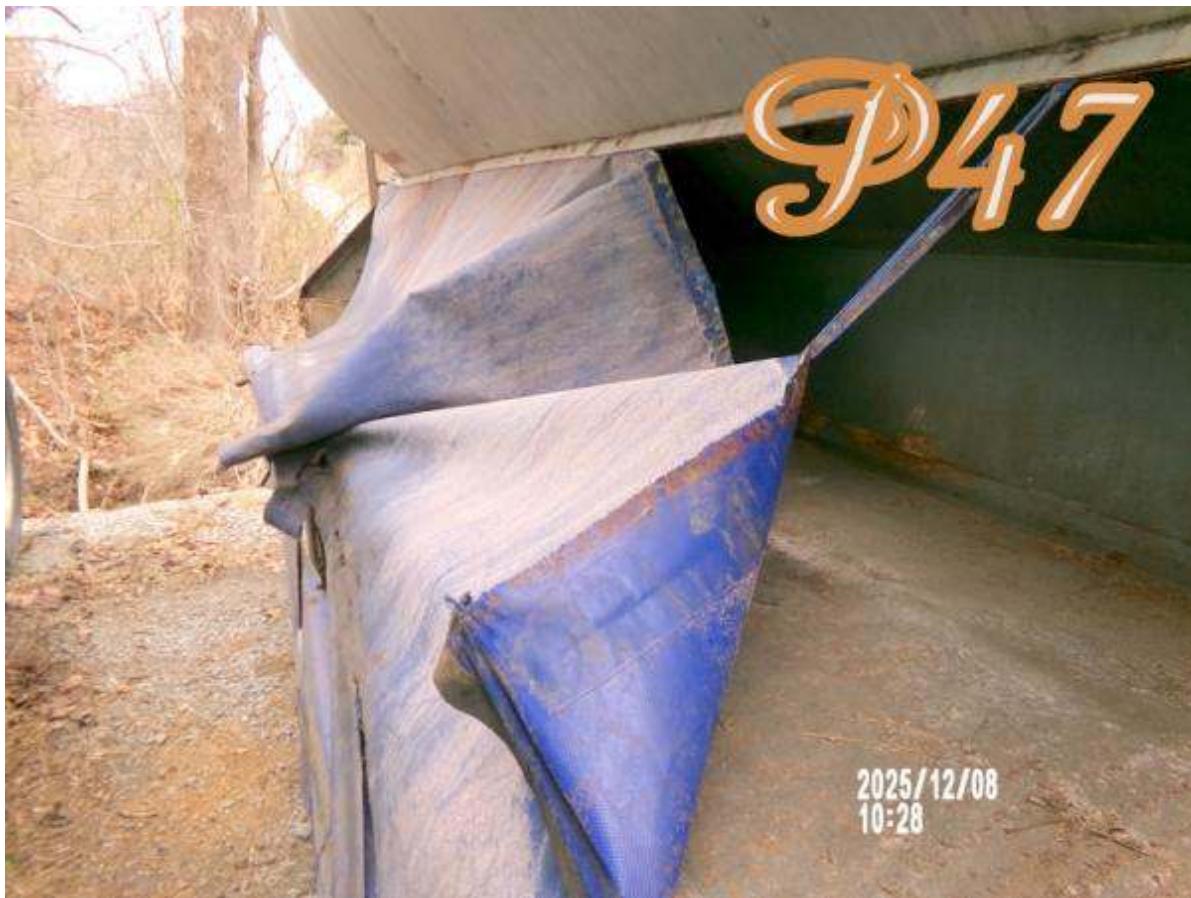
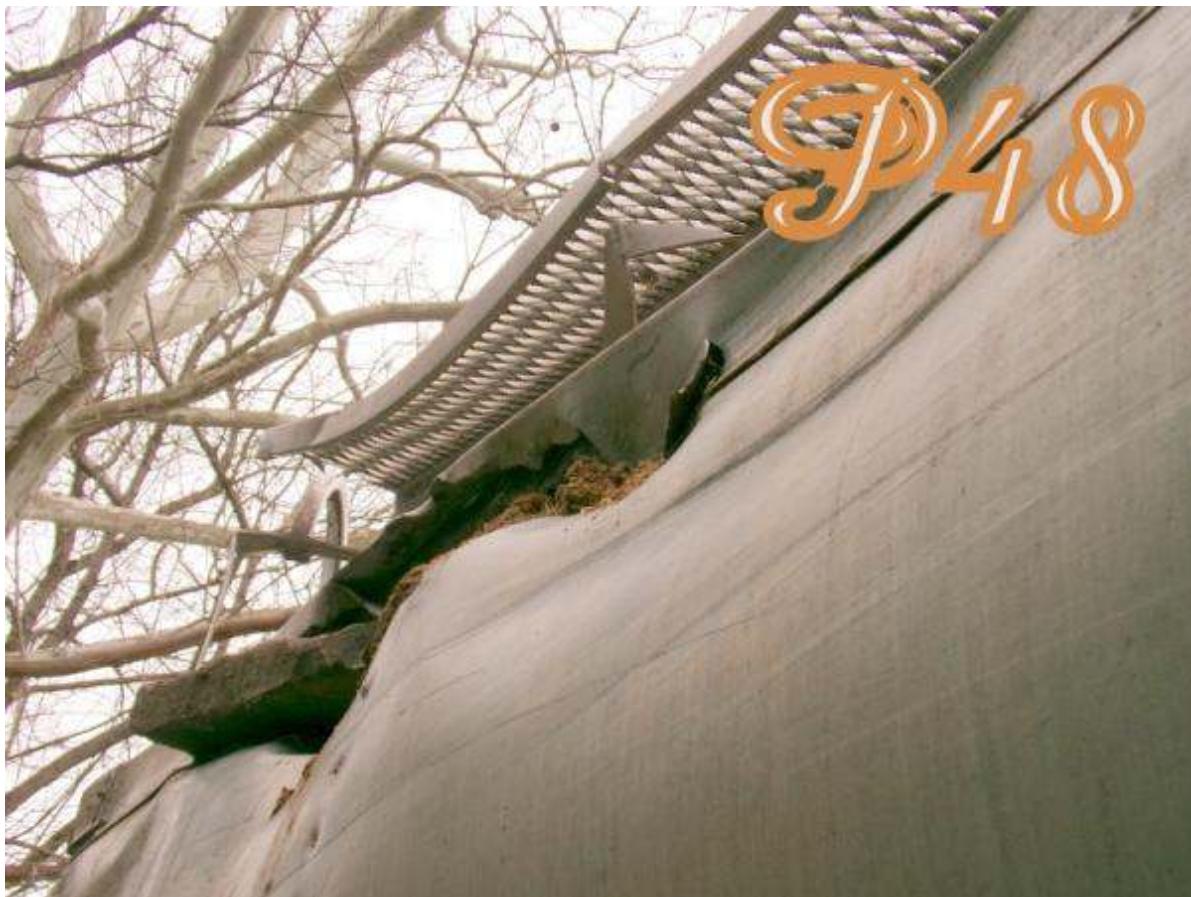
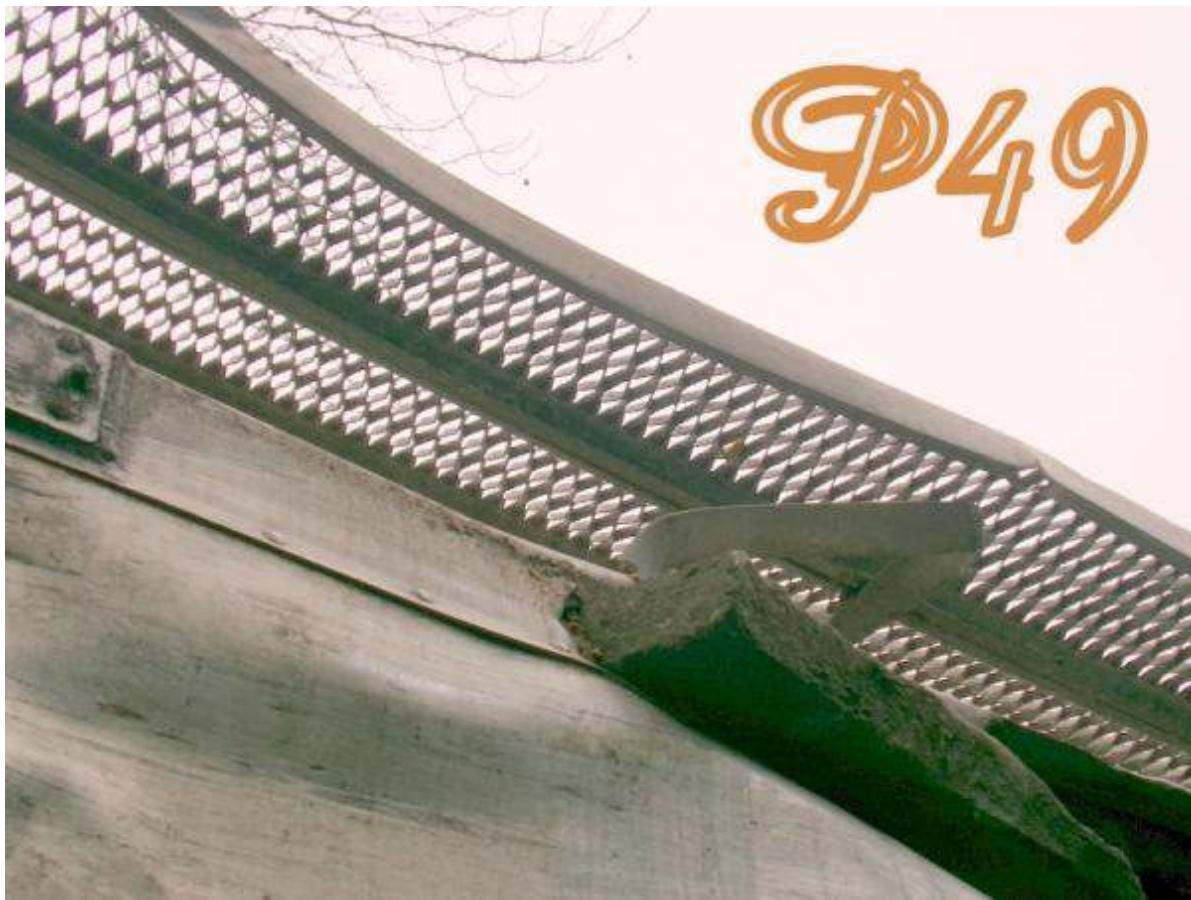
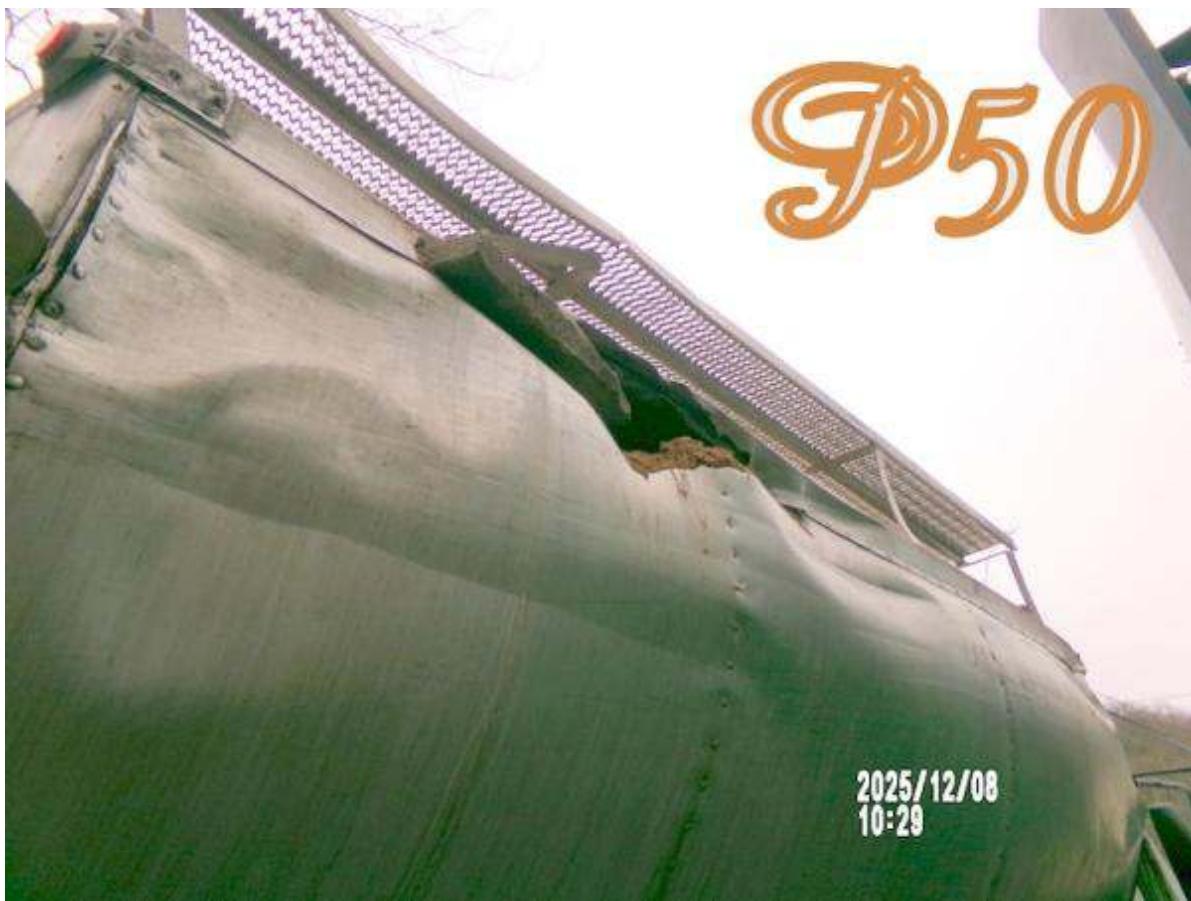
DAMAGE TANK FEED
