**Sedgwick**  
**131 Saundersville Road**  
**Hendersonville, TN 37075**

VIN: 5V8VC5321MT110015  
Style: Not Applicable  
Plate/State: 791466ST - IL  
WMI: FIN:  
Odometer:  
Color:  
Date Of Loss: 1/26/2026  
Authorized By:  
Claim Number: E2J53281  
RO:

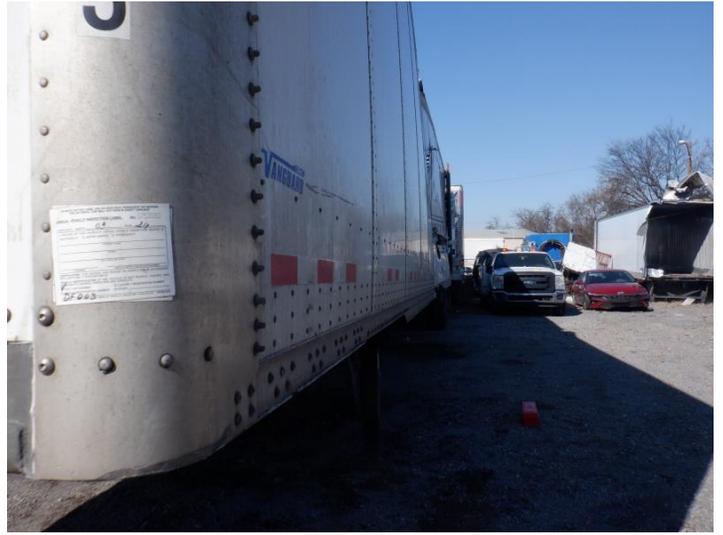
view down the bottom left rail to show the bow.

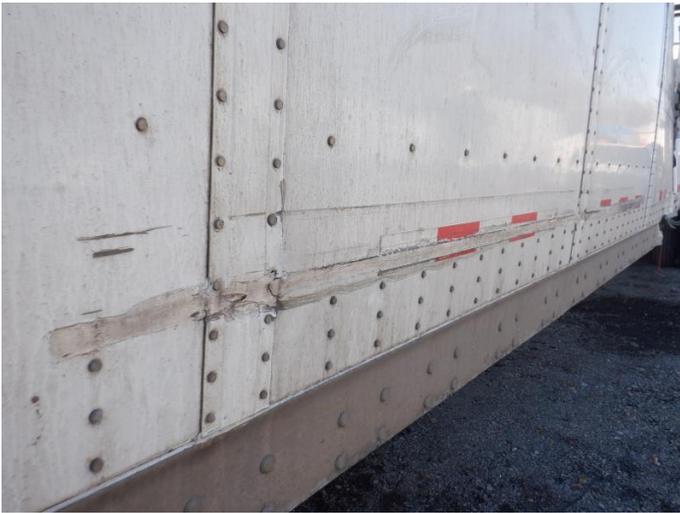
unrelated prior damage. Front left 3 panels.

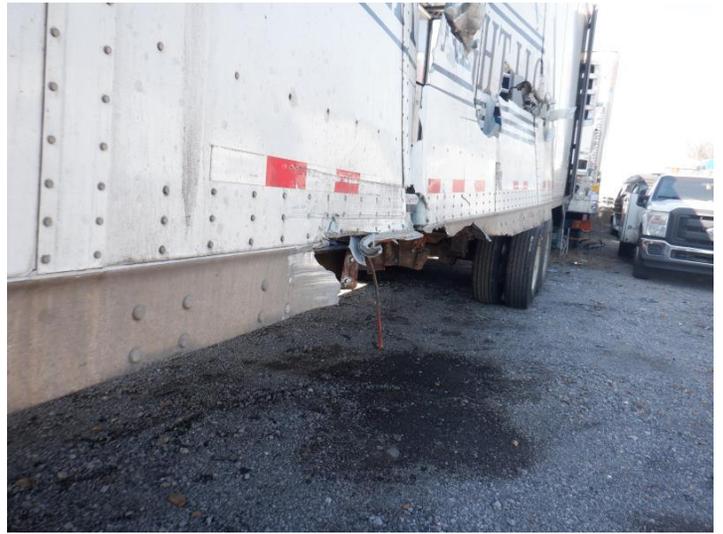
place of impact, bottom left rail, panels, crossmembers, floor.

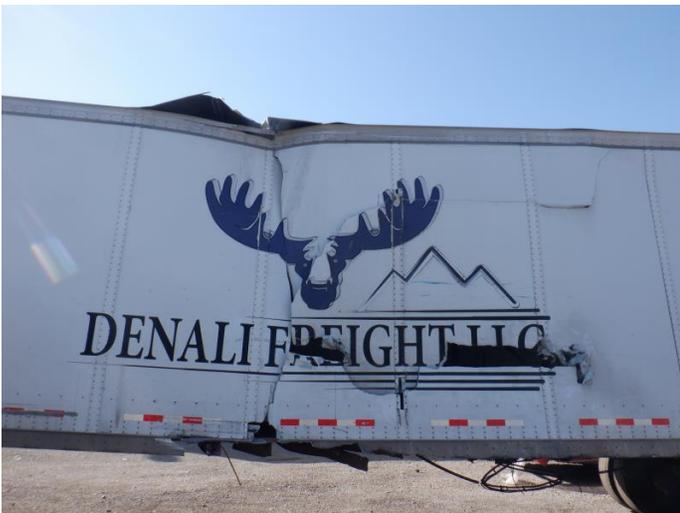
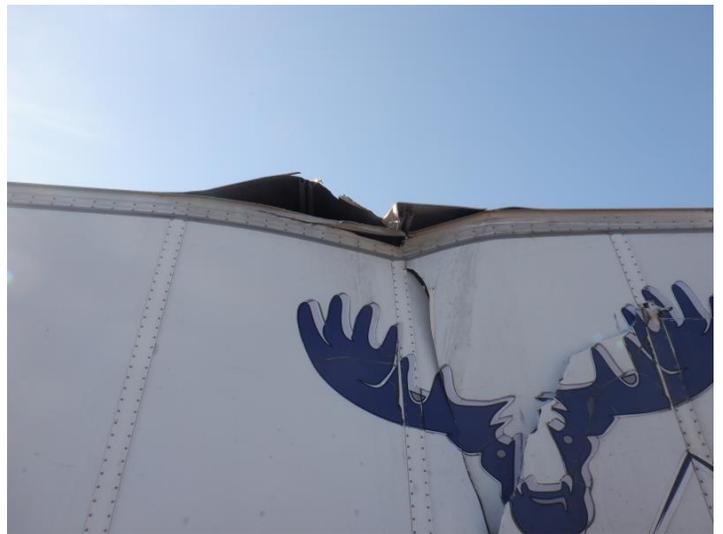
Left side view of impact area

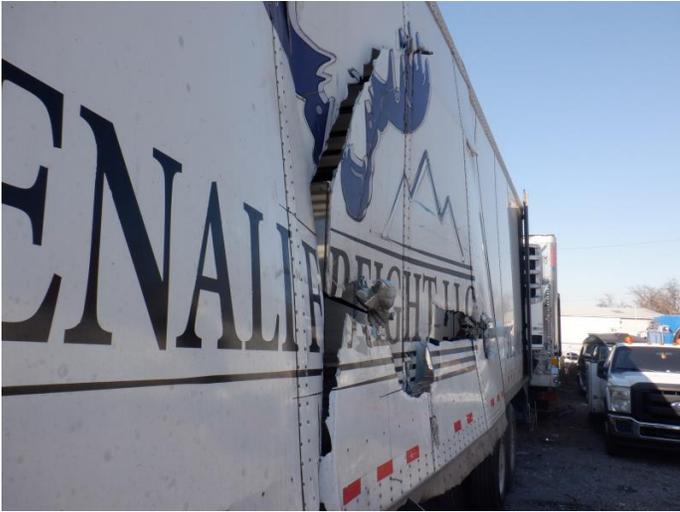
View of damaged panels

upper rail is damaged. the roof is damaged as well.

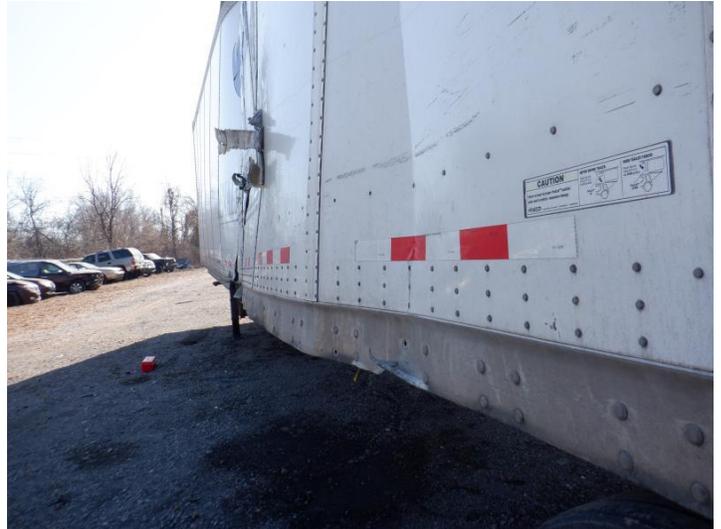
view from the rear of the trailer looking towards the front to show the deformation of the trailer.

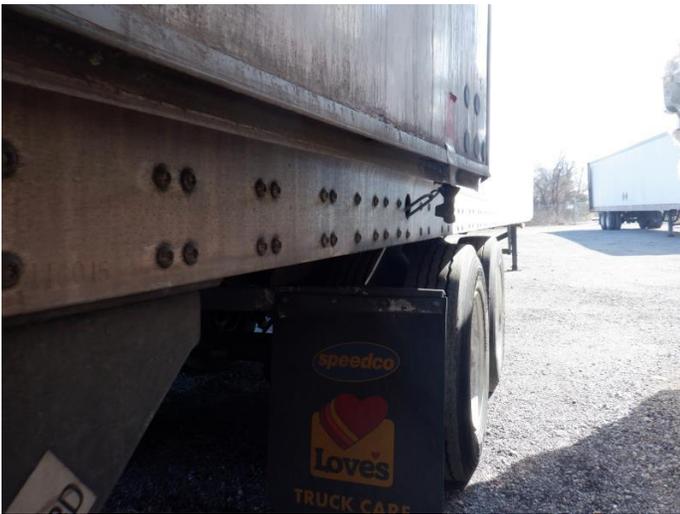
this is a view from the right side at the back looking down the lower right rail. No damage

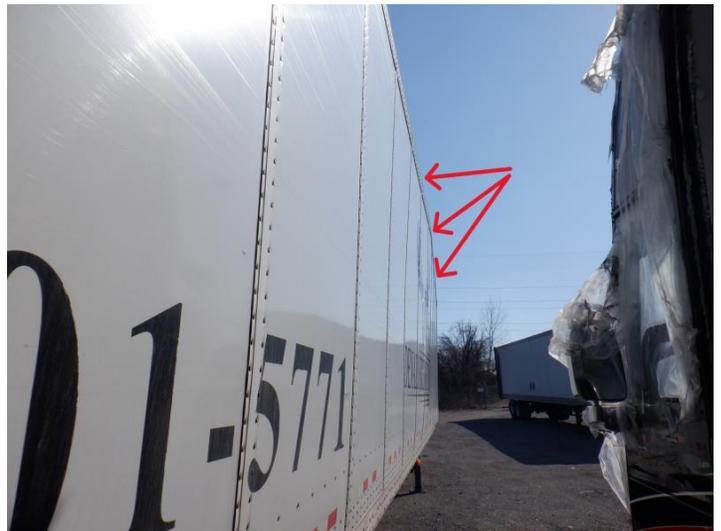
Same location looking down the right side. The arrows indicate where the right side and upper rail have bowed out from the impact to the left side pushing the right side out.

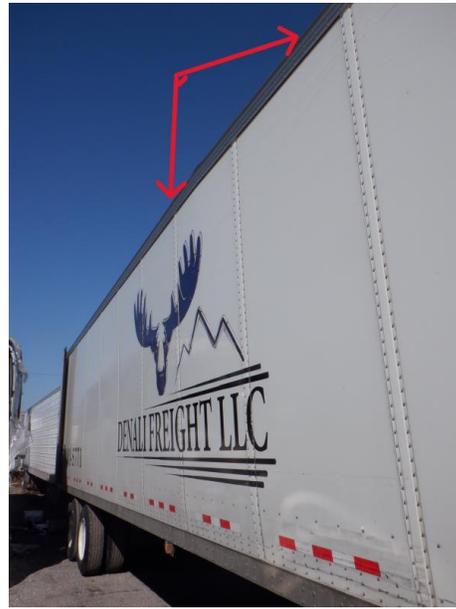
Upper right rail is bent

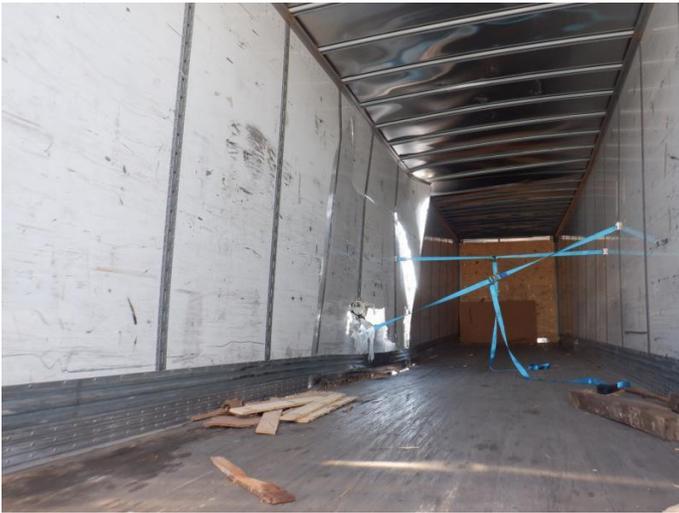
interior: looking at the left side impact damage.

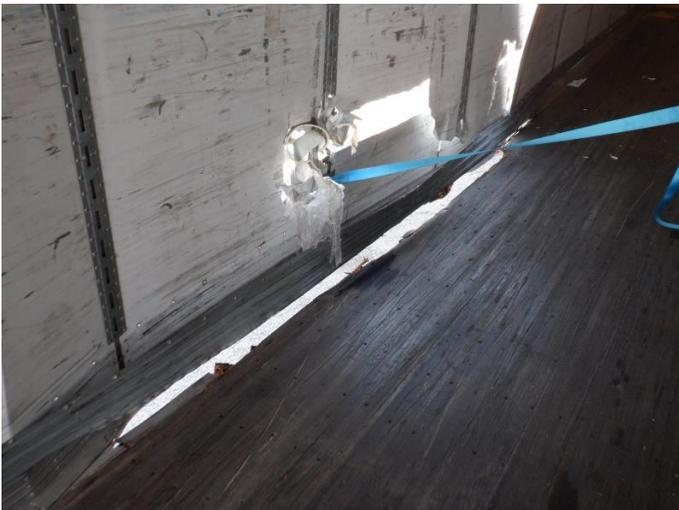
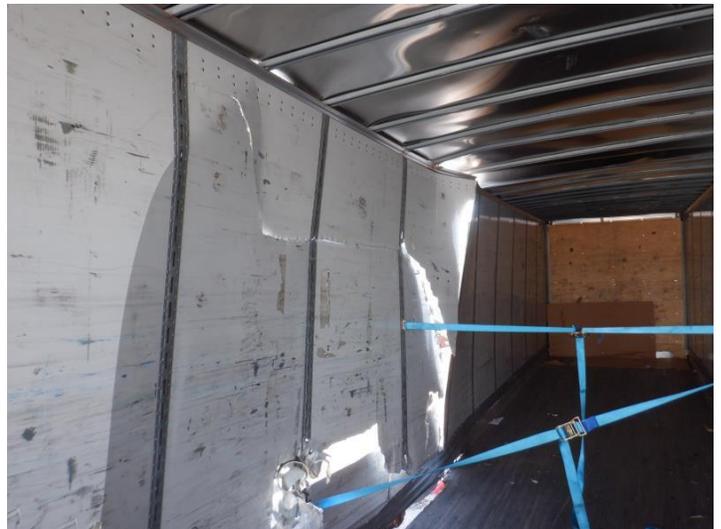
area of impact: floor, inner panels, inner post are damaged and separated.

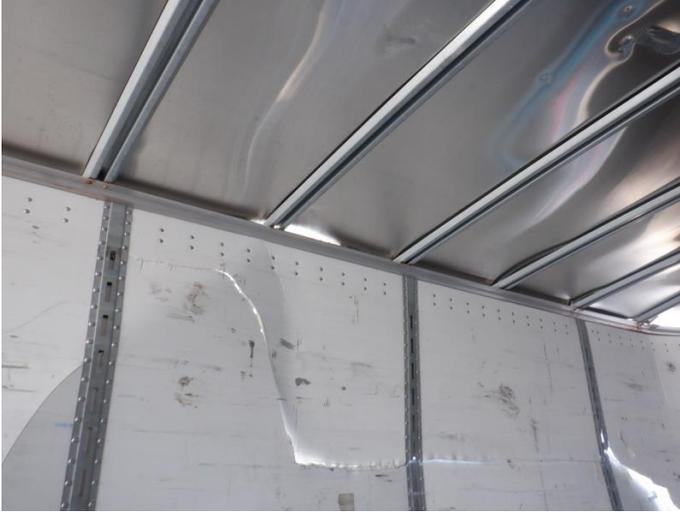
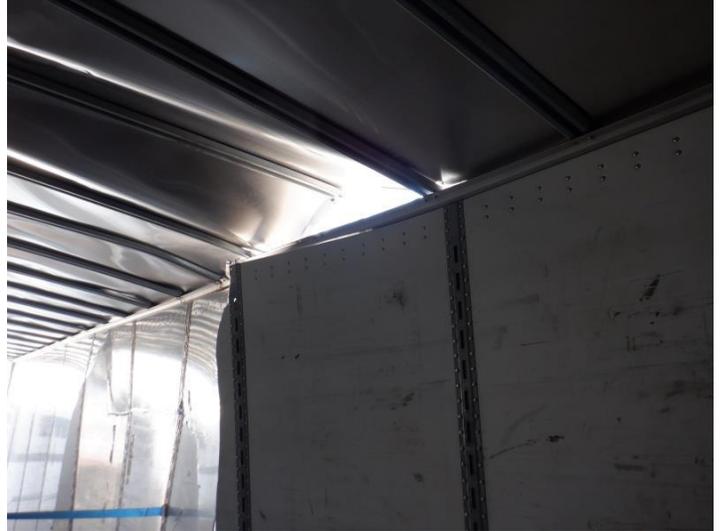
roof, is damaged and has started to separate. Vanguard trailers have a one piece roof.

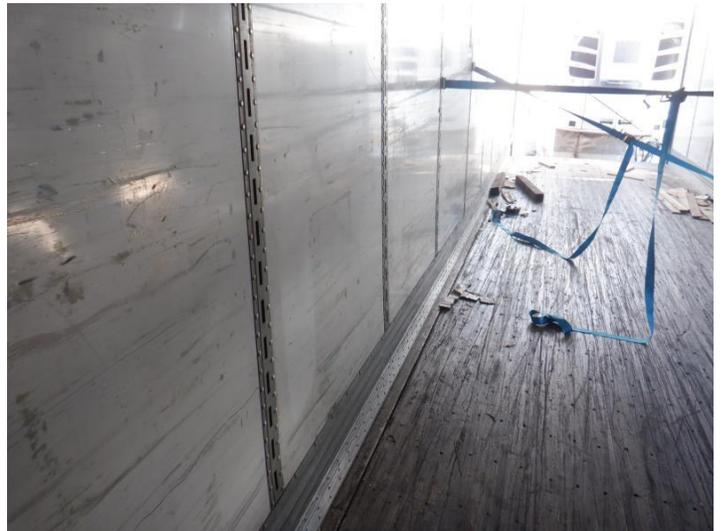
Right side directly across from the impact, signs of bowing are starting at the floor moving up the wall

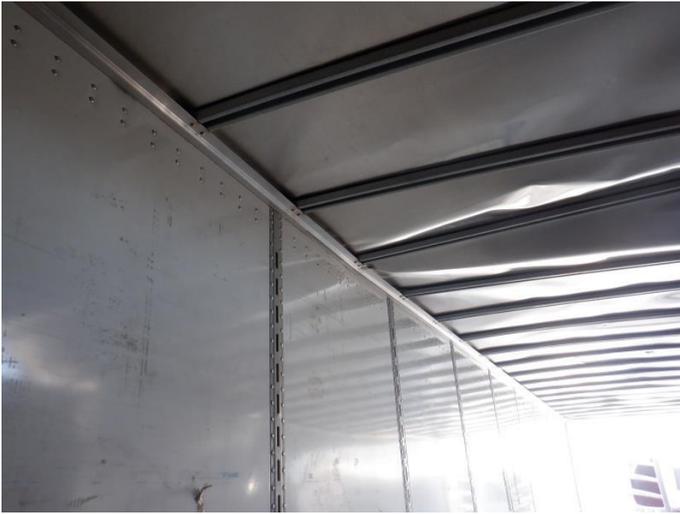
Right side shows signs it is starting to bow from the impact.

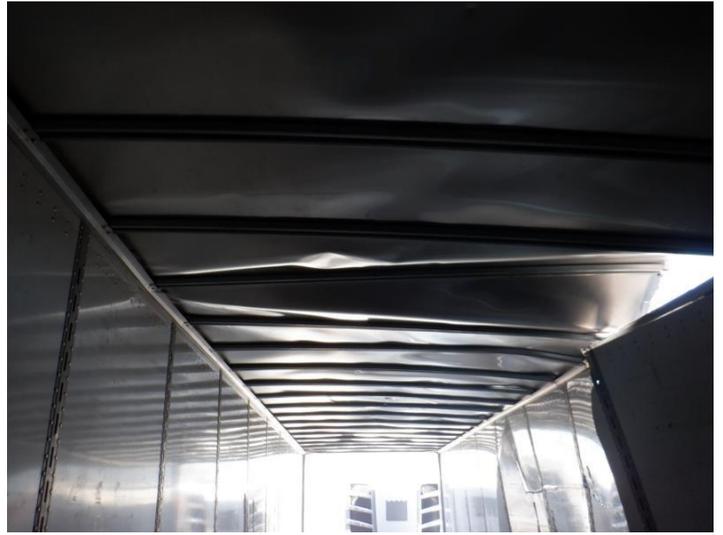
Overall view of the roof damage

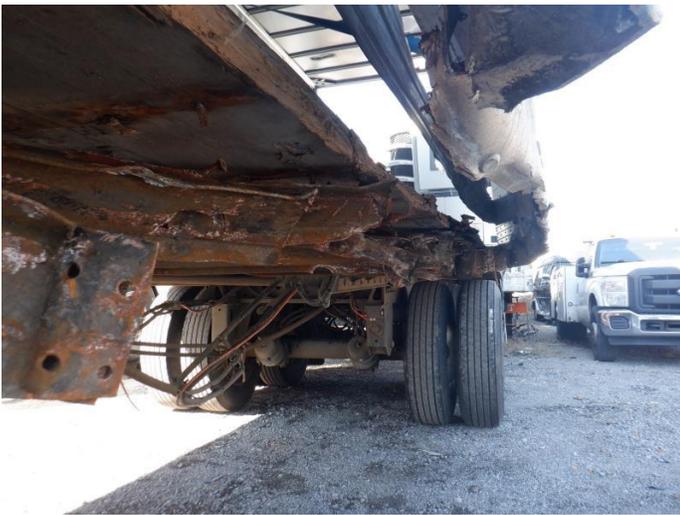
view from the left side showing around 16 floor crossmembers are damaged, as well as the flooring, and left side trailer wiring.

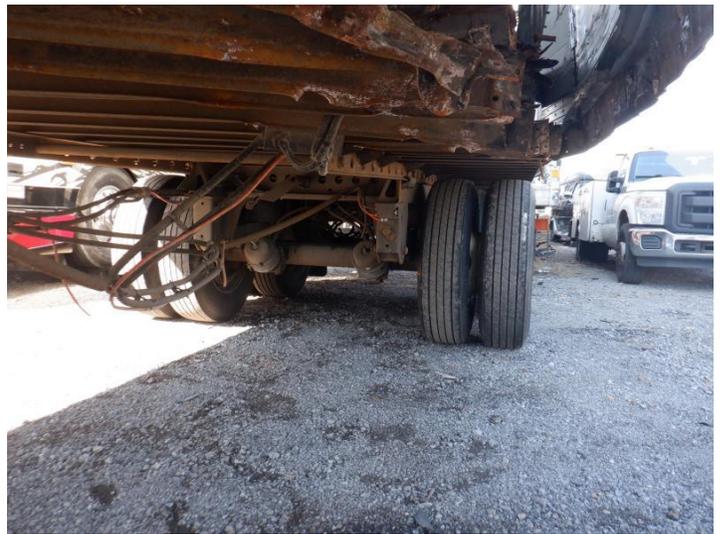
View of the rear axle set. they appear strait and undamaged.

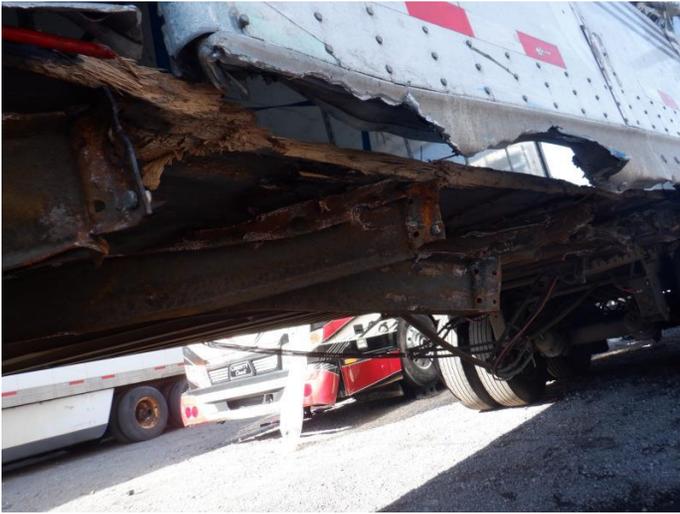
lower damages

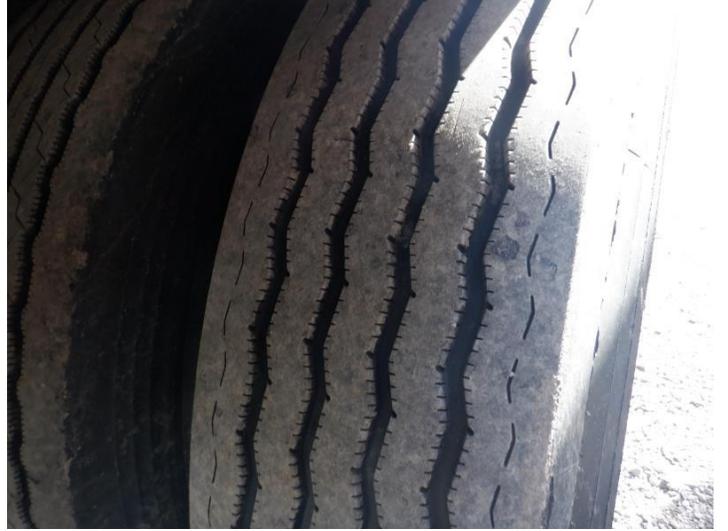
Over all great condition. Around 8/32nds

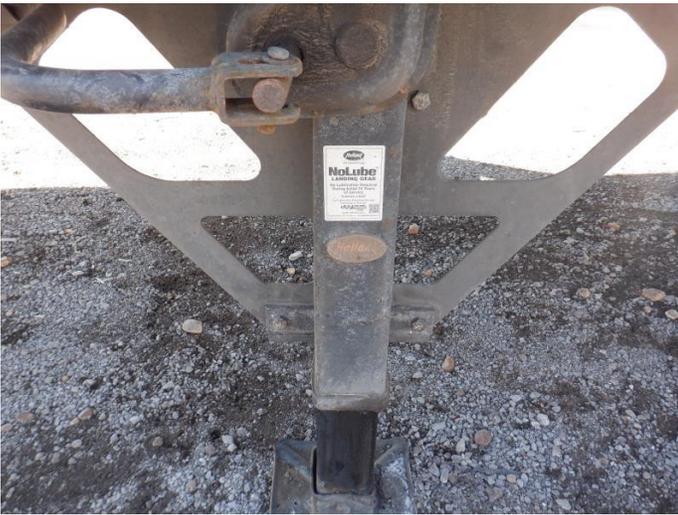
Jack set. no damage
