Claim Number: 00659070 SCA File: 8173248

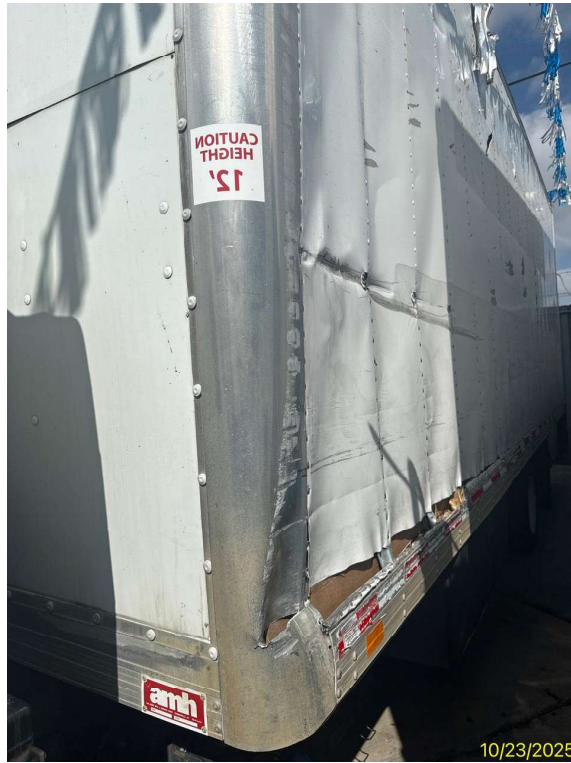
Description: Damage Area - Close up

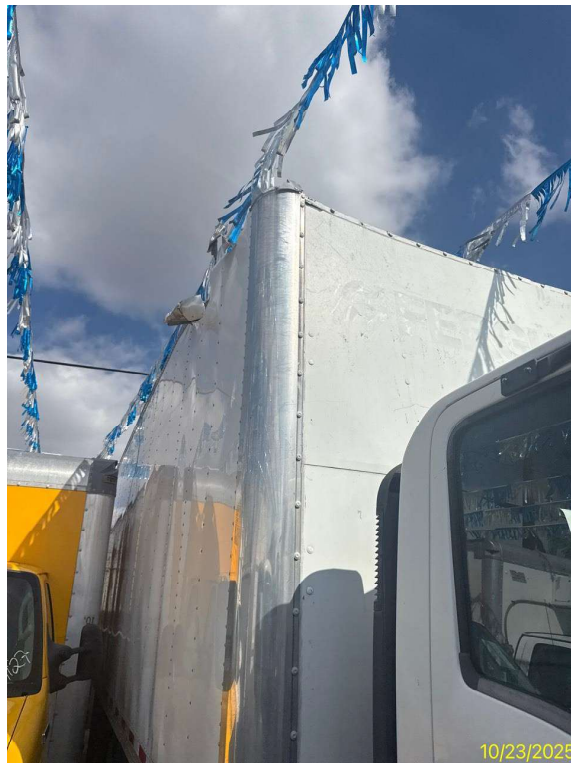
Description: Damage Area - From Left Angle

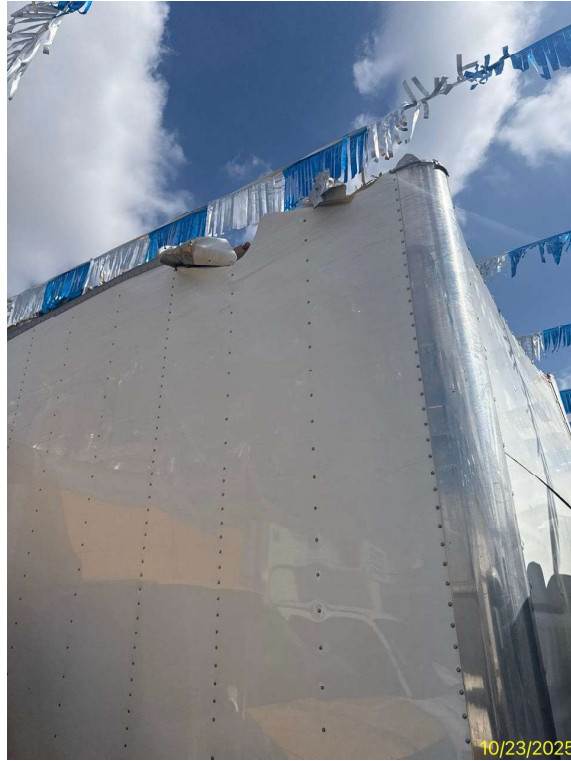
Description: Damage Area - From Right Angle

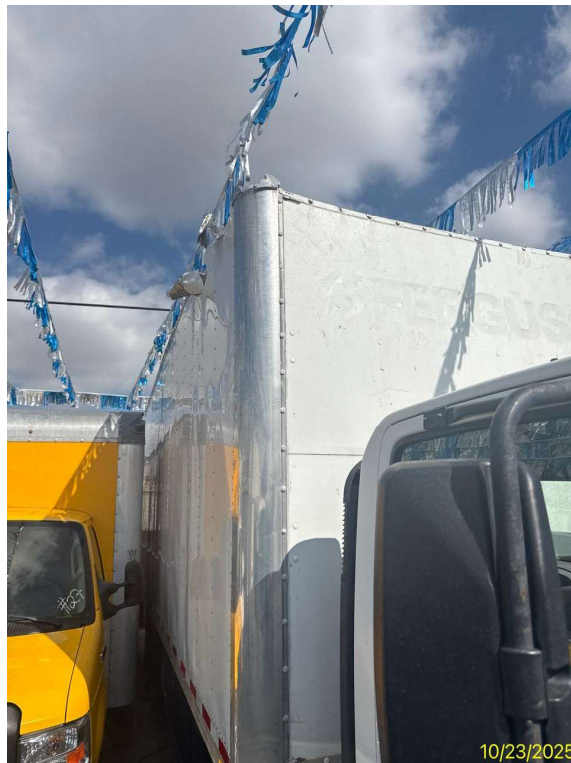
Description: Damage Area - Overview
