FREIGHTLINER

VEHICLE EMISSION CONTROL INFORMATION
 Manufactured By: DAIMLER VEHICULOS COMERCIALES MEXICO Date of Manufacture: 05/19
 VIN/VN: 3AKJHHDRALSLP9072 REGULATORY CLASS: High-roof sleeper cab tractors above 26,000
 VEH FAMILY CO: LDTN2TRAC14C pounds GVWR
 GVWR/PNBV-KG: 23,745
 GVWR/PNBV-LBS: 52,350 EMISSION CONTROL IDENTIFIERS:

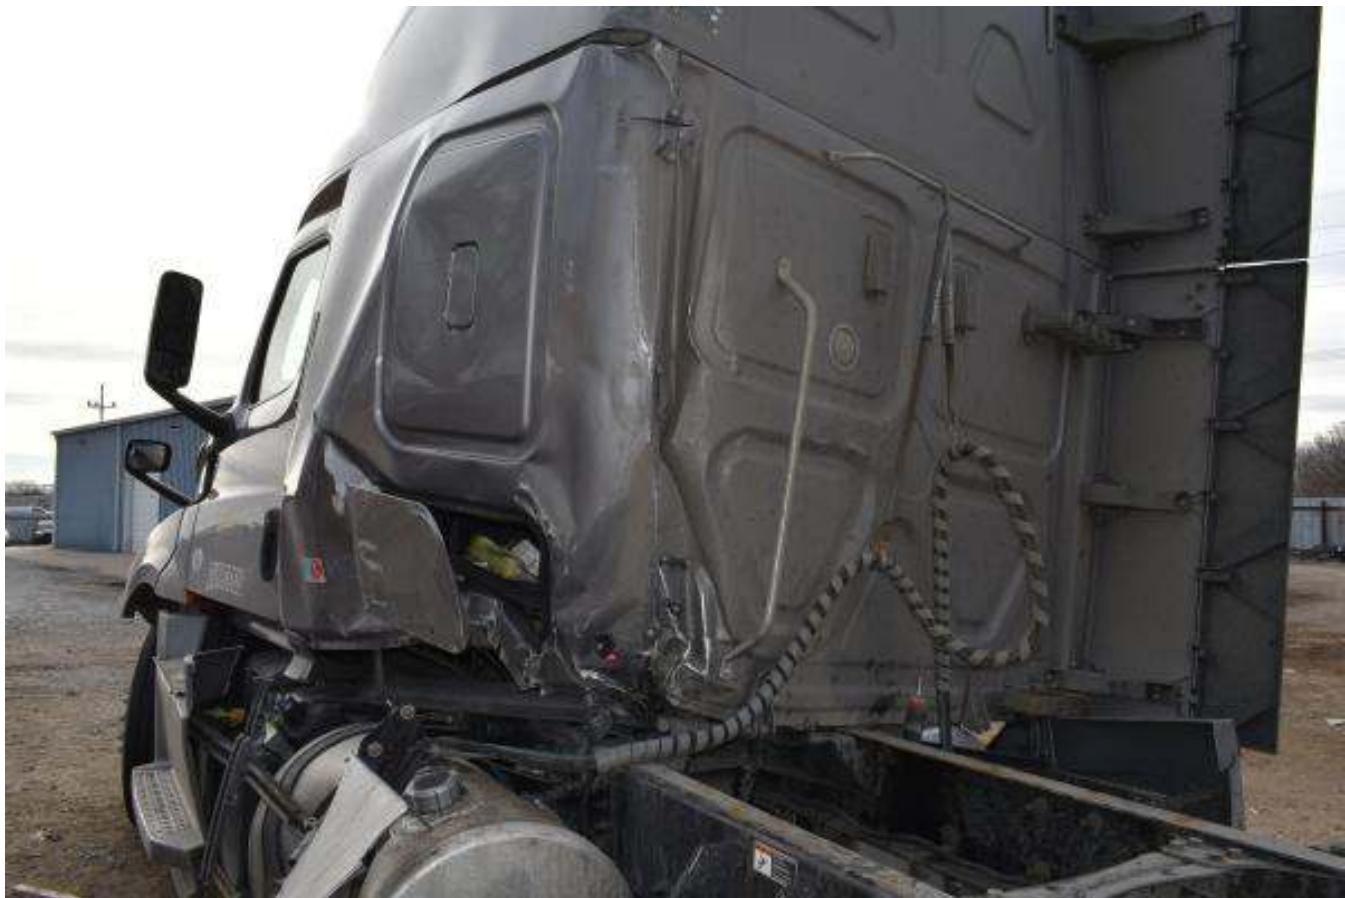
LF REAR DAMAGE

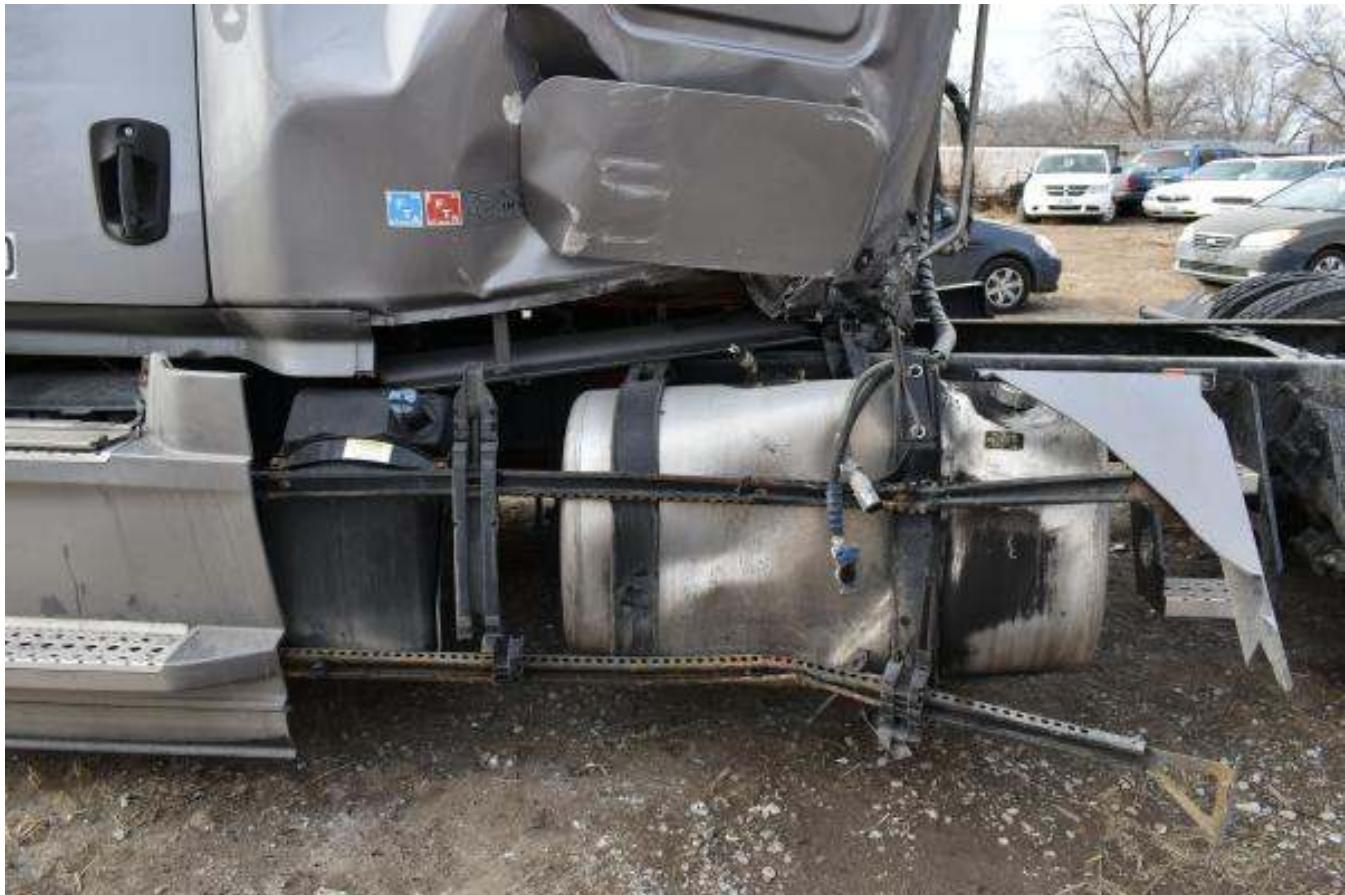
LF REAR CORNER DAMAGE

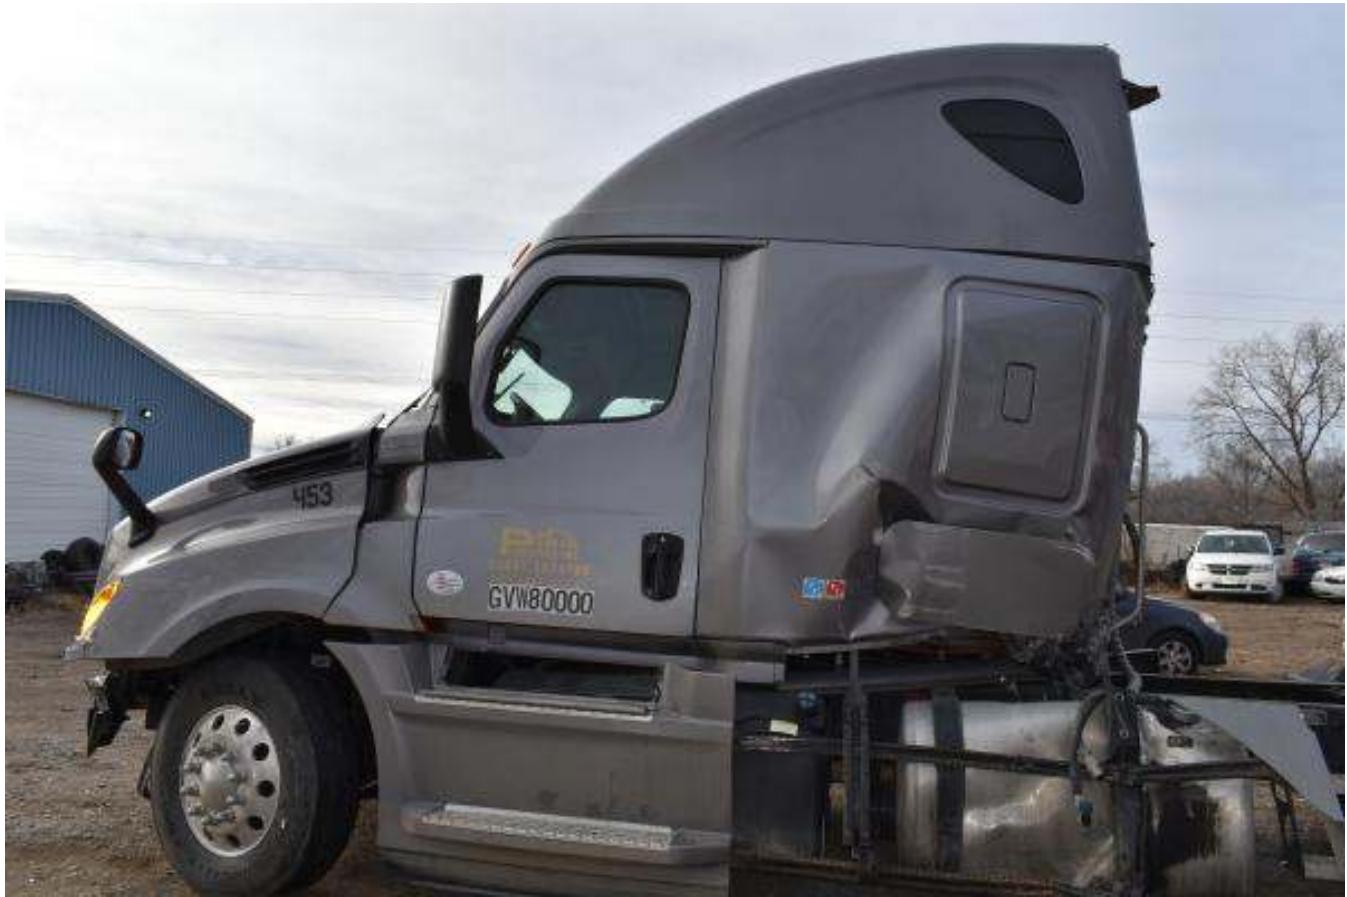
LF SIDE DAMAGE

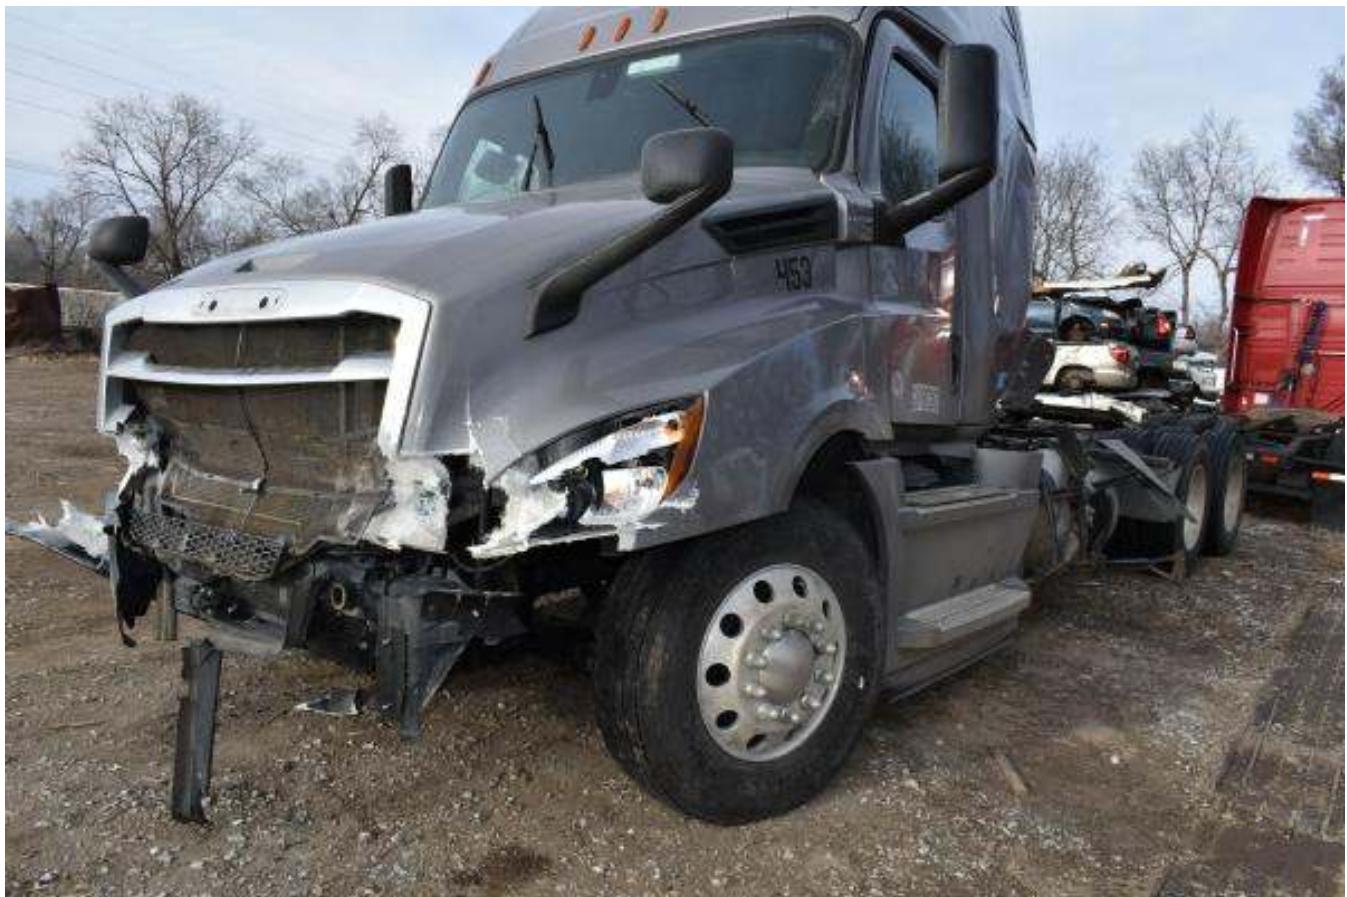
LF FRONT CORNER DAMAGE

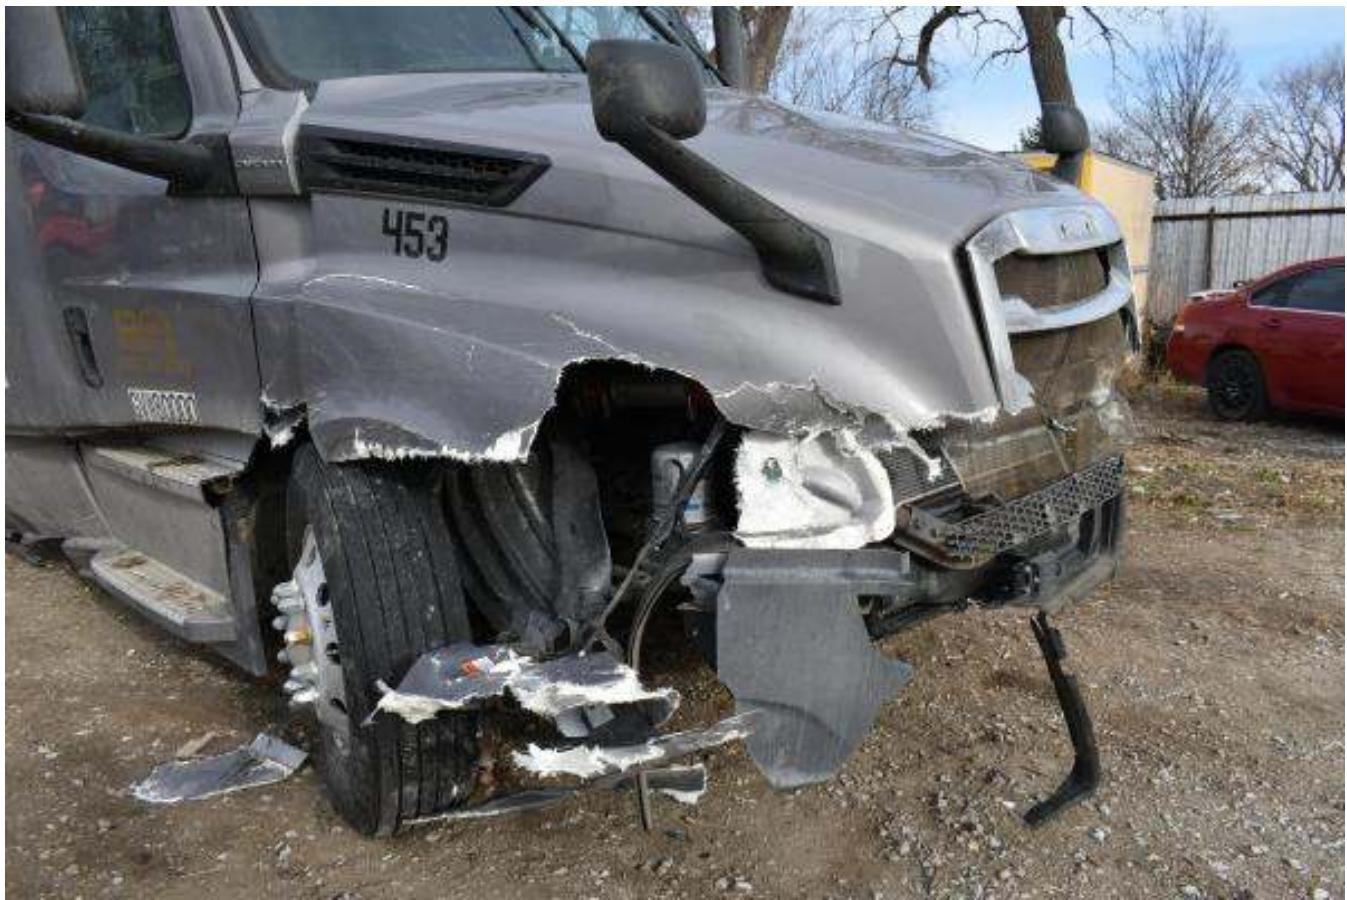
RT FRONT CORNER DAMAGE

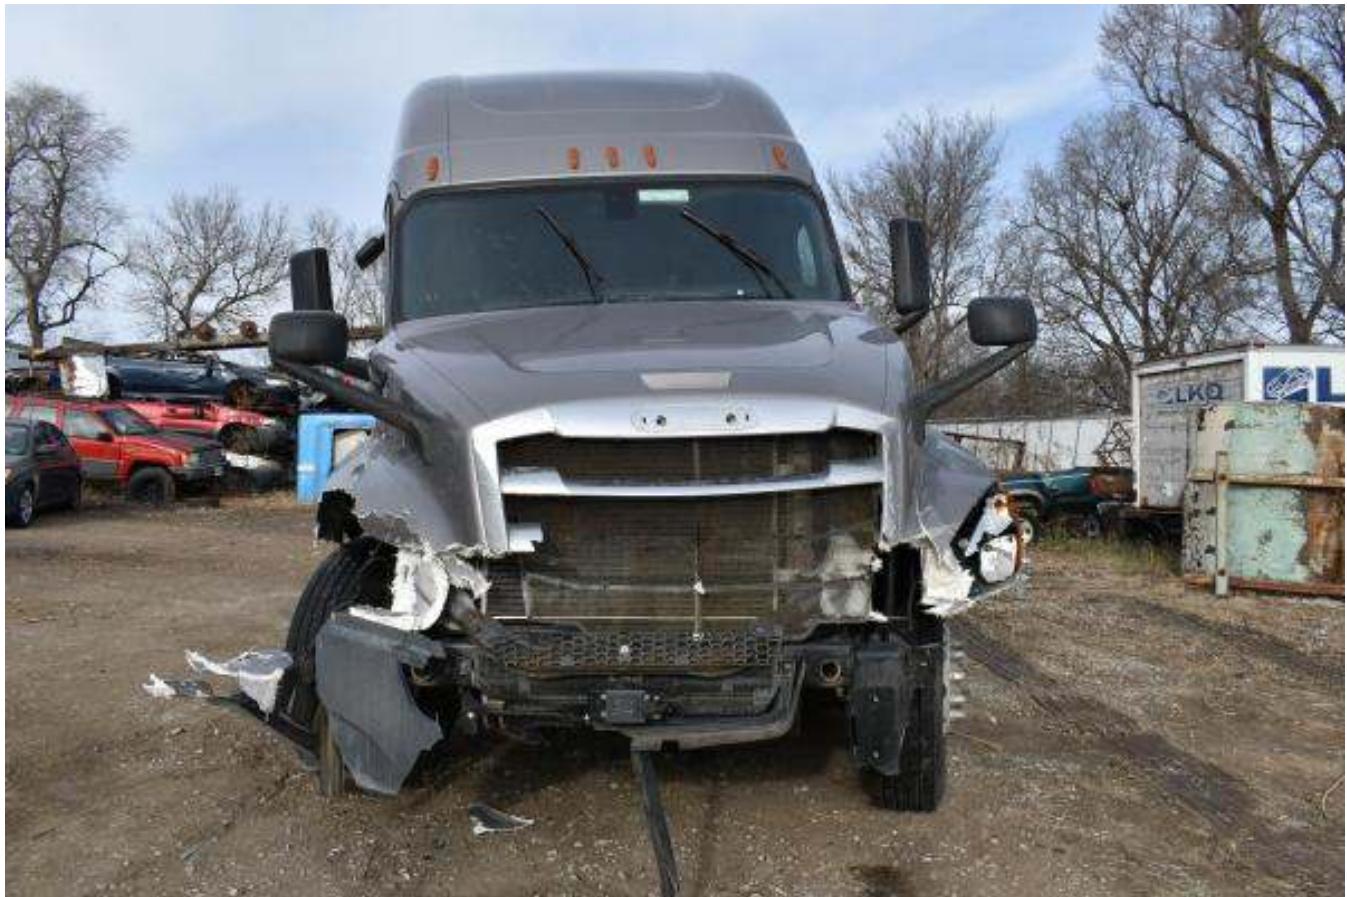
FRONT DAMAGE

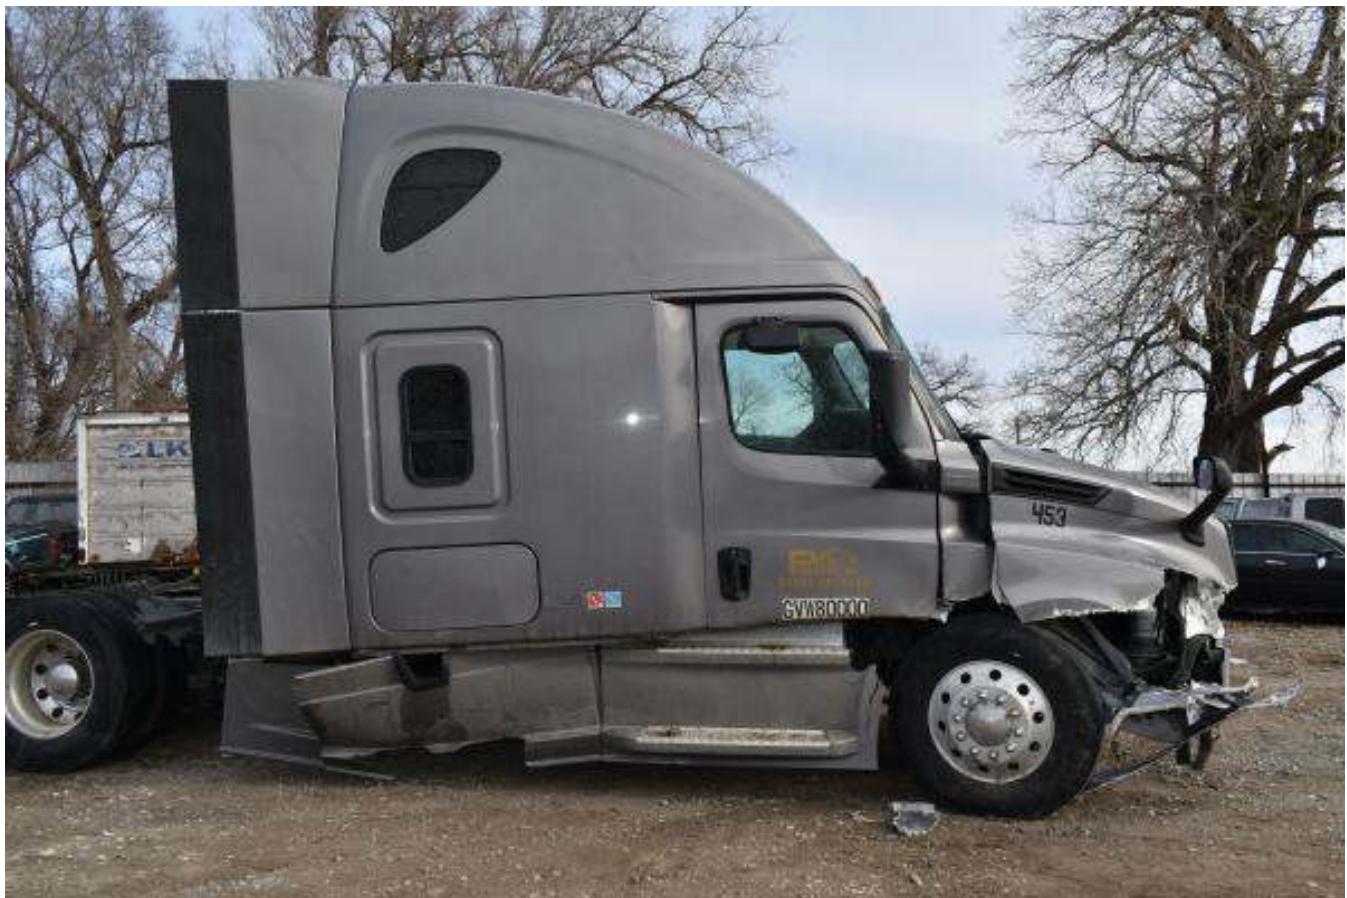
RT SIDE DAMAGE

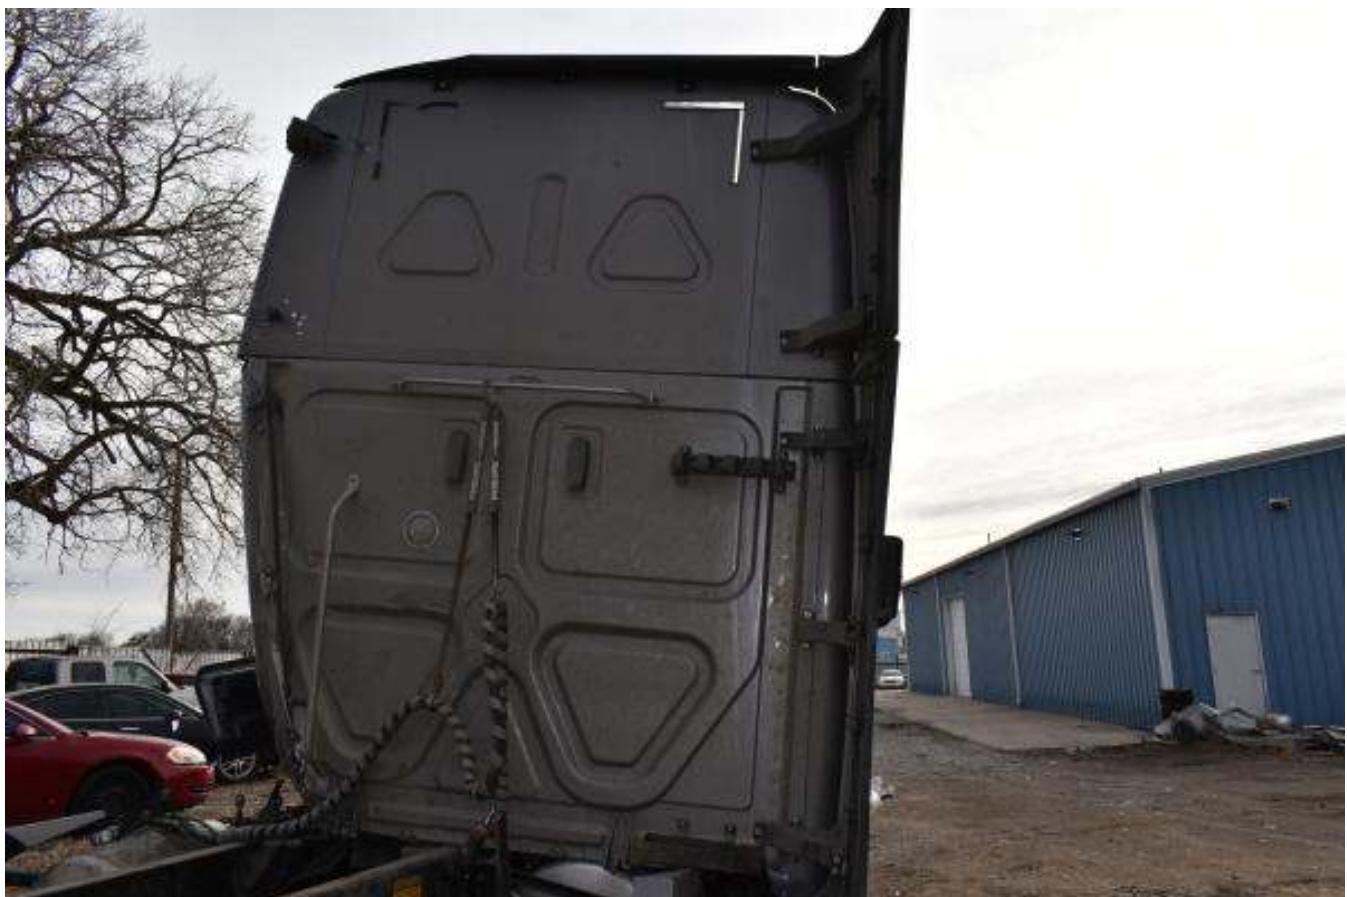
REAR DAMAGE

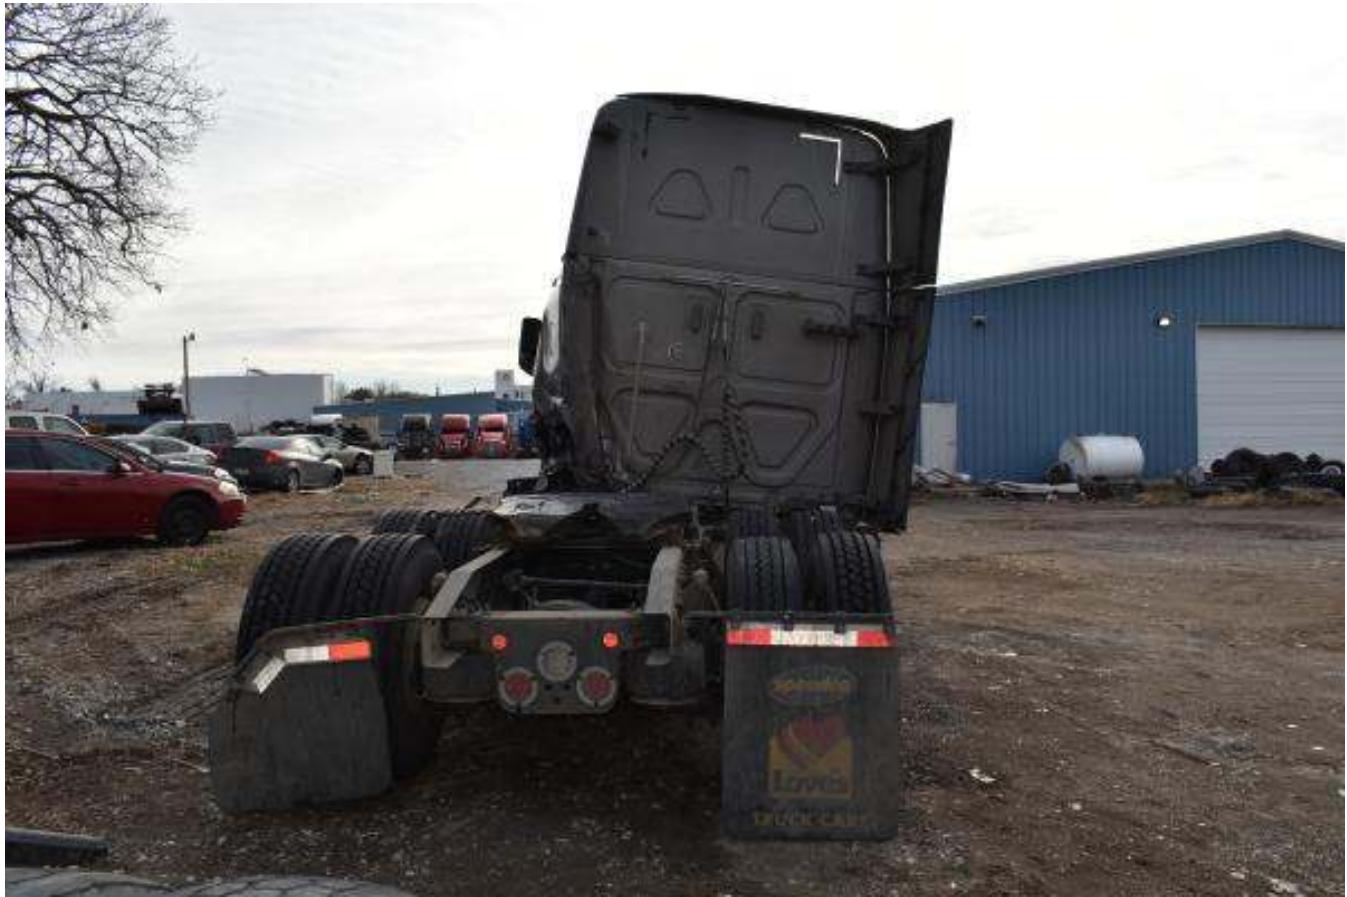
REAR VIEW TO SHOW RT SIDE SWAY

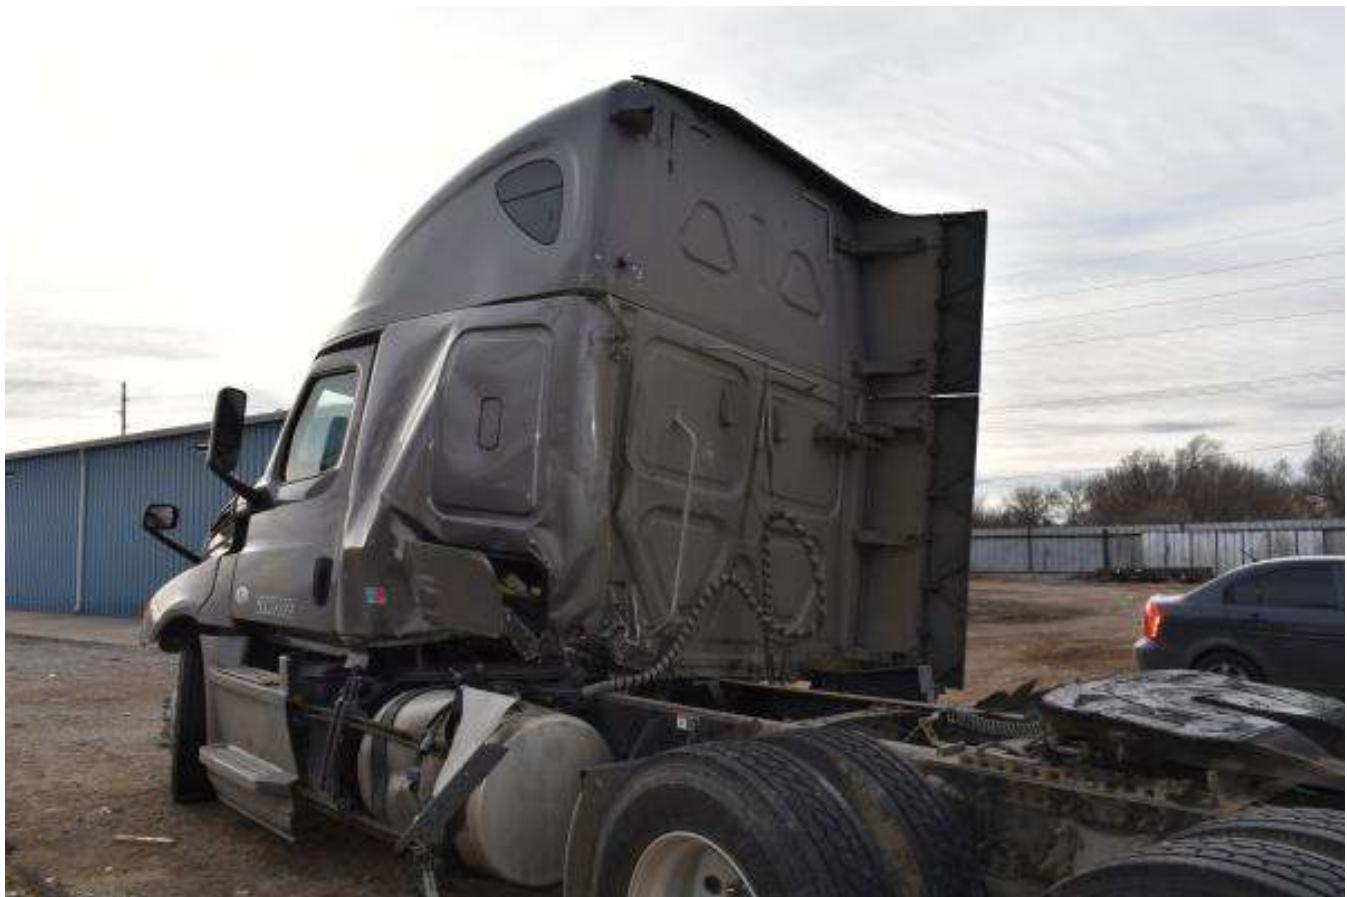
LF REAR SWAY
