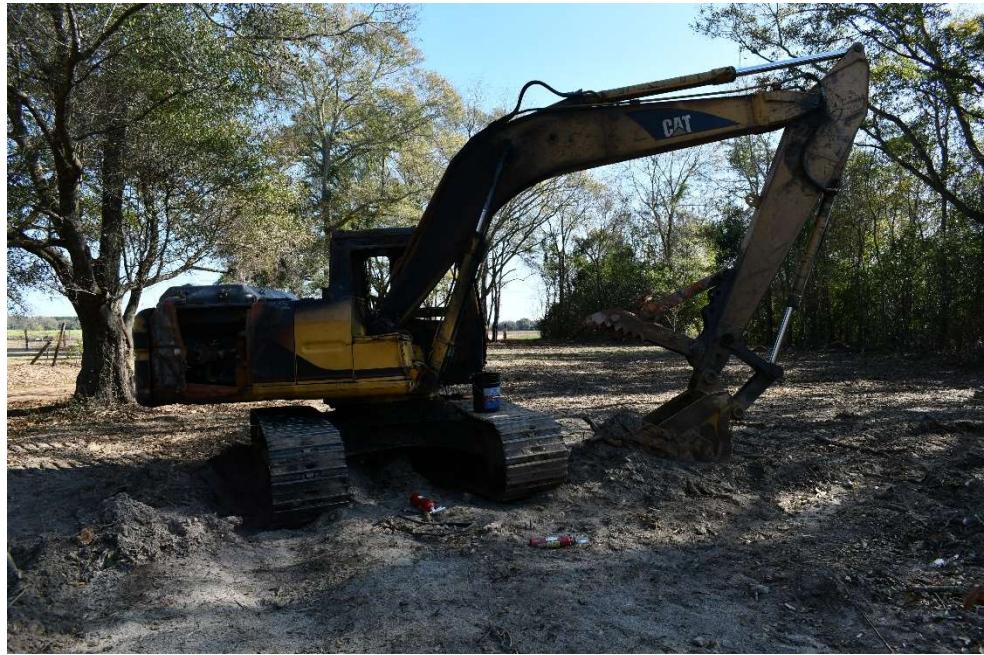
Photo 001: Showing discoloration of boom and rear of excavator.

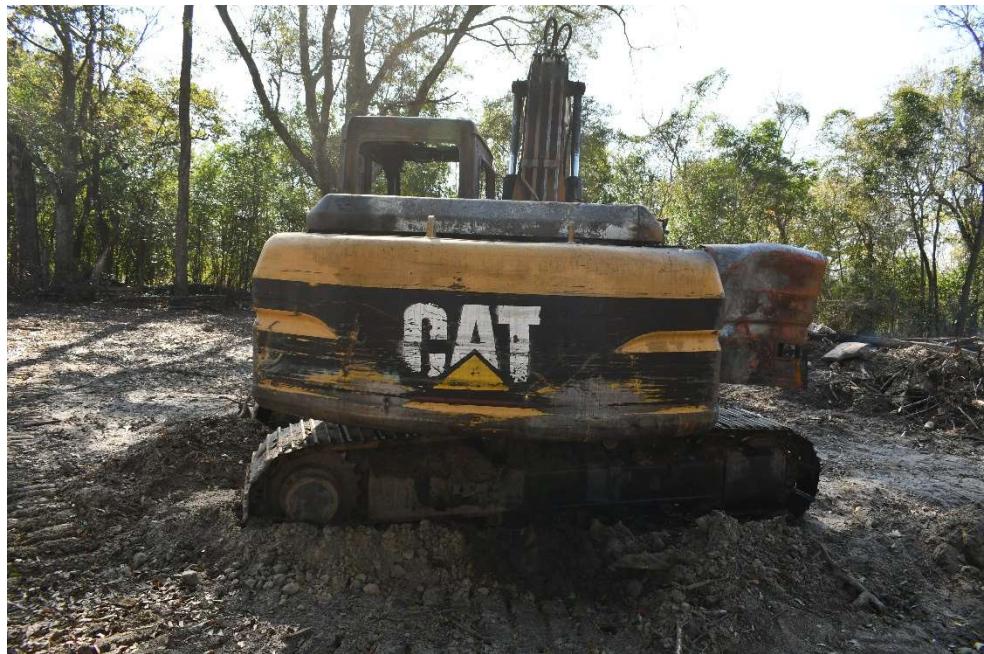
Photo 002: Showing Discoloration and oxidation of engine cover.

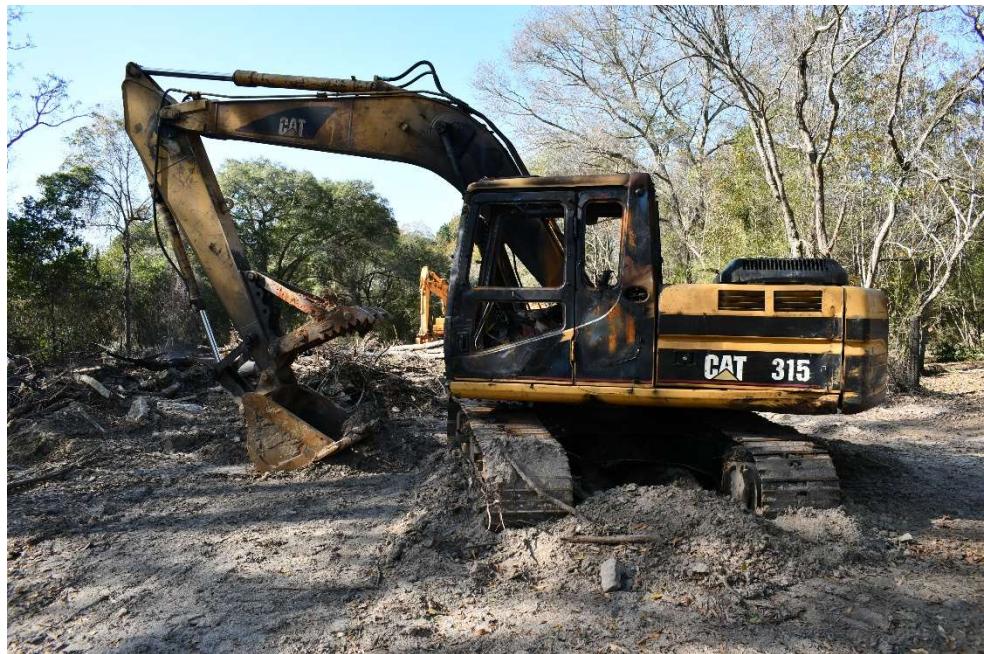
Photo 003: Showing oxidation on cab and mass loss of window glass.

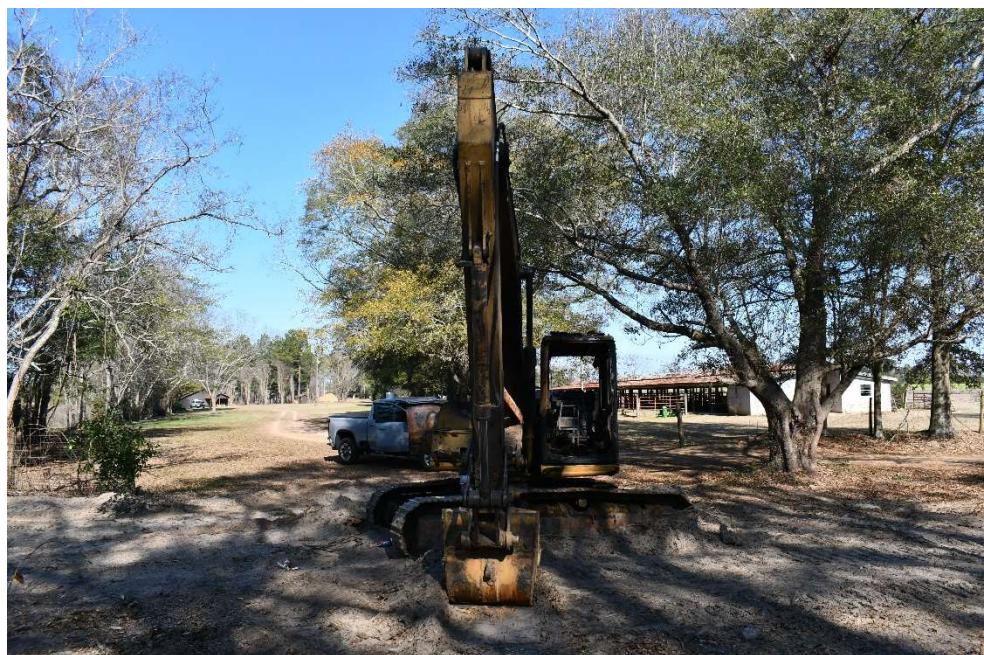
Photo 004: Showing Discoloration and mass loss of cab glass.

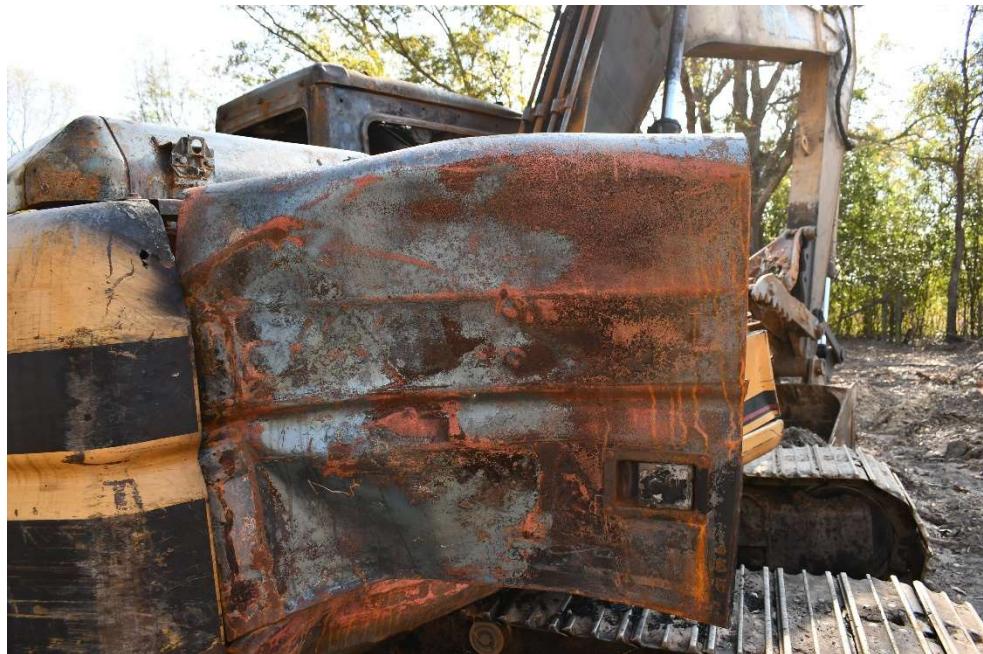
Photo 005: Showing Discoloration and oxidation on hydraulic pump compartment door, area of origin.

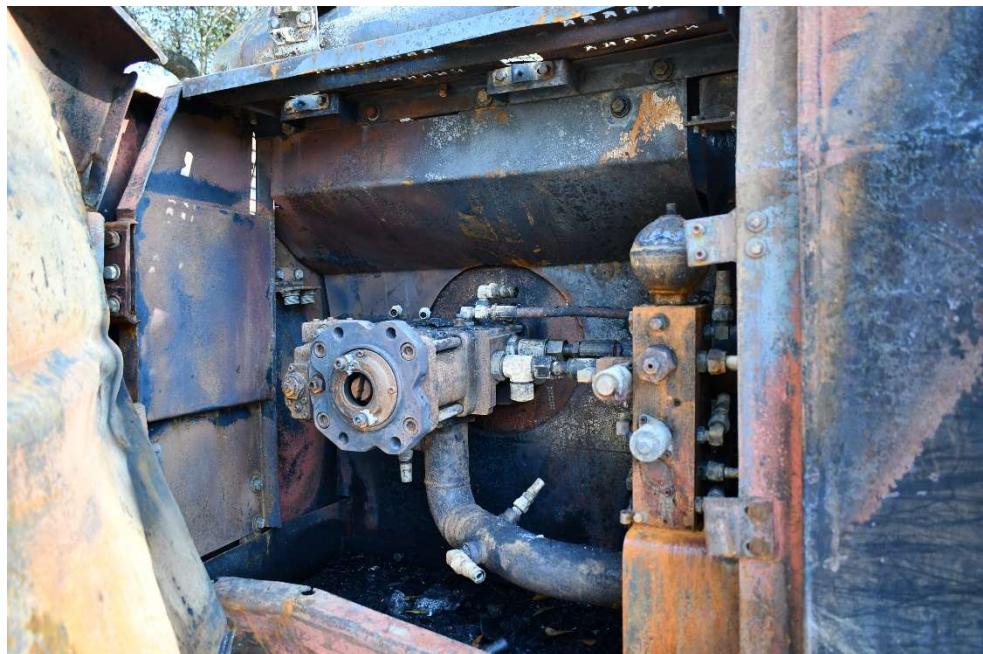
Photo 006: Showing total mass loss of hydraulic hoses and oxidation and discoloration to inside compartment.

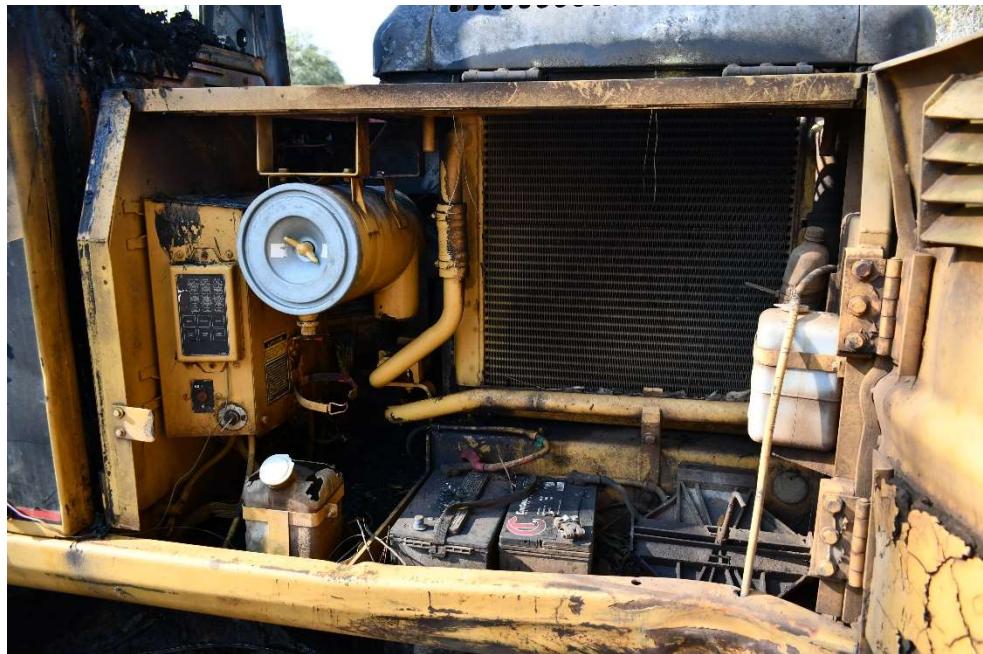
Photo 007: Showing radiator, batteries and air intake with no visible fire effects.

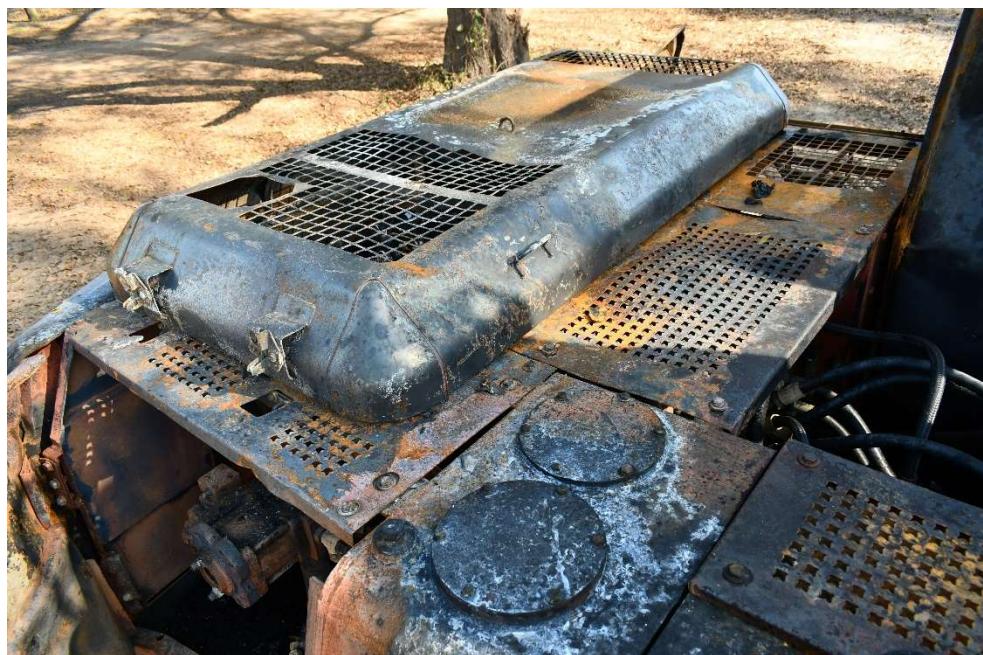
Photo 008: Showing severe oxidation around hydraulic pump compartment extending across the top of engine compartment.

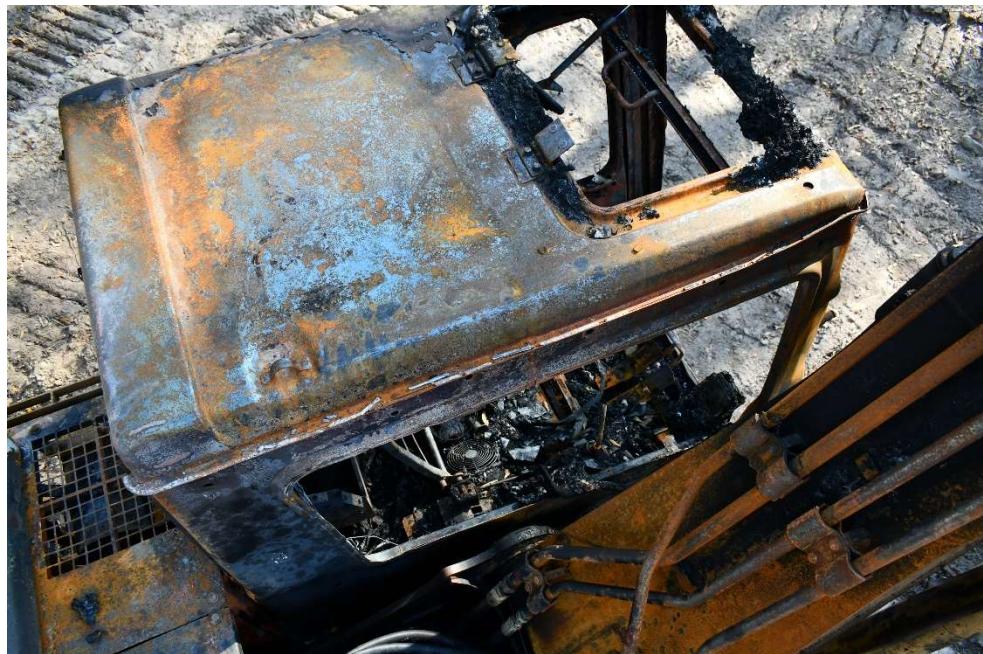
Photo 009: Showing oxidation on cab with mass loss of cab glass.

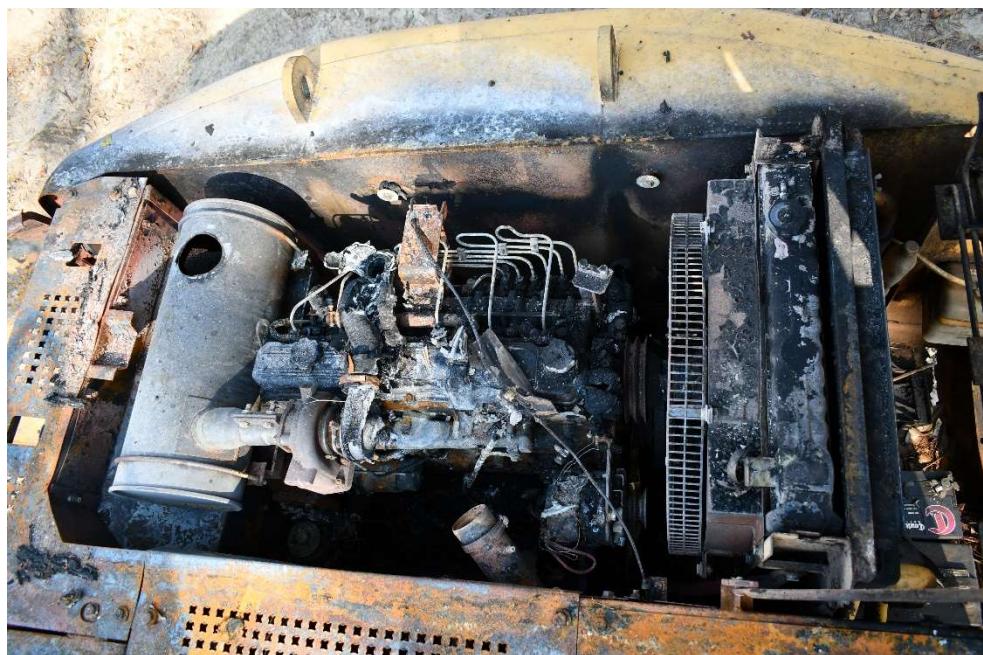
Photo 010: Showing minor mass loss of components on top of engine, fire movement from left to right of photo.
