VIN of 2023 freightliner tractor VIN: 3AKJHHDR0PSUP4928.

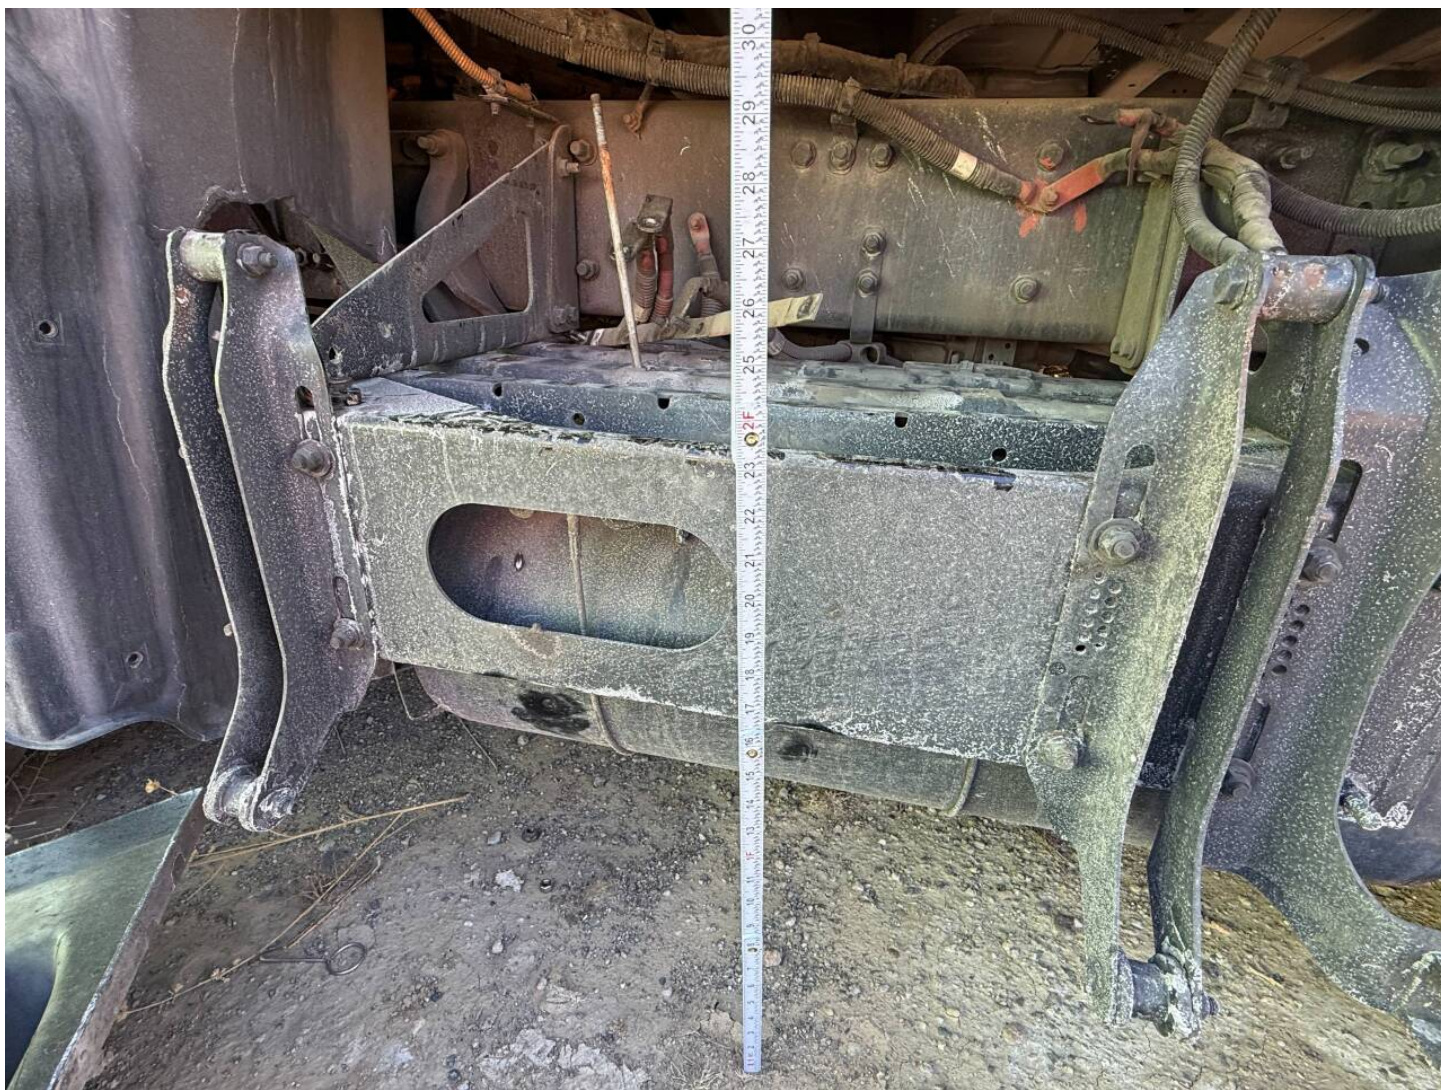
Damage noted to driver side of vehicle of 2023 freightliner tractor VIN: 3AKJHHDR0PSUP4928.

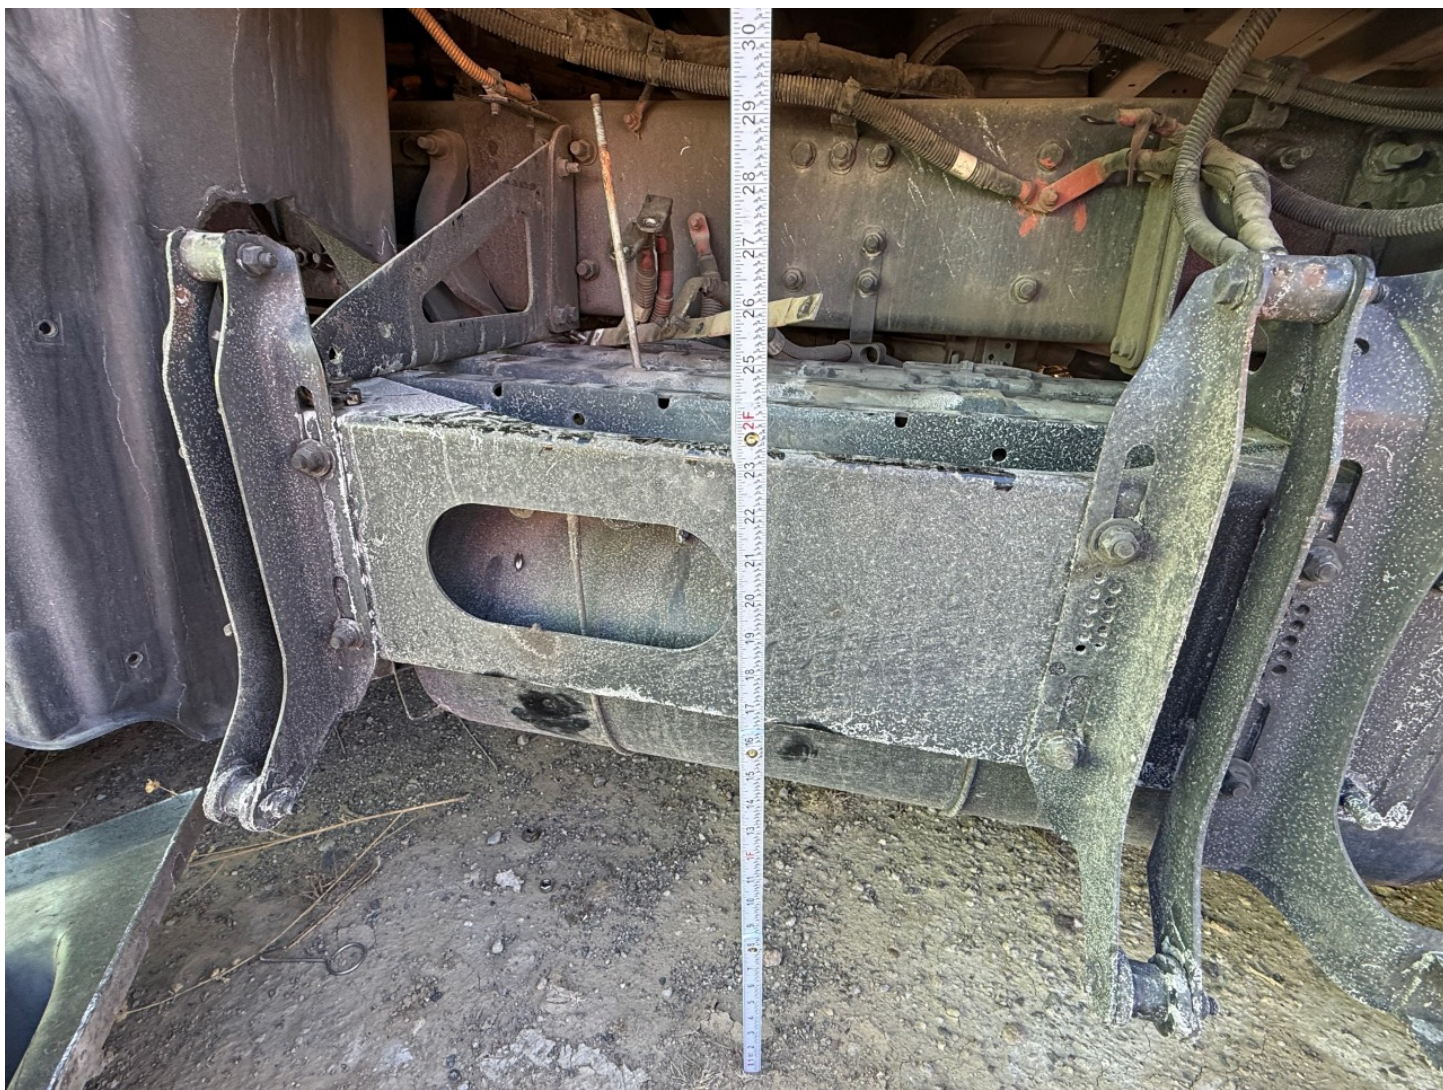
Damage noted to driver side of vehicle of 2023 freightliner tractor VIN: 3AKJHHDR0PSUP4928.

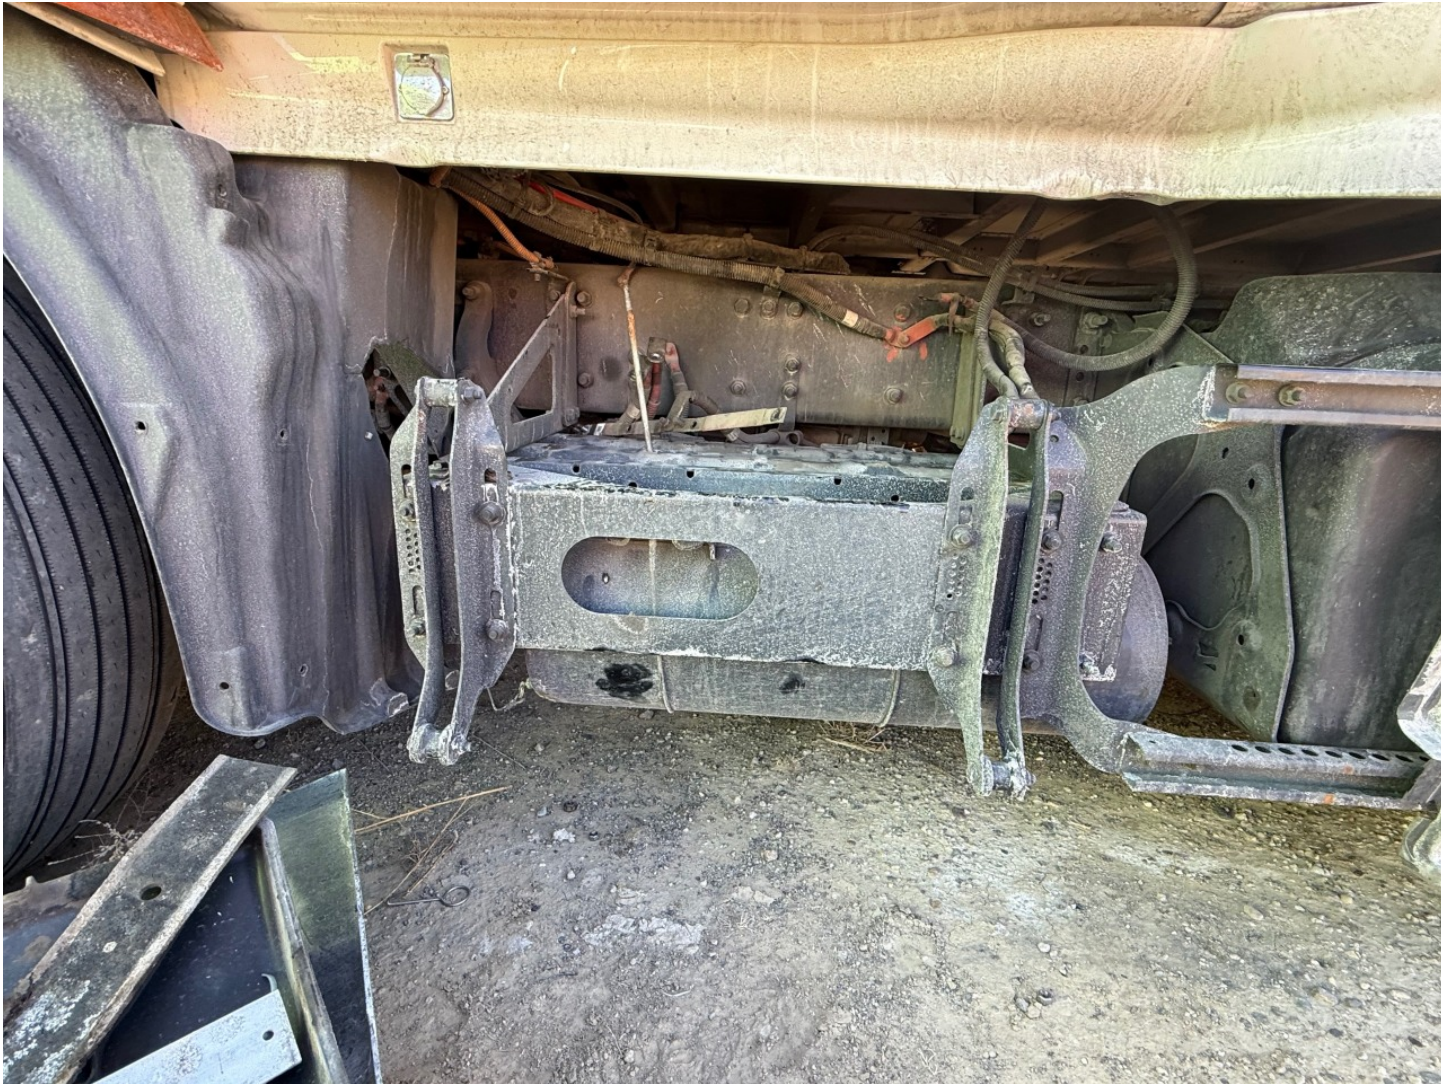
Damage noted to driver side of vehicle of 2023 freightliner tractor VIN: 3AKJHHDR0PSUP4928.

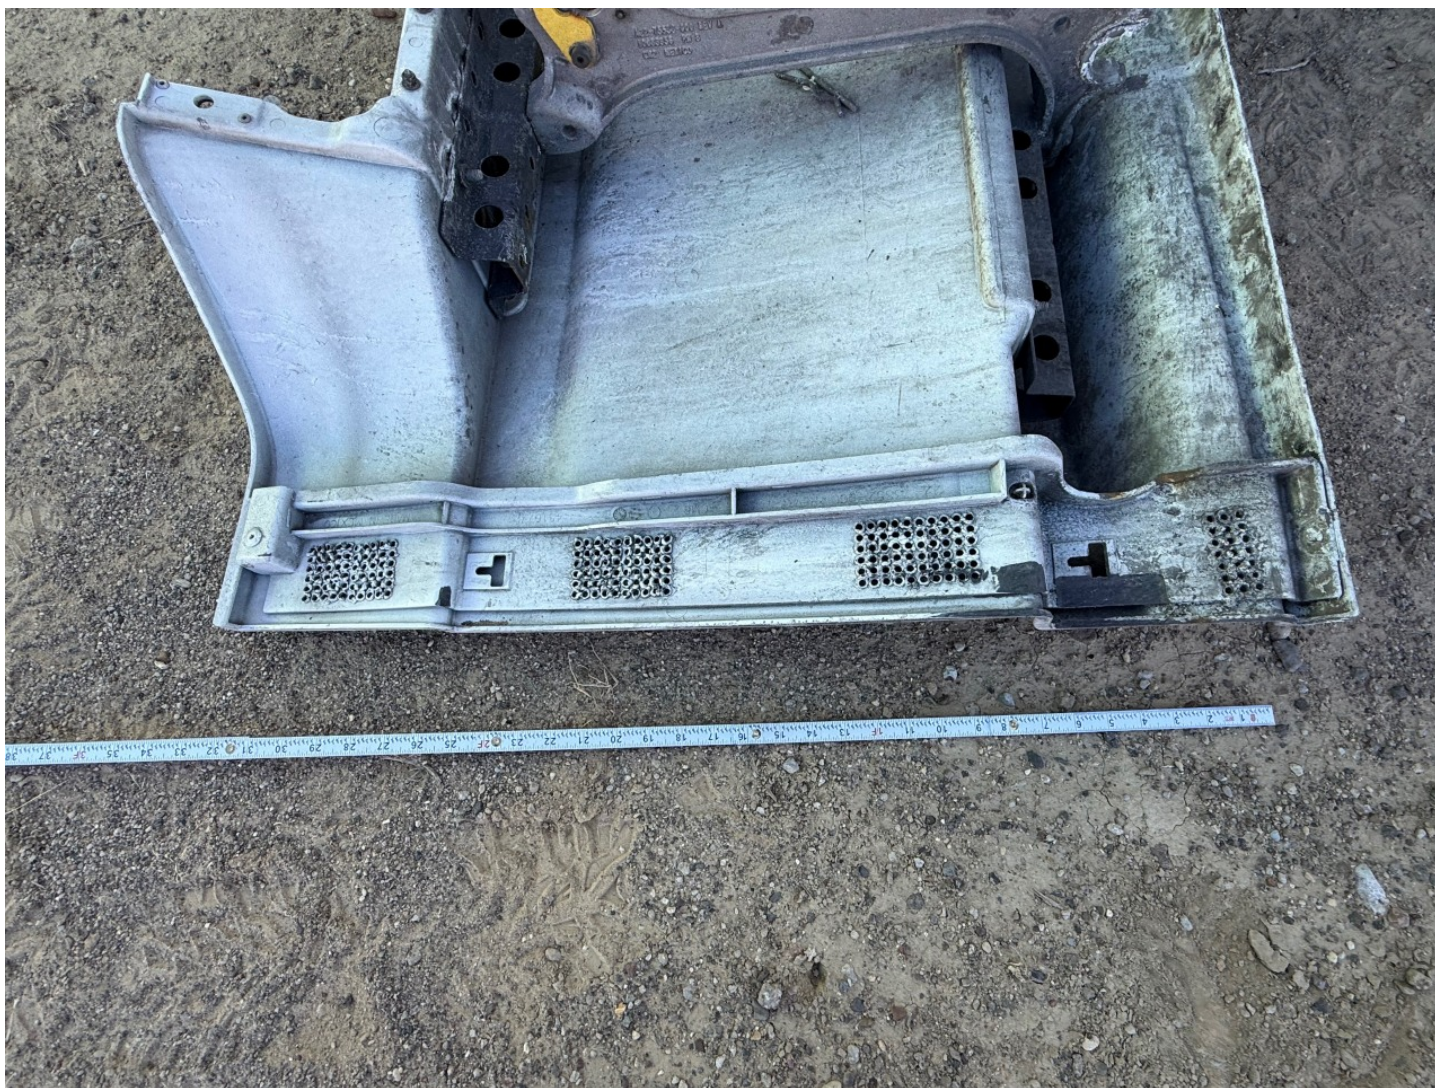
Damage noted to driver side of vehicle of 2023 freightliner tractor VIN: 3AKJHHDR0PSUP4928.

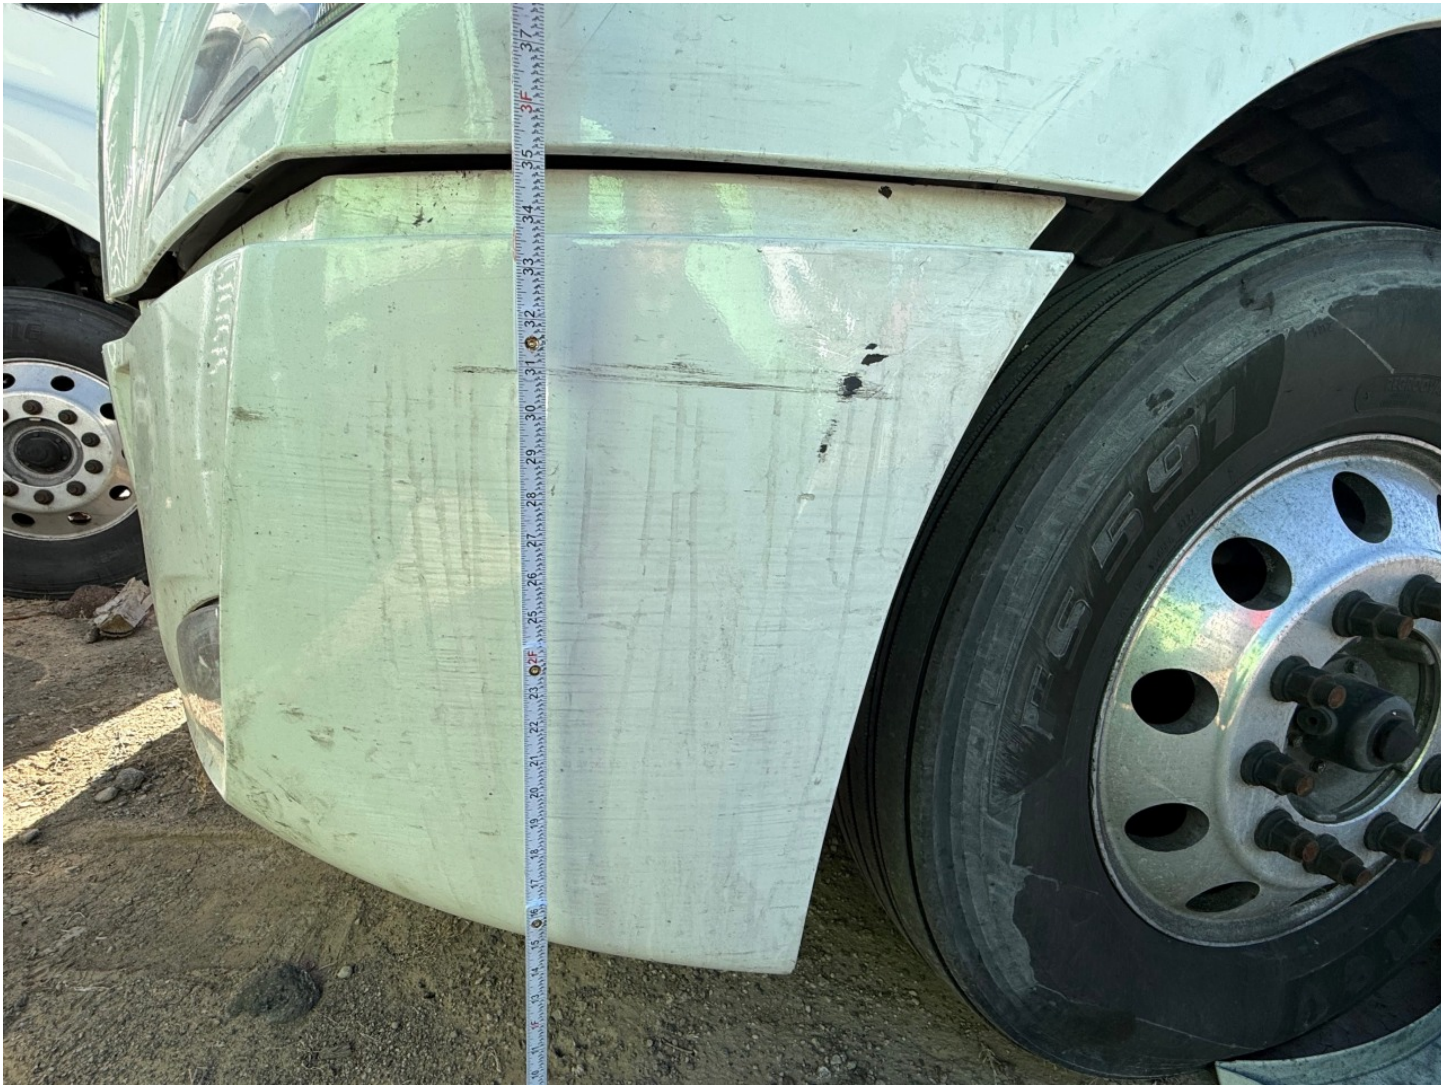
Damage noted to driver side of vehicle of 2023 freightliner tractor VIN: 3AKJHHDR0PSUP4928.

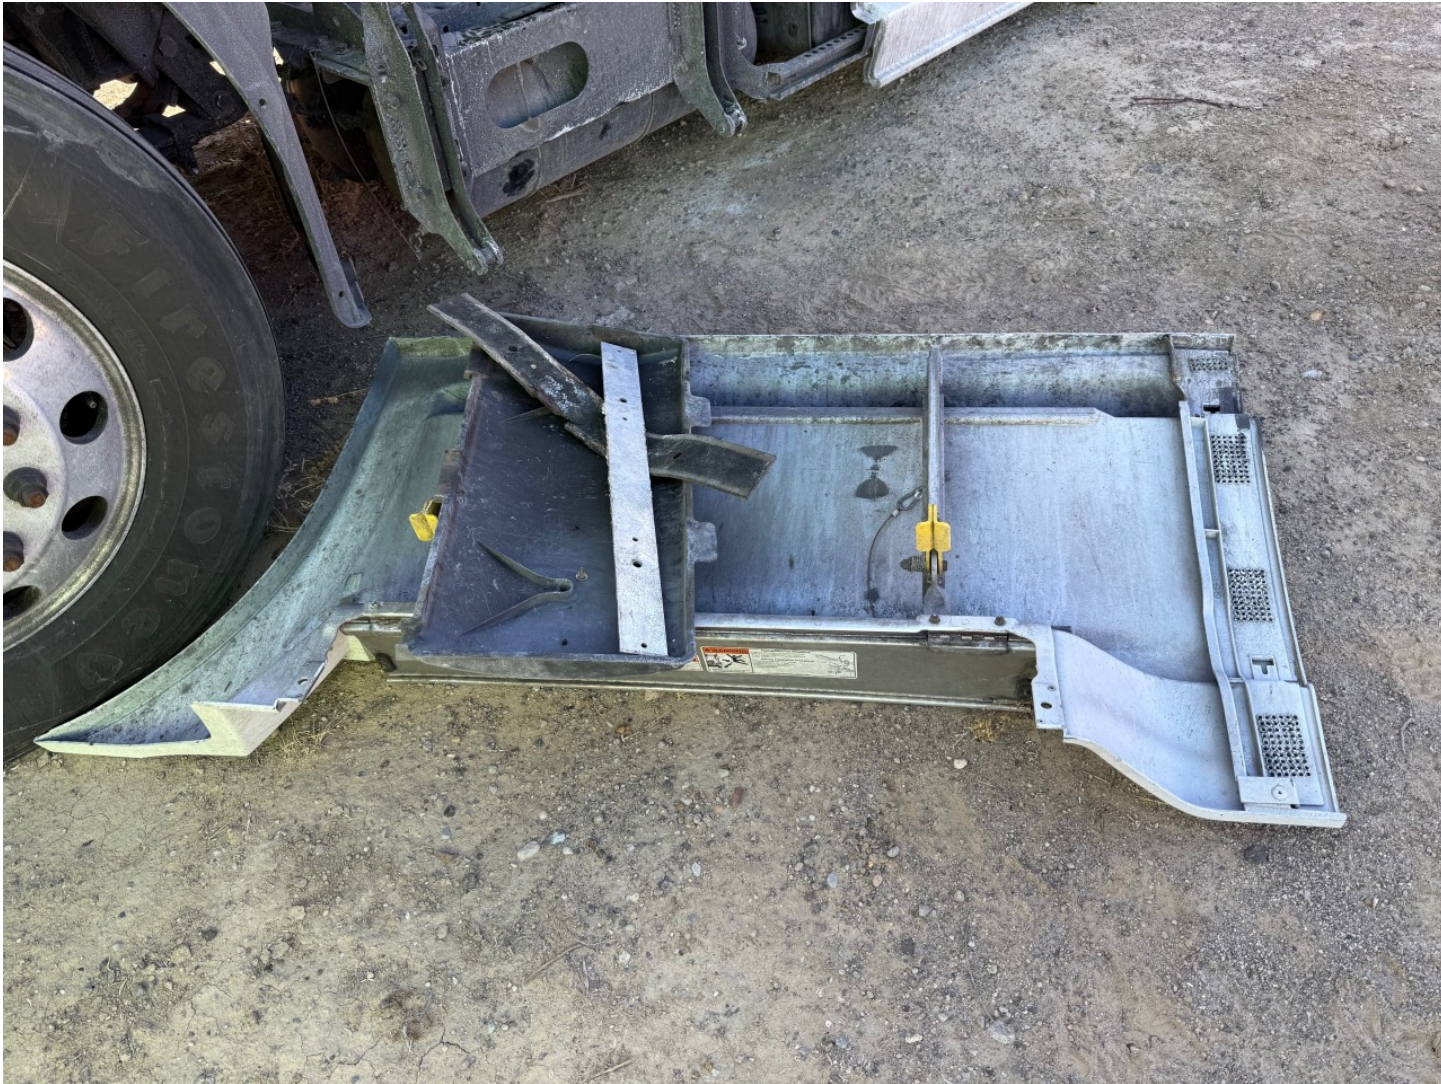
Damage noted to driver side of vehicle of 2023 freightliner tractor VIN: 3AKJHHDR0PSUP4928.

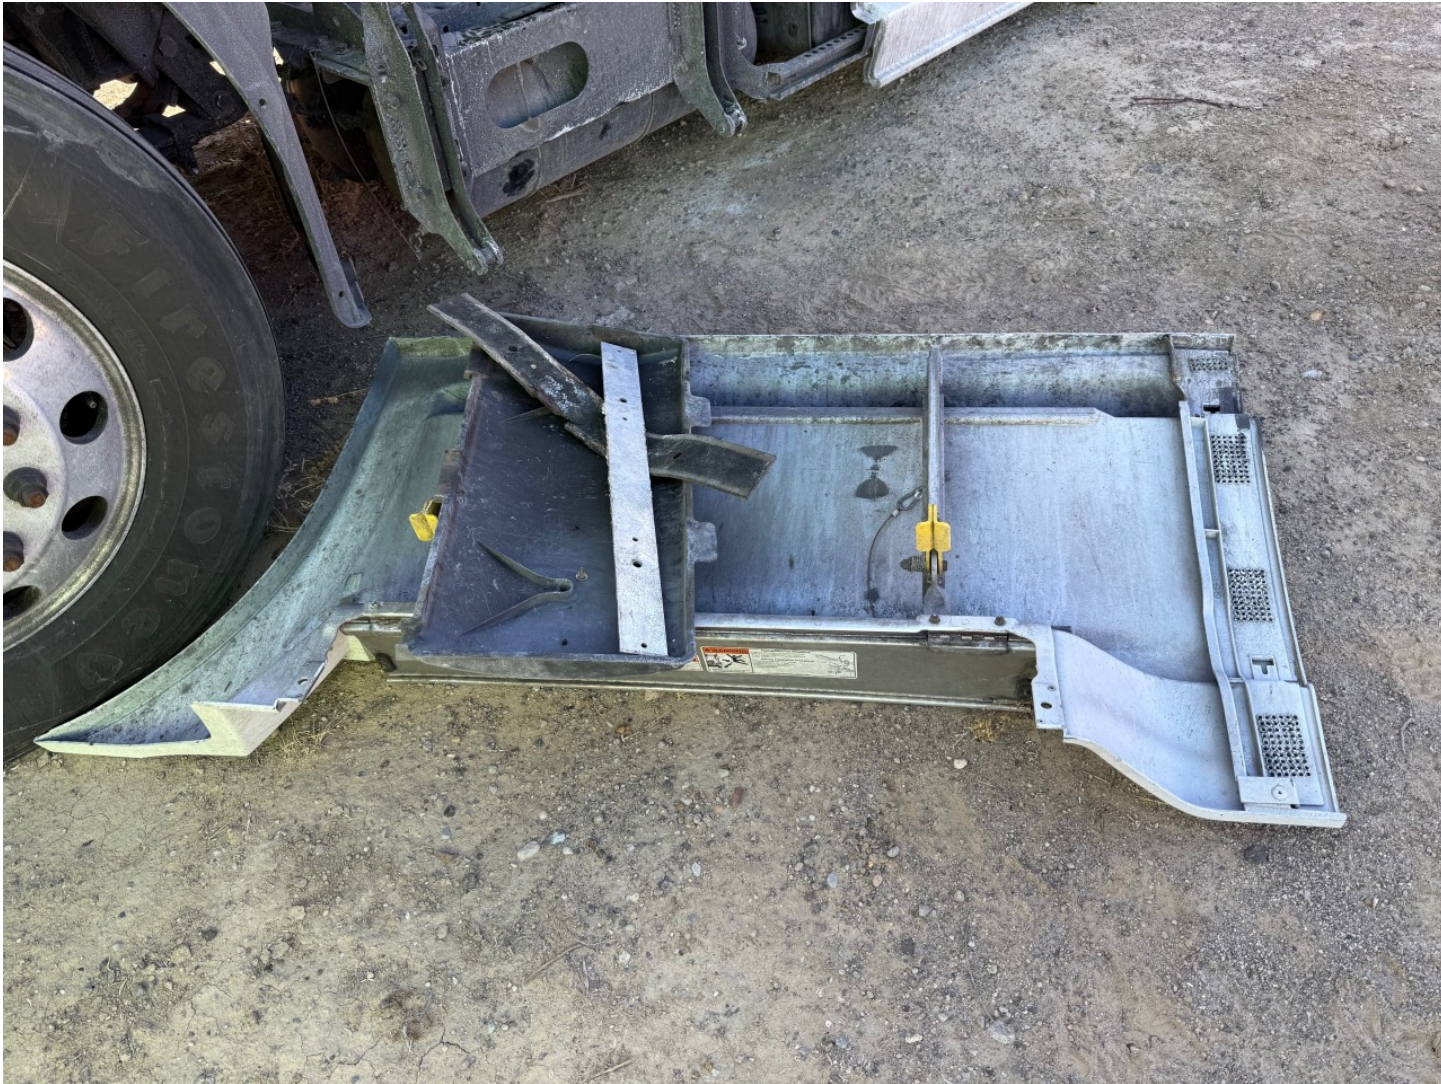
Damage noted to driver side of vehicle of 2023 freightliner tractor VIN: 3AKJHHDR0PSUP4928.

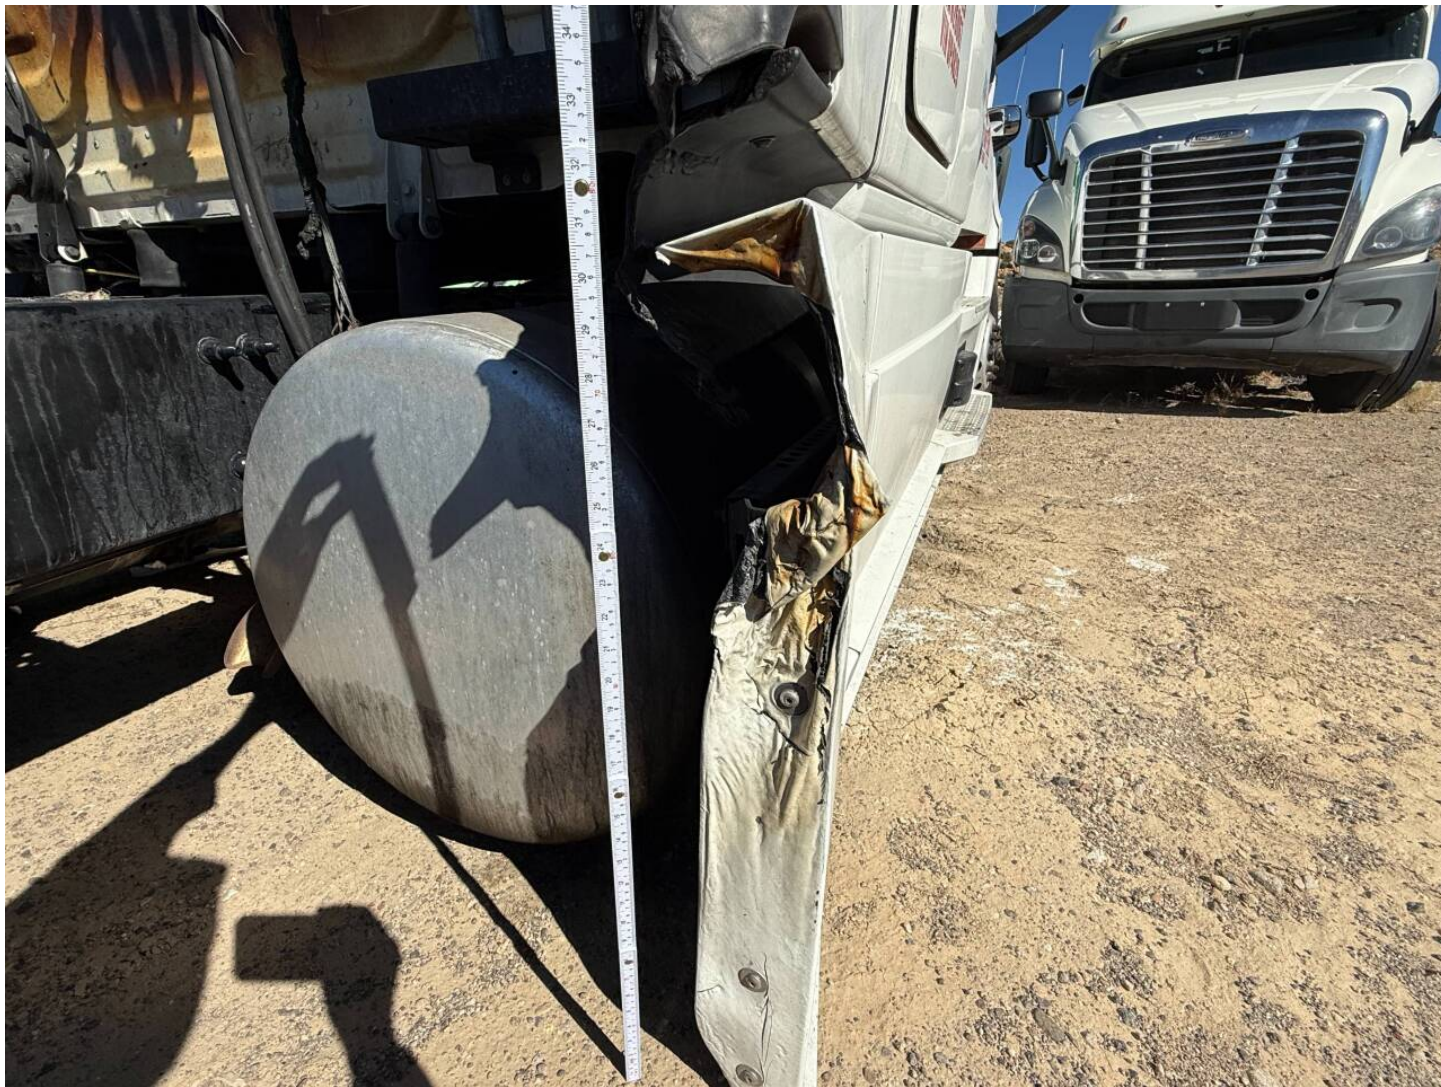
Damage noted to passenger side of vehicle of 2023 freightliner tractor VIN: 3AKJHHDR0PSUP4928.

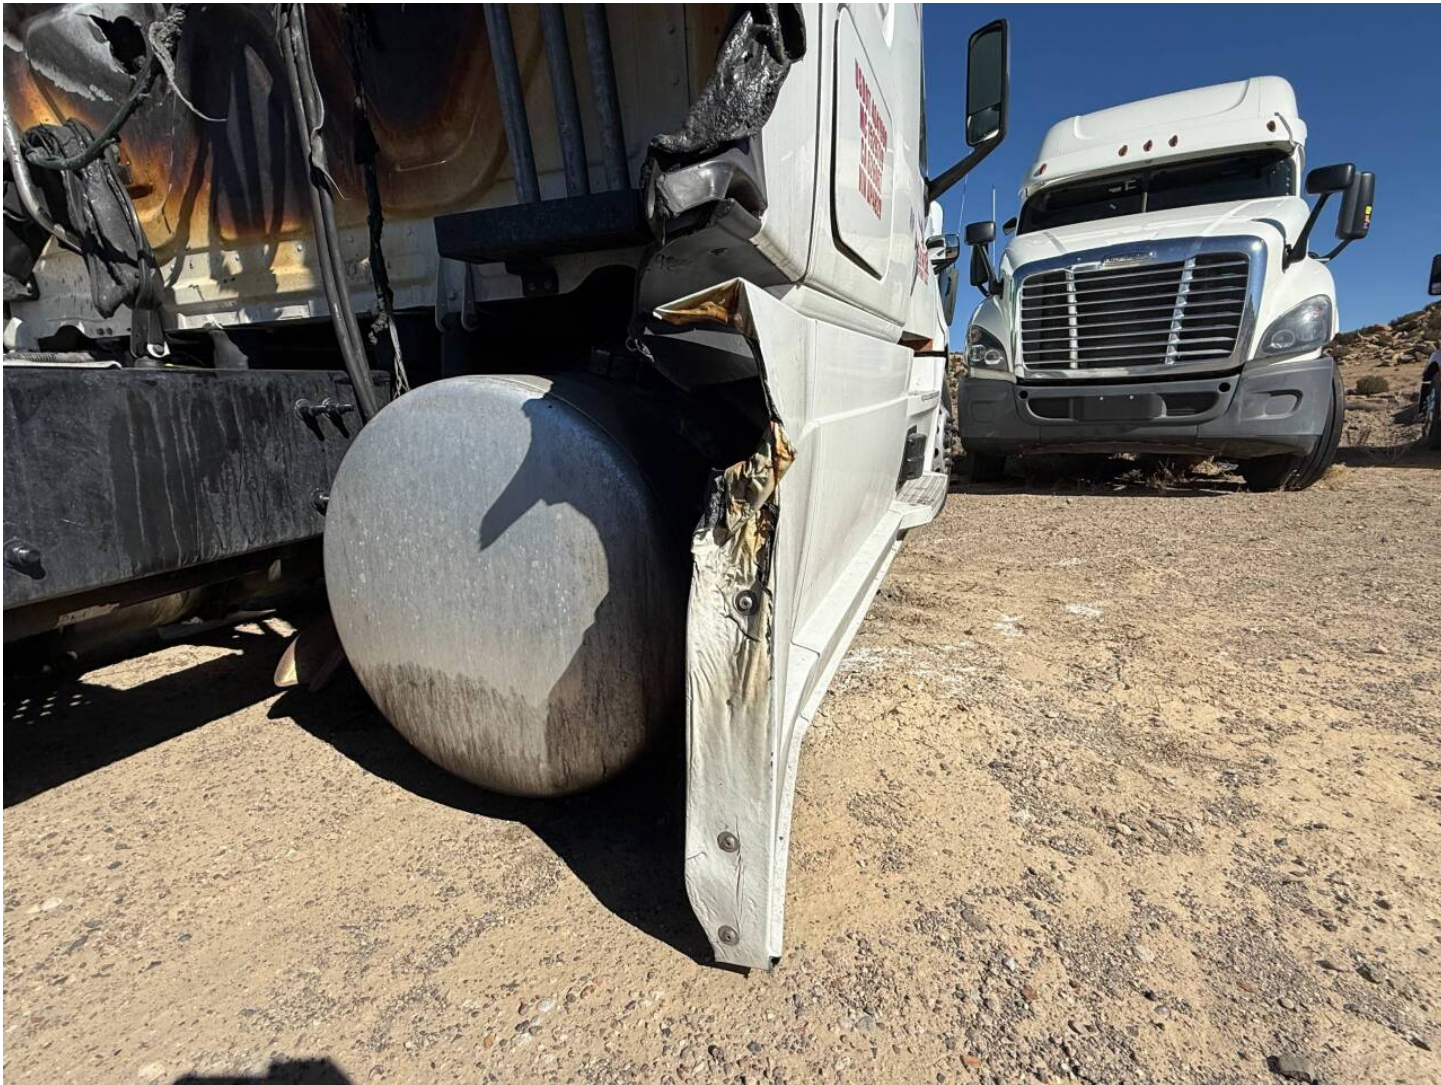
Damage noted to passenger side of vehicle of 2023 freightliner tractor VIN: 3AKJHHDR0PSUP4928.

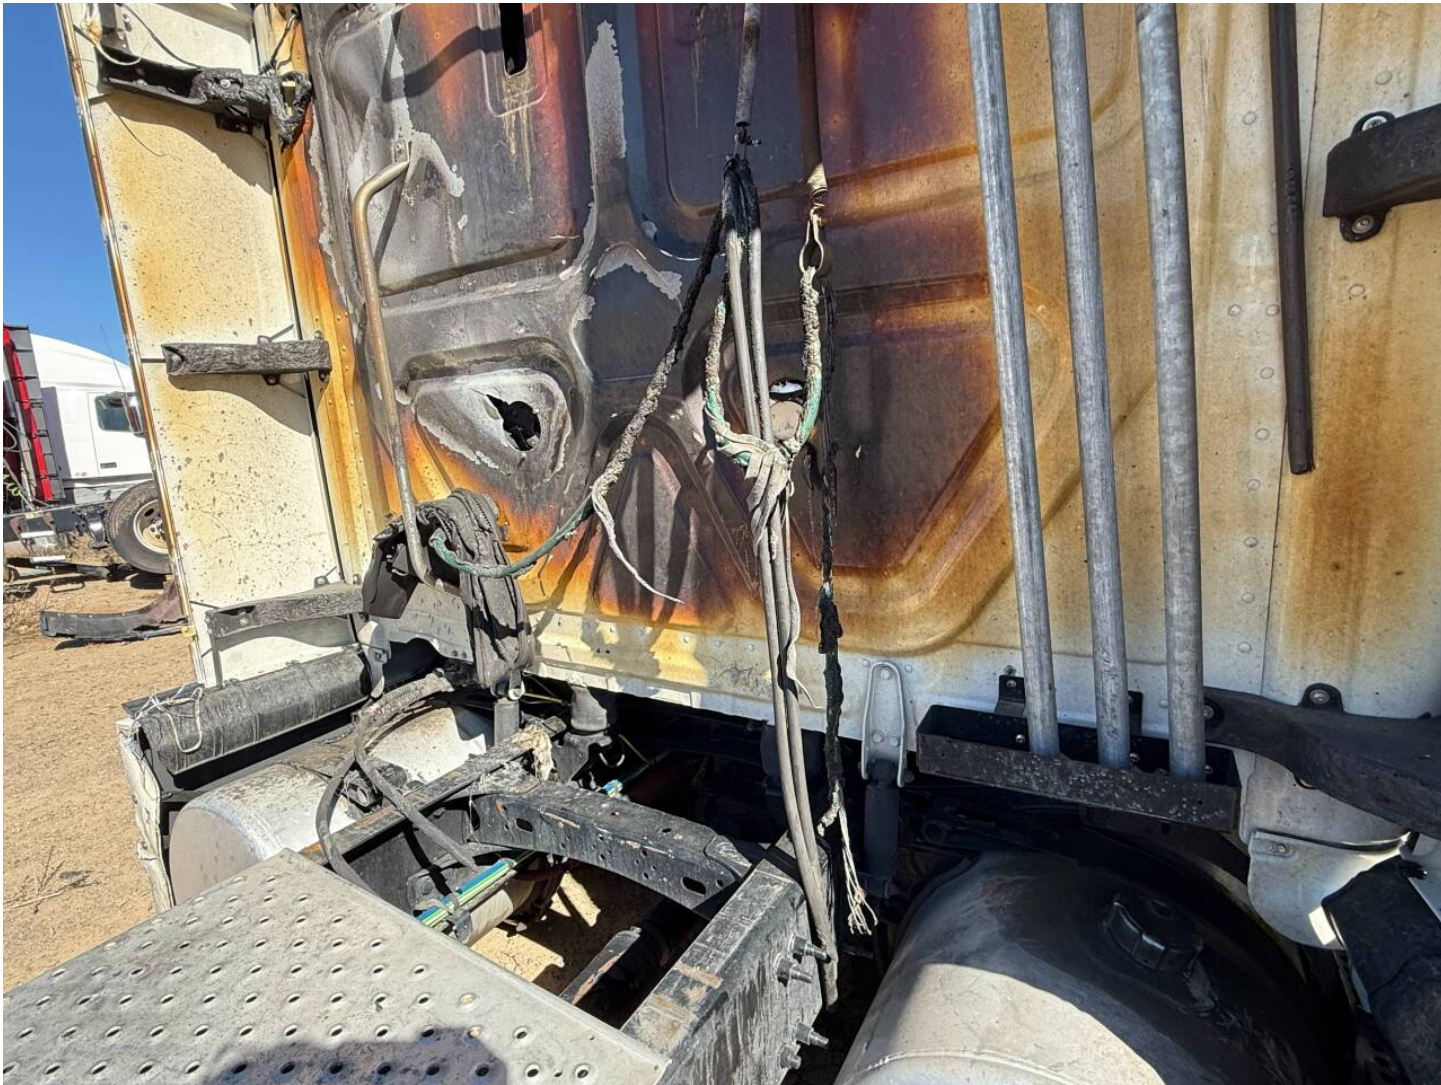
Damage noted to rear of vehicle of 2023 freightliner tractor VIN: 3AKJHHDR0PSUP4928.

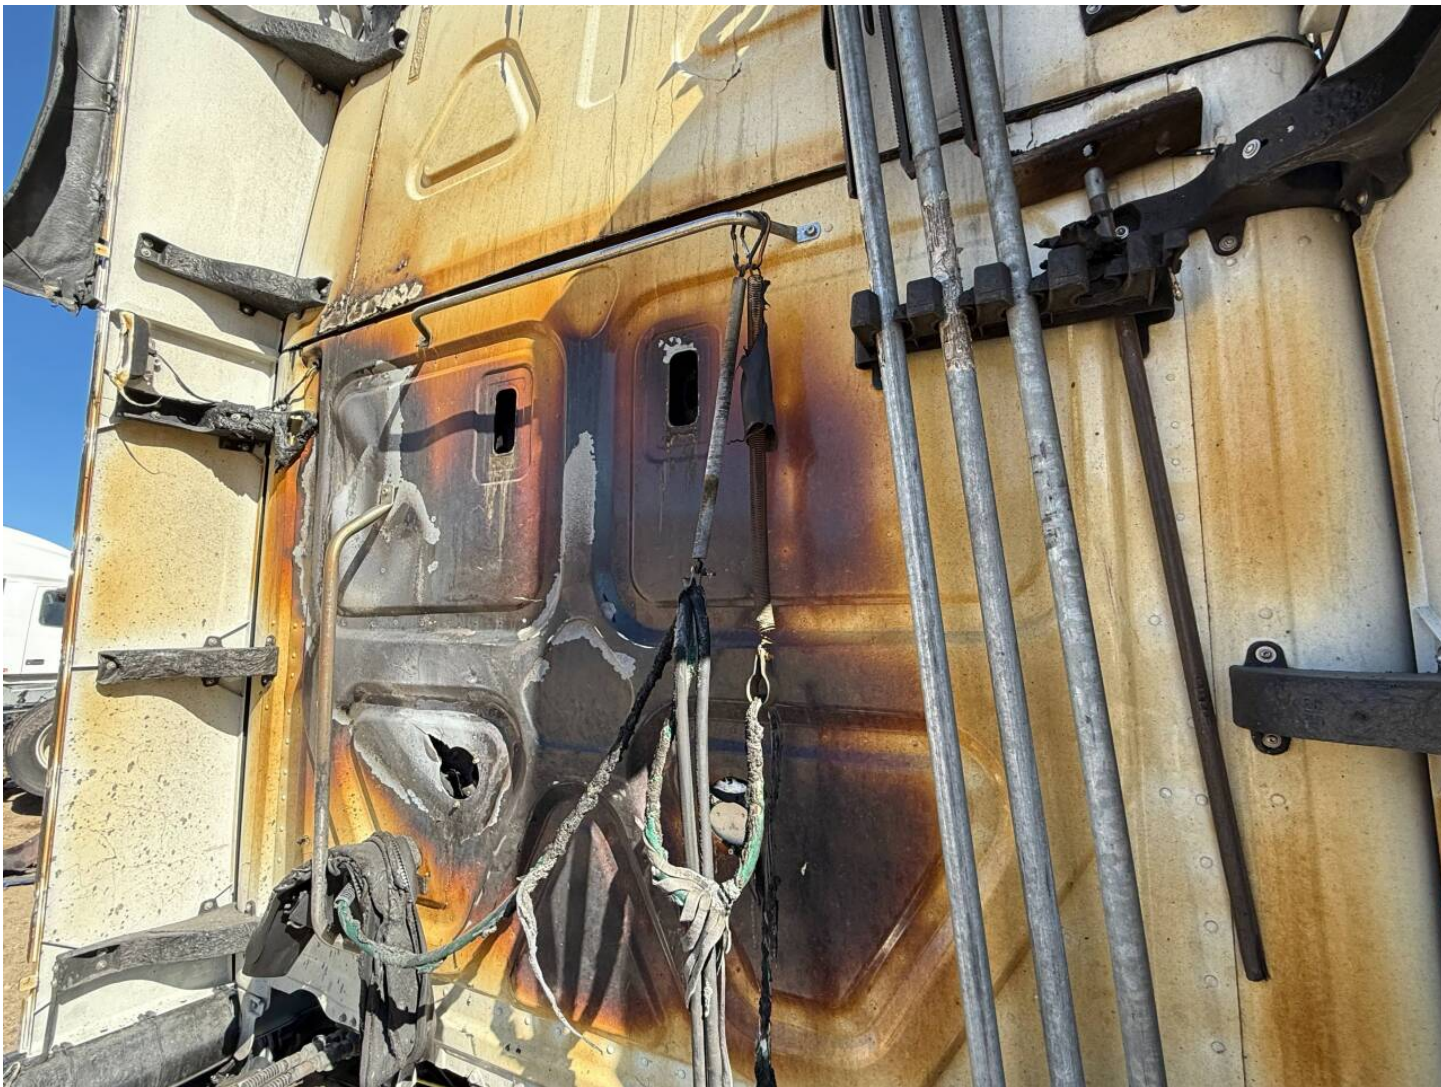
Damage noted to rear of vehicle of 2023 freightliner tractor VIN: 3AKJHHDR0PSUP4928.

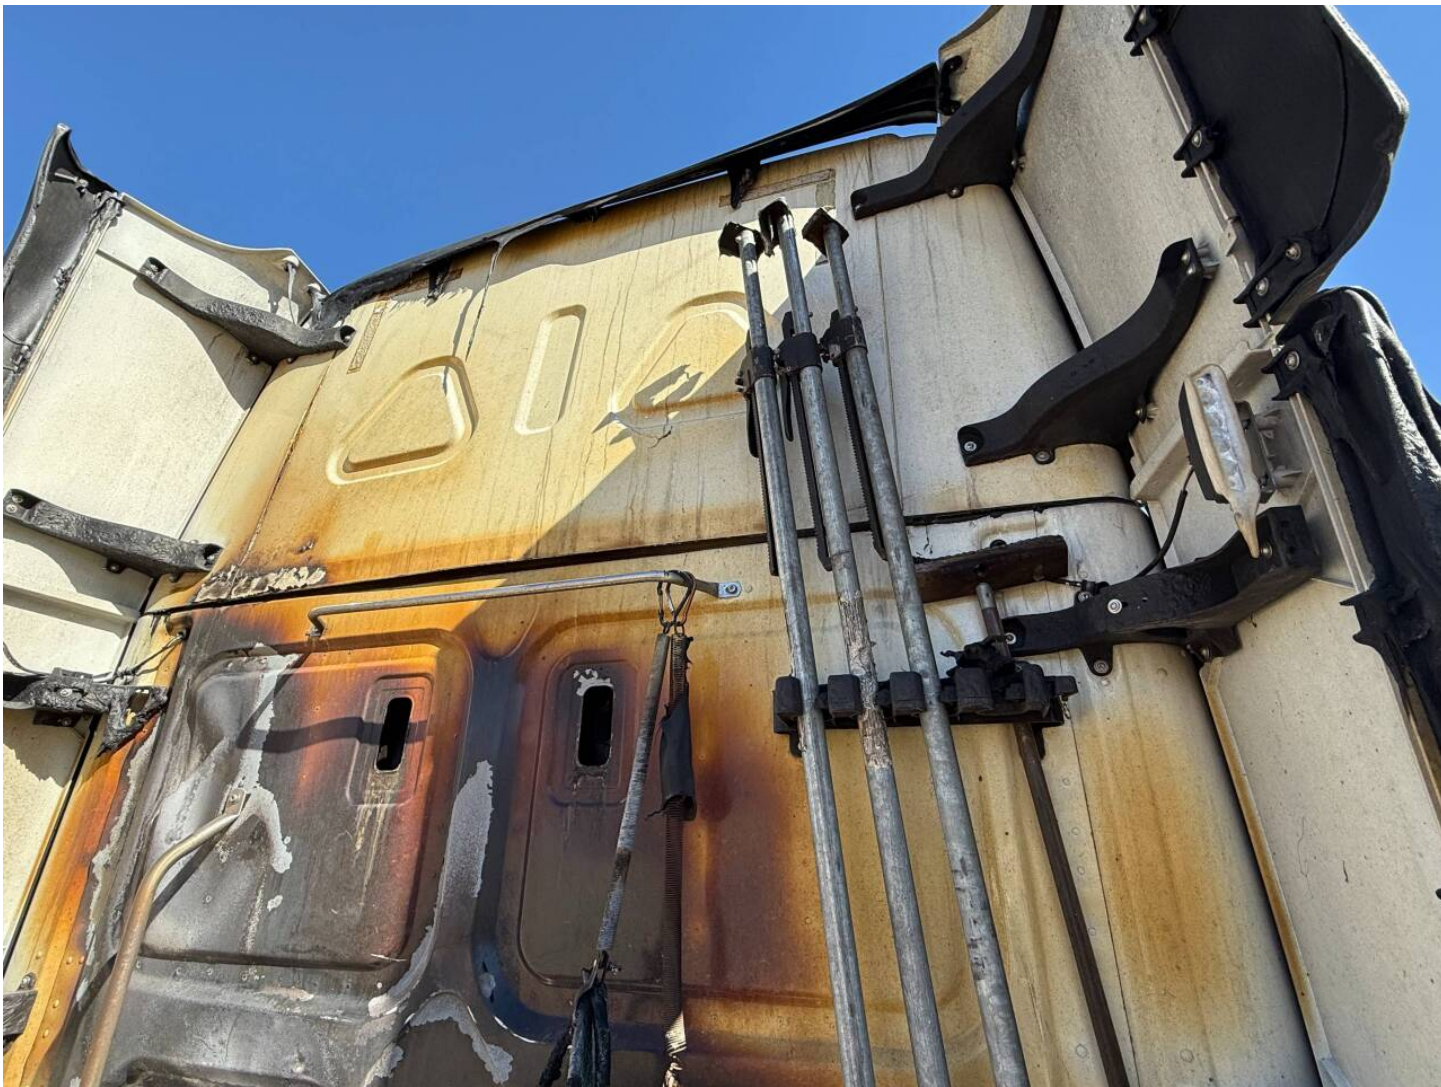
Damage noted to rear of vehicle of 2023 freightliner tractor VIN: 3AKJHHDR0PSUP4928.

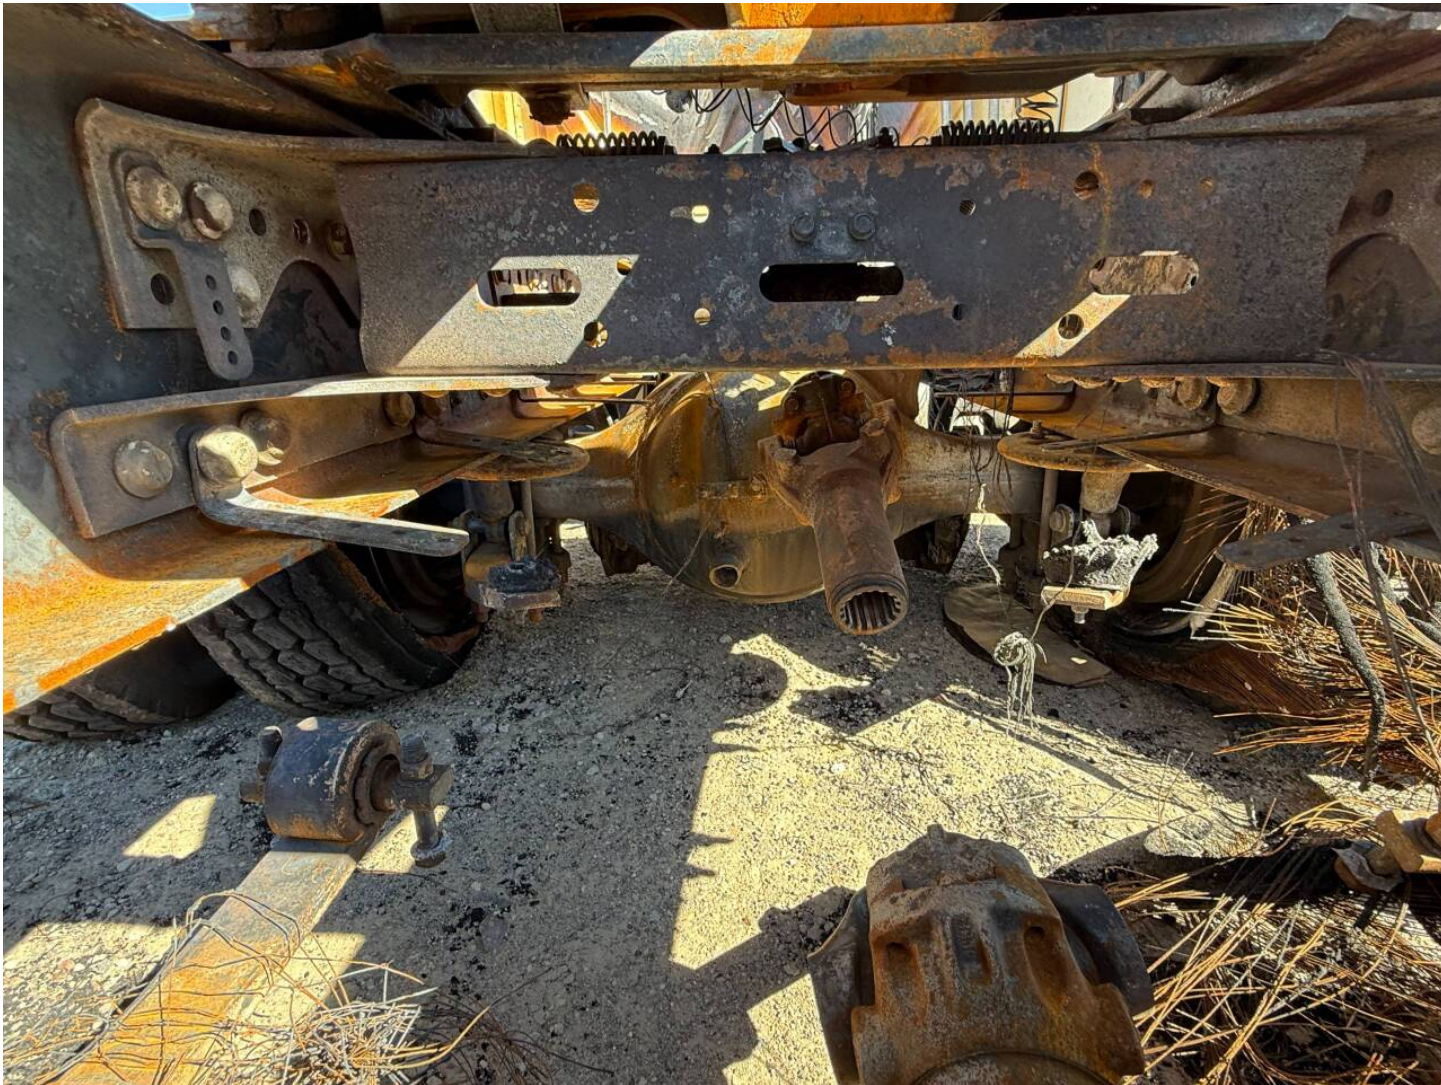
Damage noted to rear of vehicle of 2023 freightliner tractor VIN: 3AKJHHDR0PSUP4928.

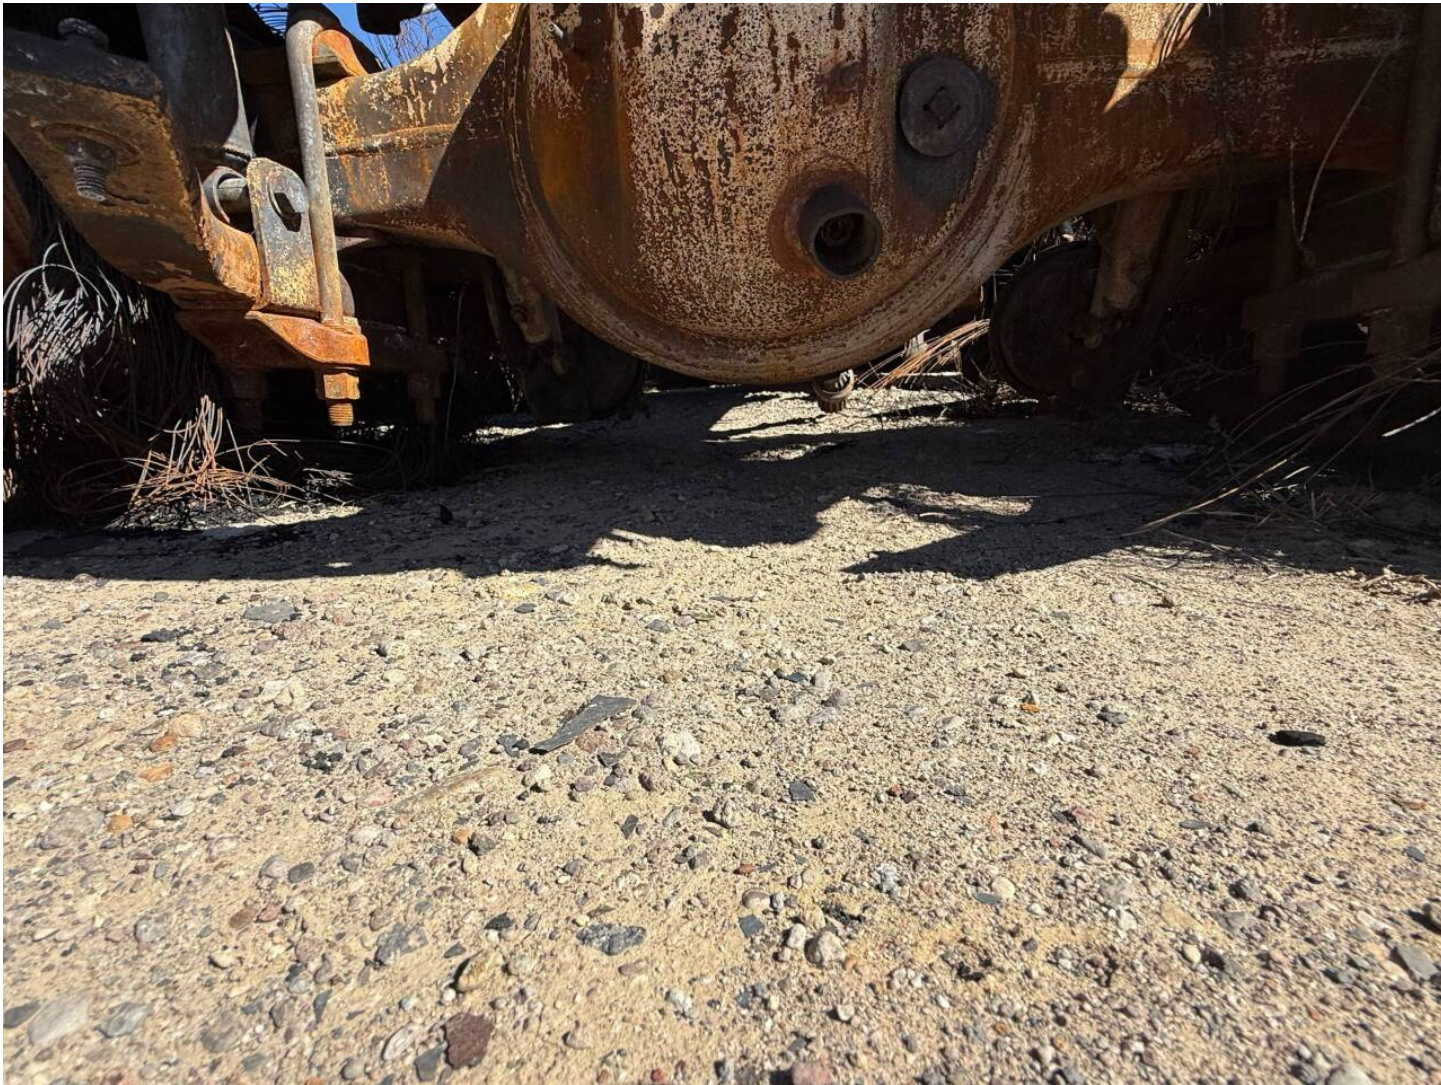
Damage noted to rear of vehicle of 2023 freightliner tractor VIN: 3AKJHHDR0PSUP4928.
