VIN of 2023 freightliner tractor VIN: 3AKJHHDR0PSUP4928.

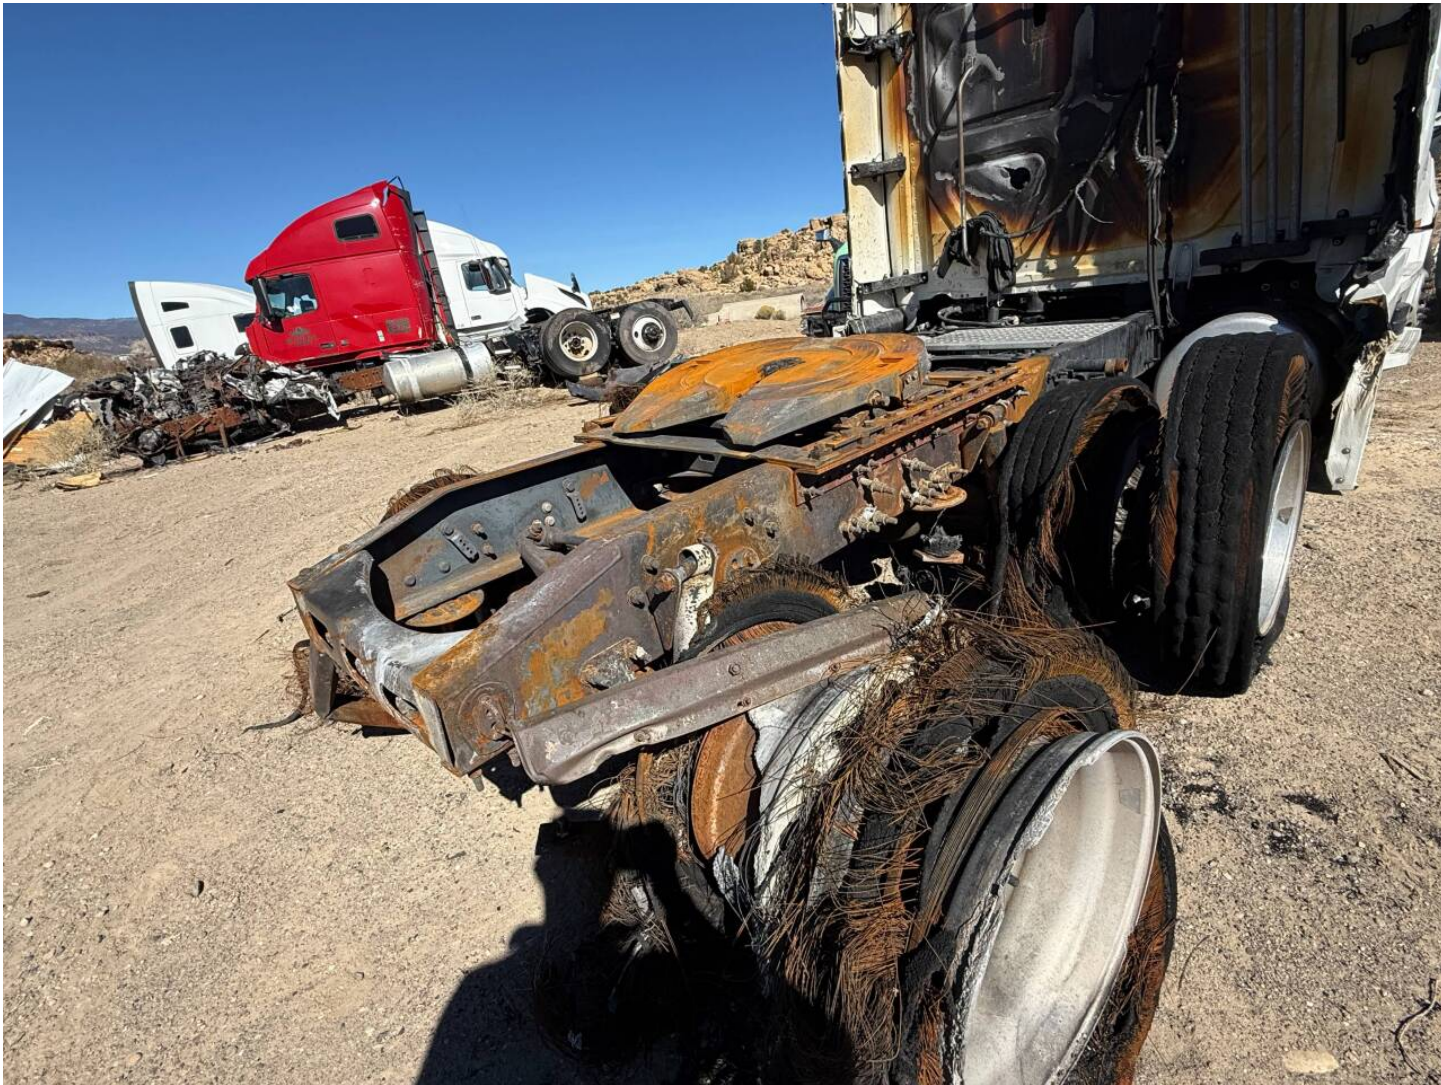
Damage noted to rear of vehicle of 2023 freightliner tractor VIN: 3AKJHHDR0PSUP4928.

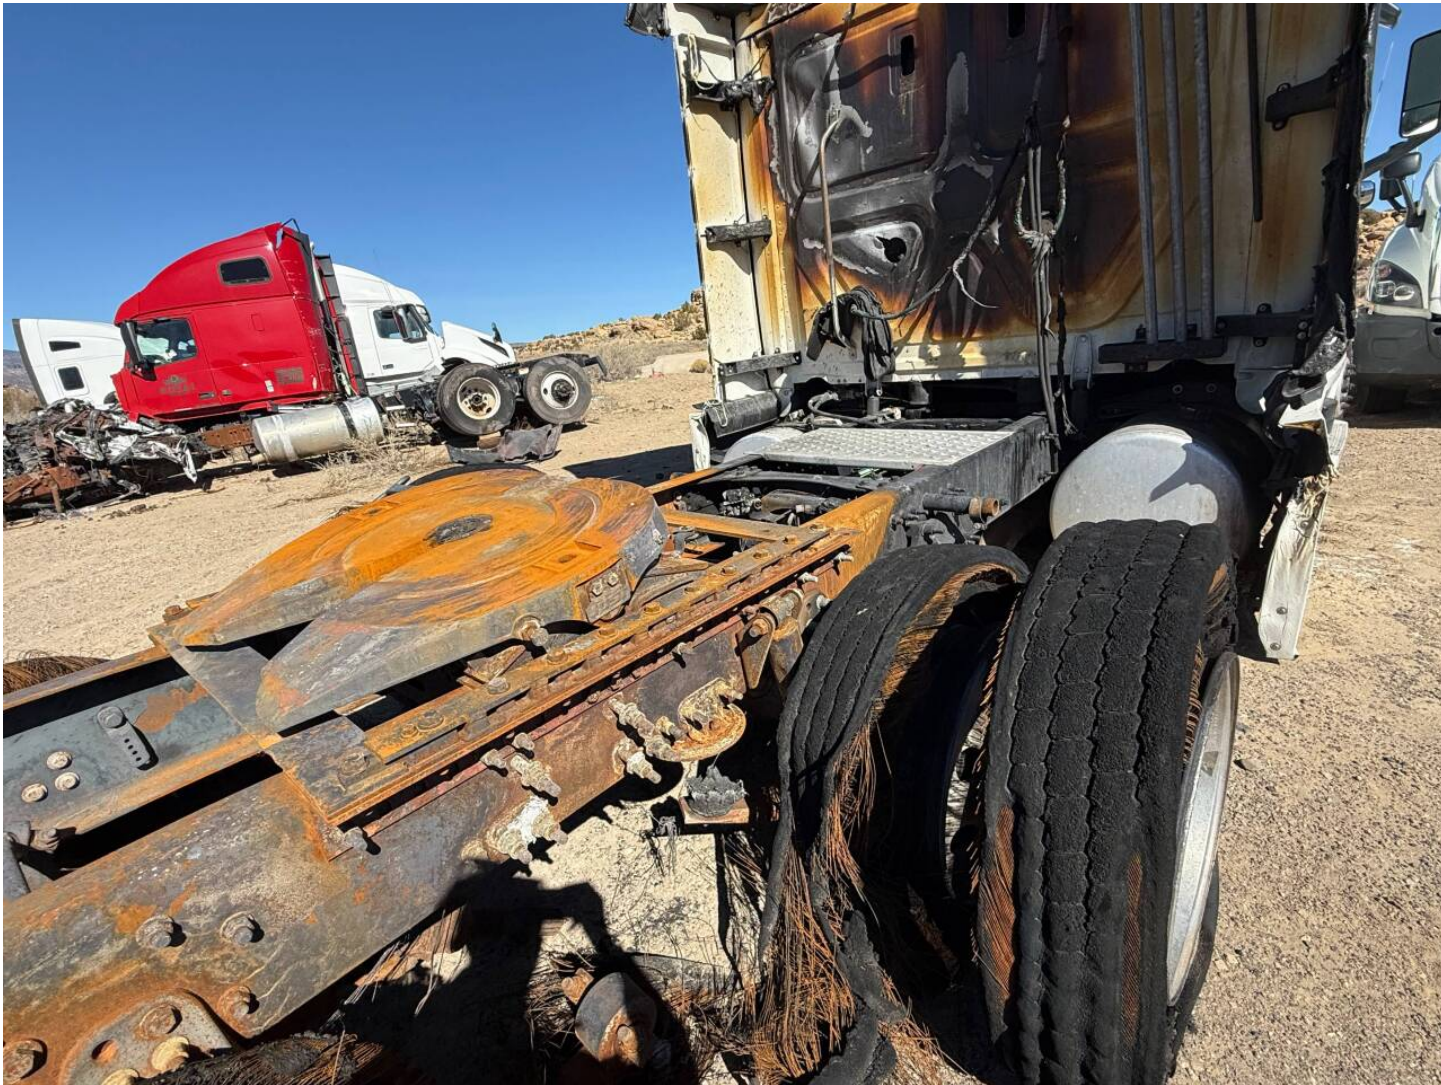
Damage noted to rear of vehicle of 2023 freightliner tractor VIN: 3AKJHHDR0PSUP4928.

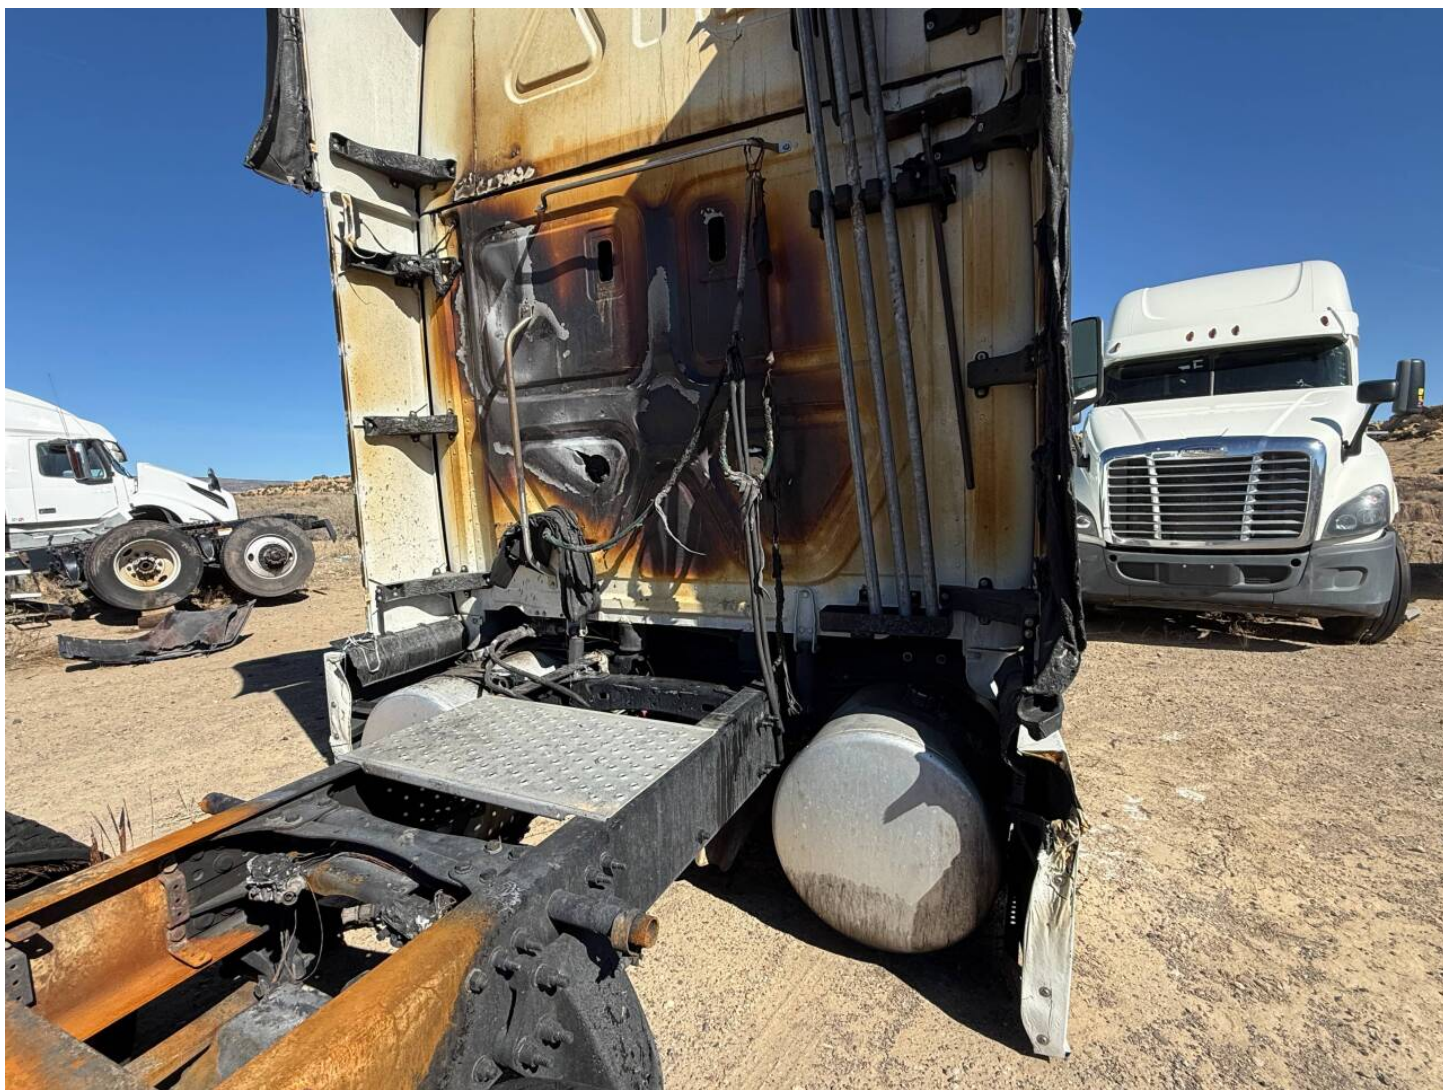
Damage noted to rear of vehicle of 2023 freightliner tractor VIN: 3AKJHHDR0PSUP4928.

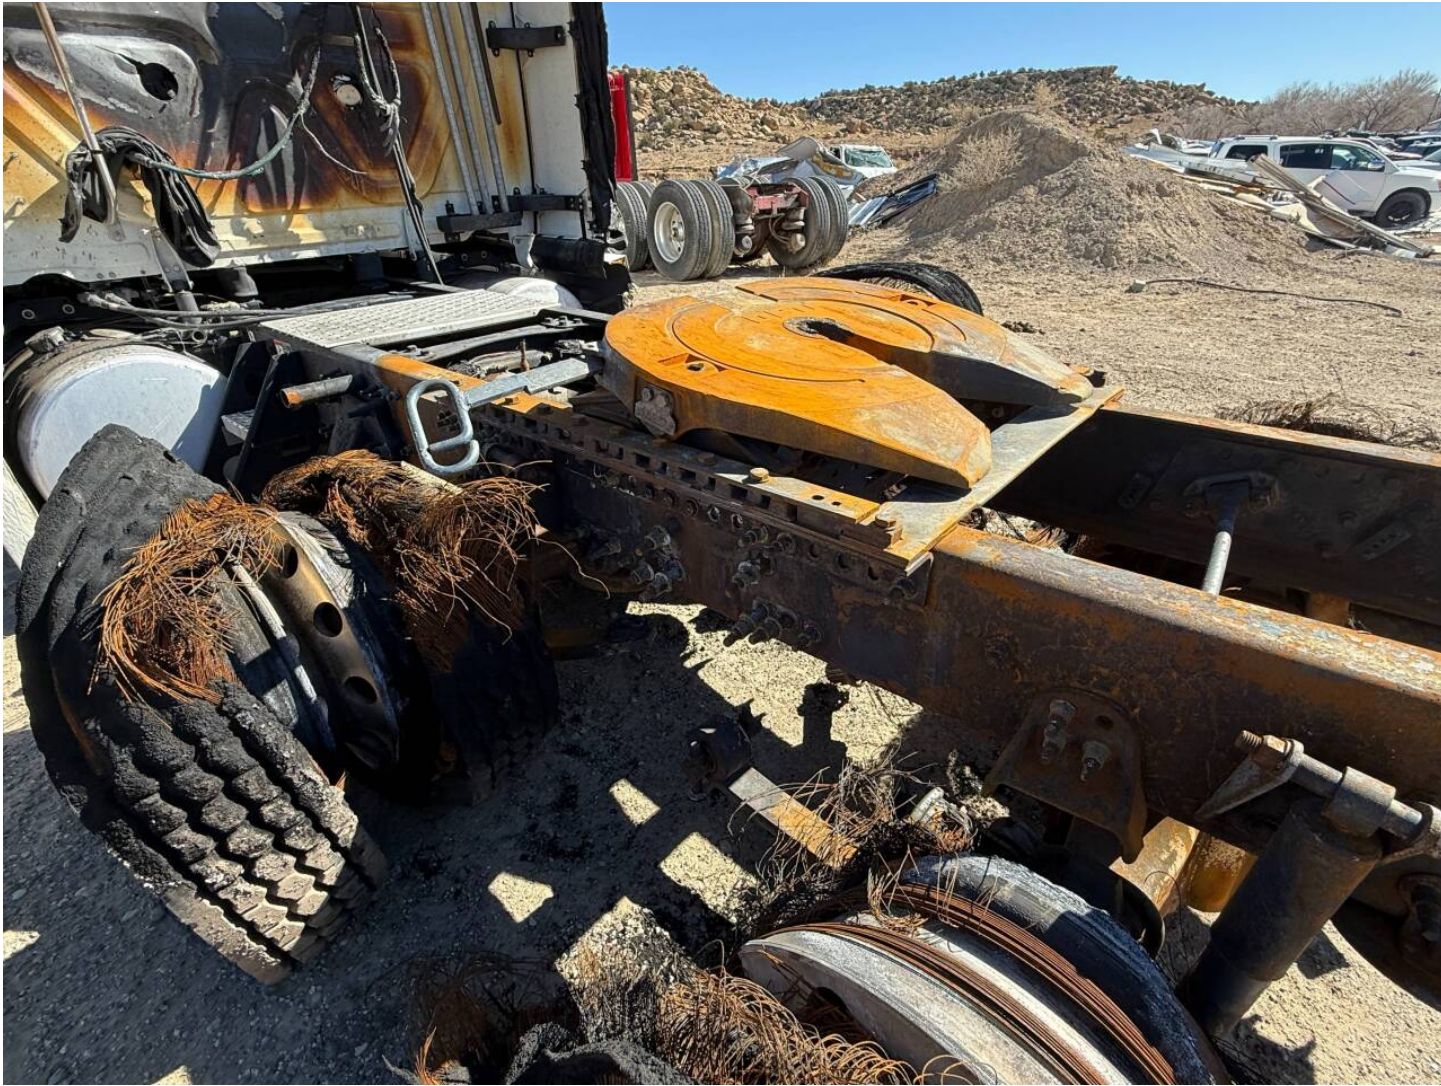
Damage noted to rear of vehicle of 2023 freightliner tractor VIN: 3AKJHHDR0PSUP4928.

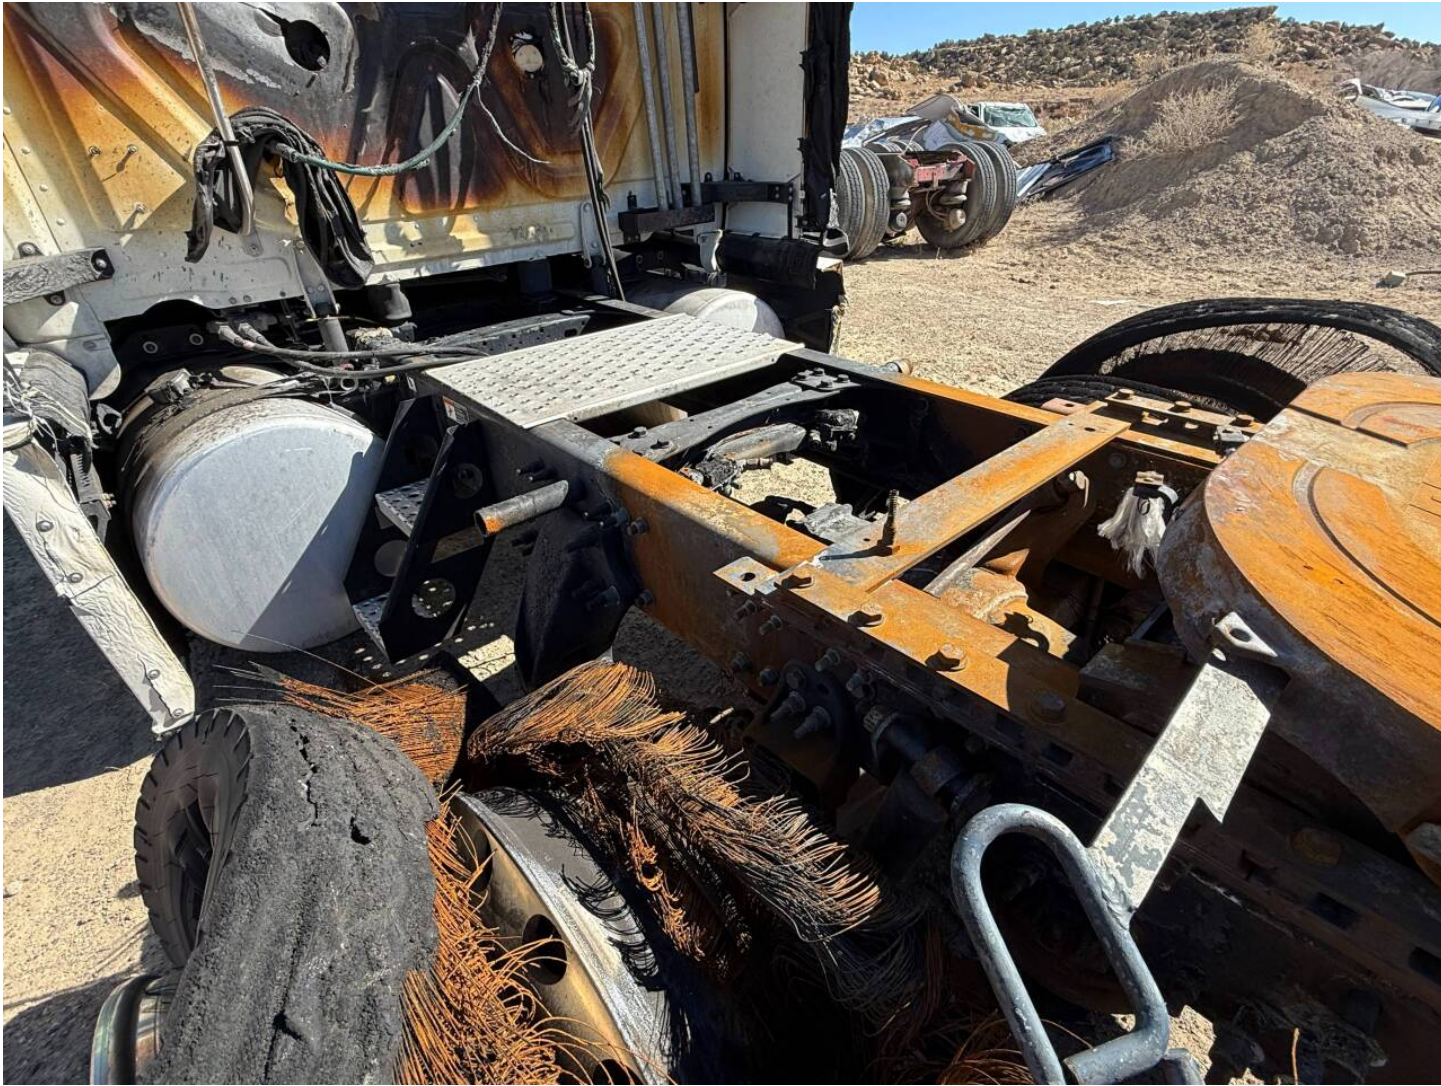
Damage noted to rear of vehicle of 2023 freightliner tractor VIN: 3AKJHHDR0PSUP4928.

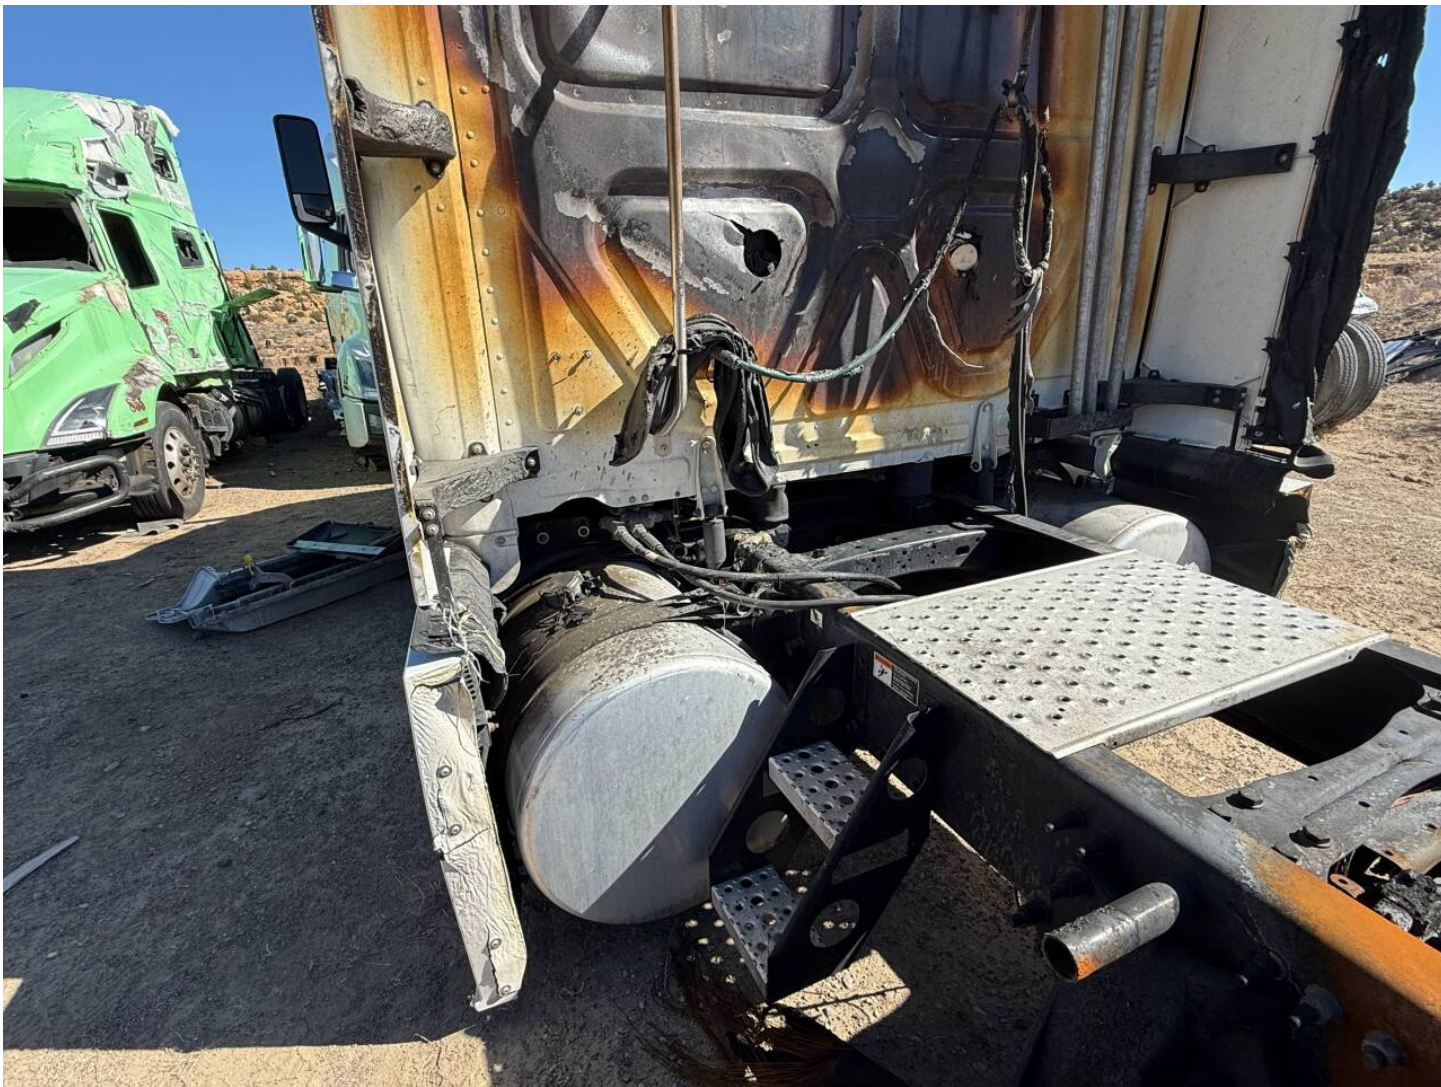
Damage noted to rear of vehicle of 2023 freightliner tractor VIN: 3AKJHHDR0PSUP4928.

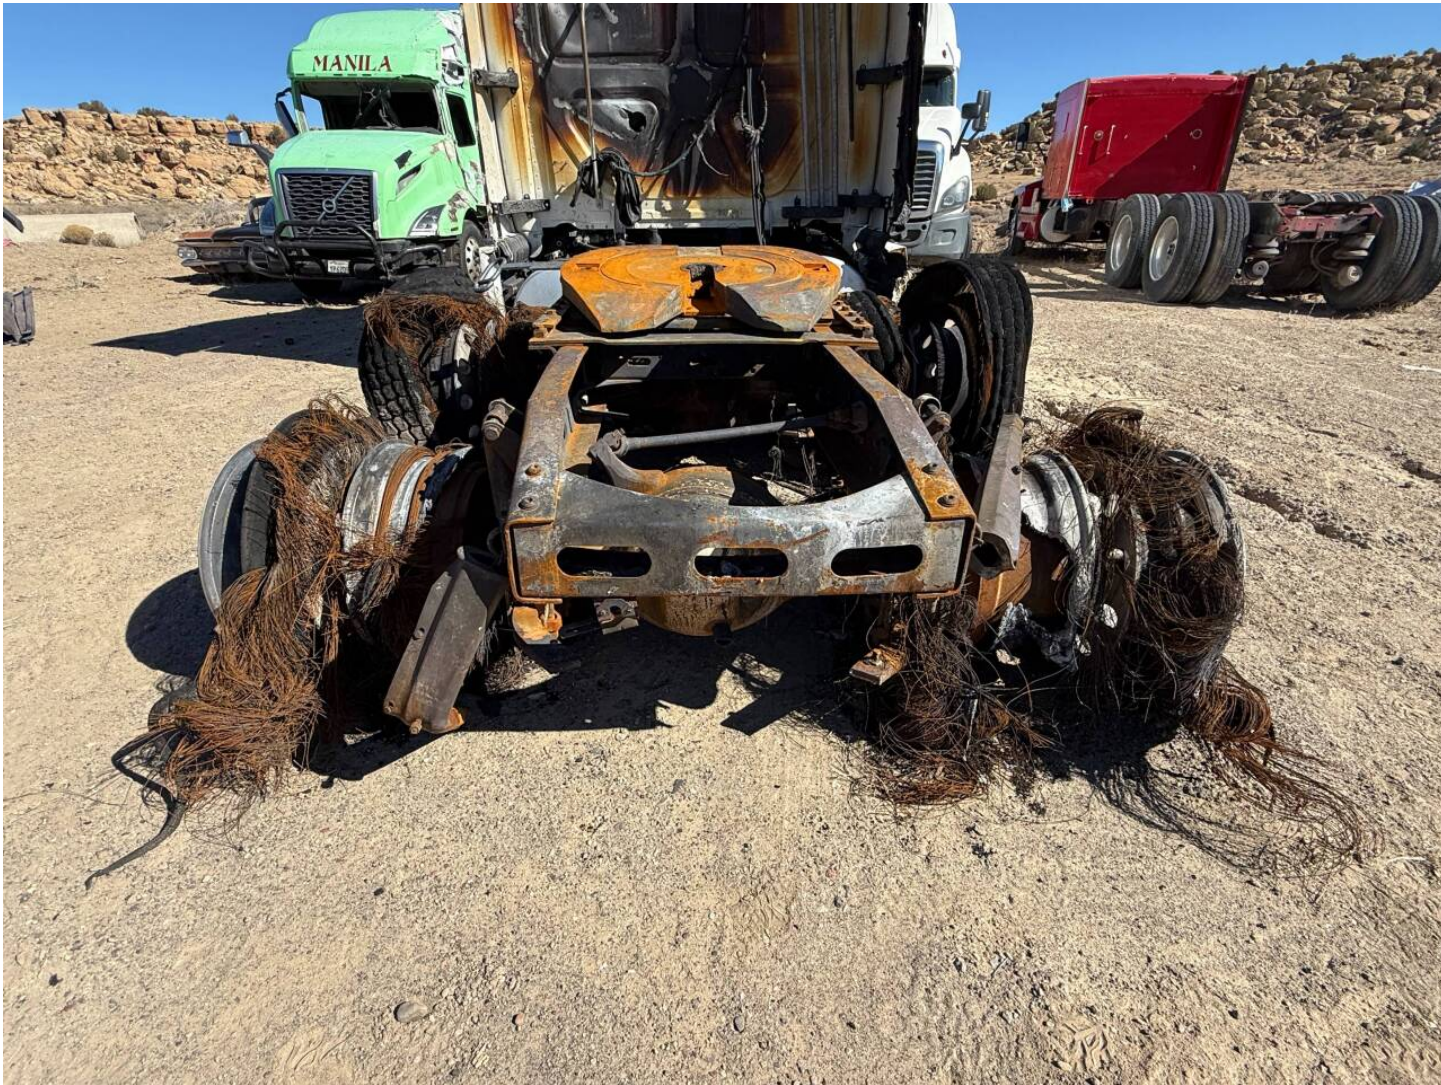
Damage noted to rear of vehicle of 2023 freightliner tractor VIN: 3AKJHHDR0PSUP4928.

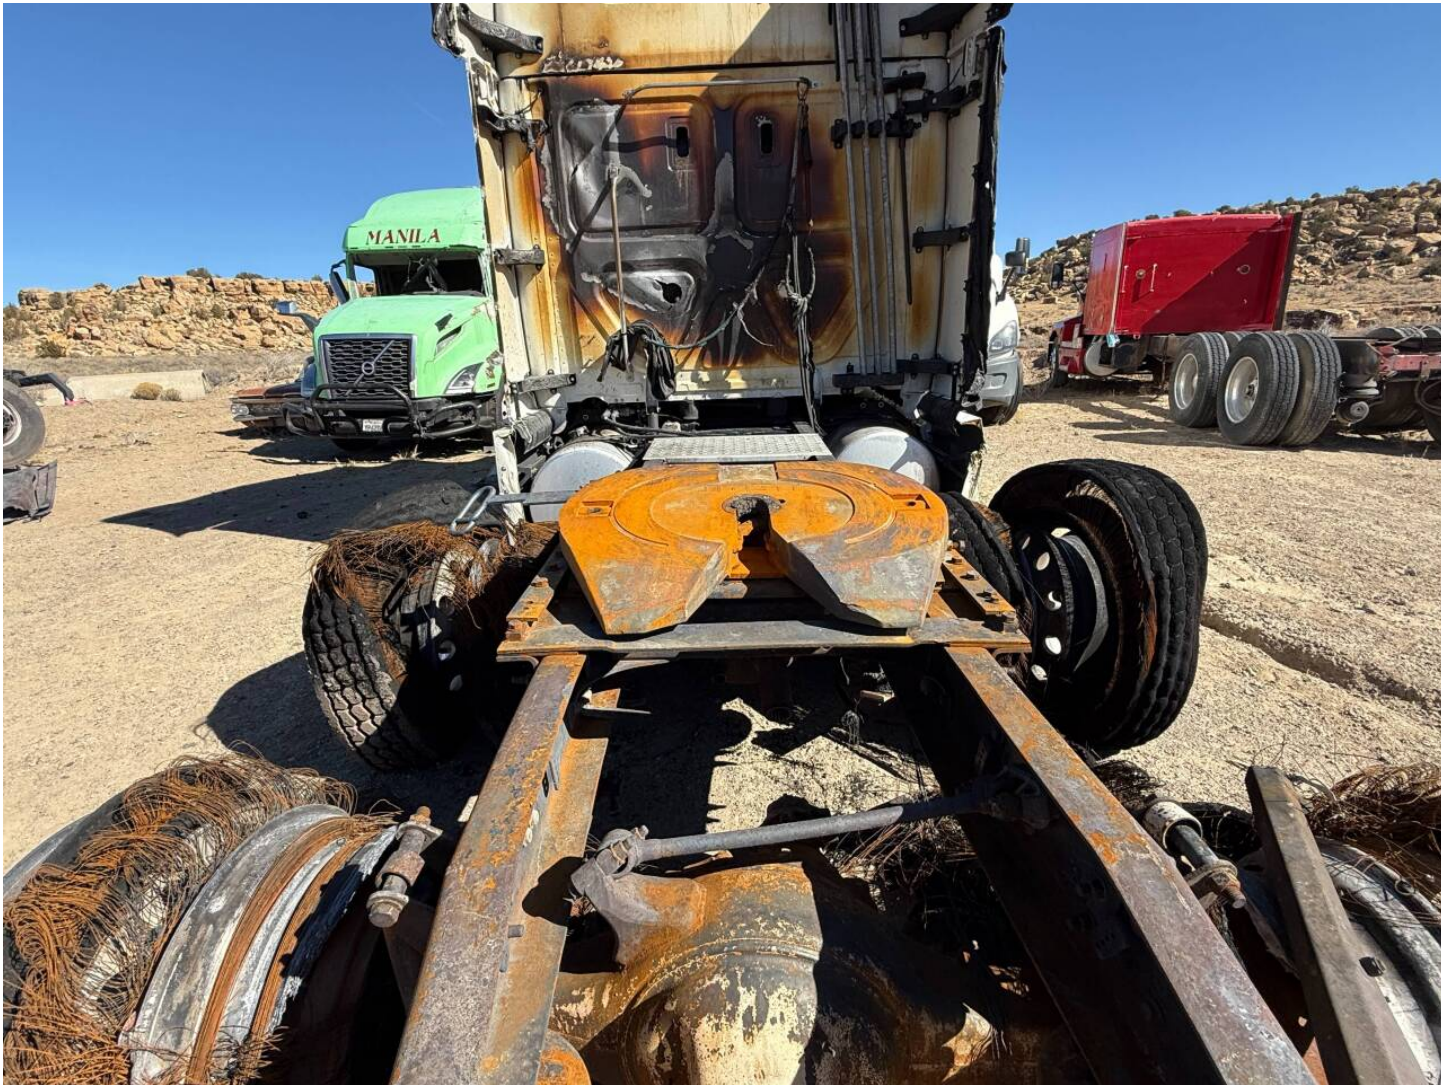
Damage noted to rear of vehicle of 2023 freightliner tractor VIN: 3AKJHHDR0PSUP4928.

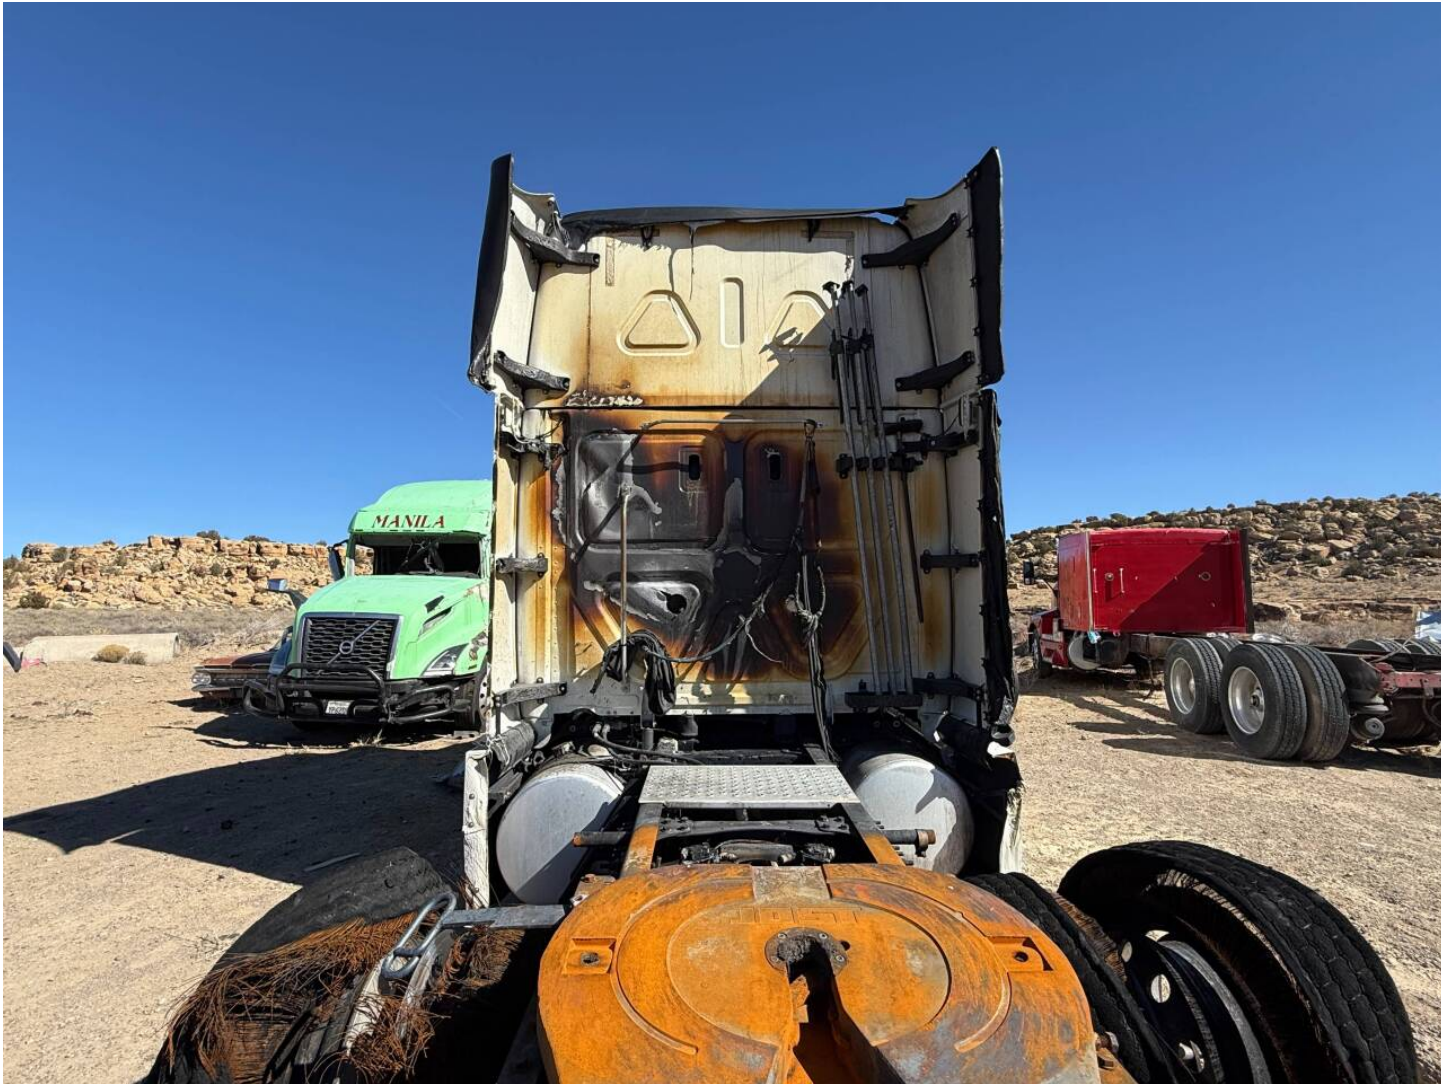
Damage noted to rear of vehicle of 2023 freightliner tractor VIN: 3AKJHHDR0PSUP4928.

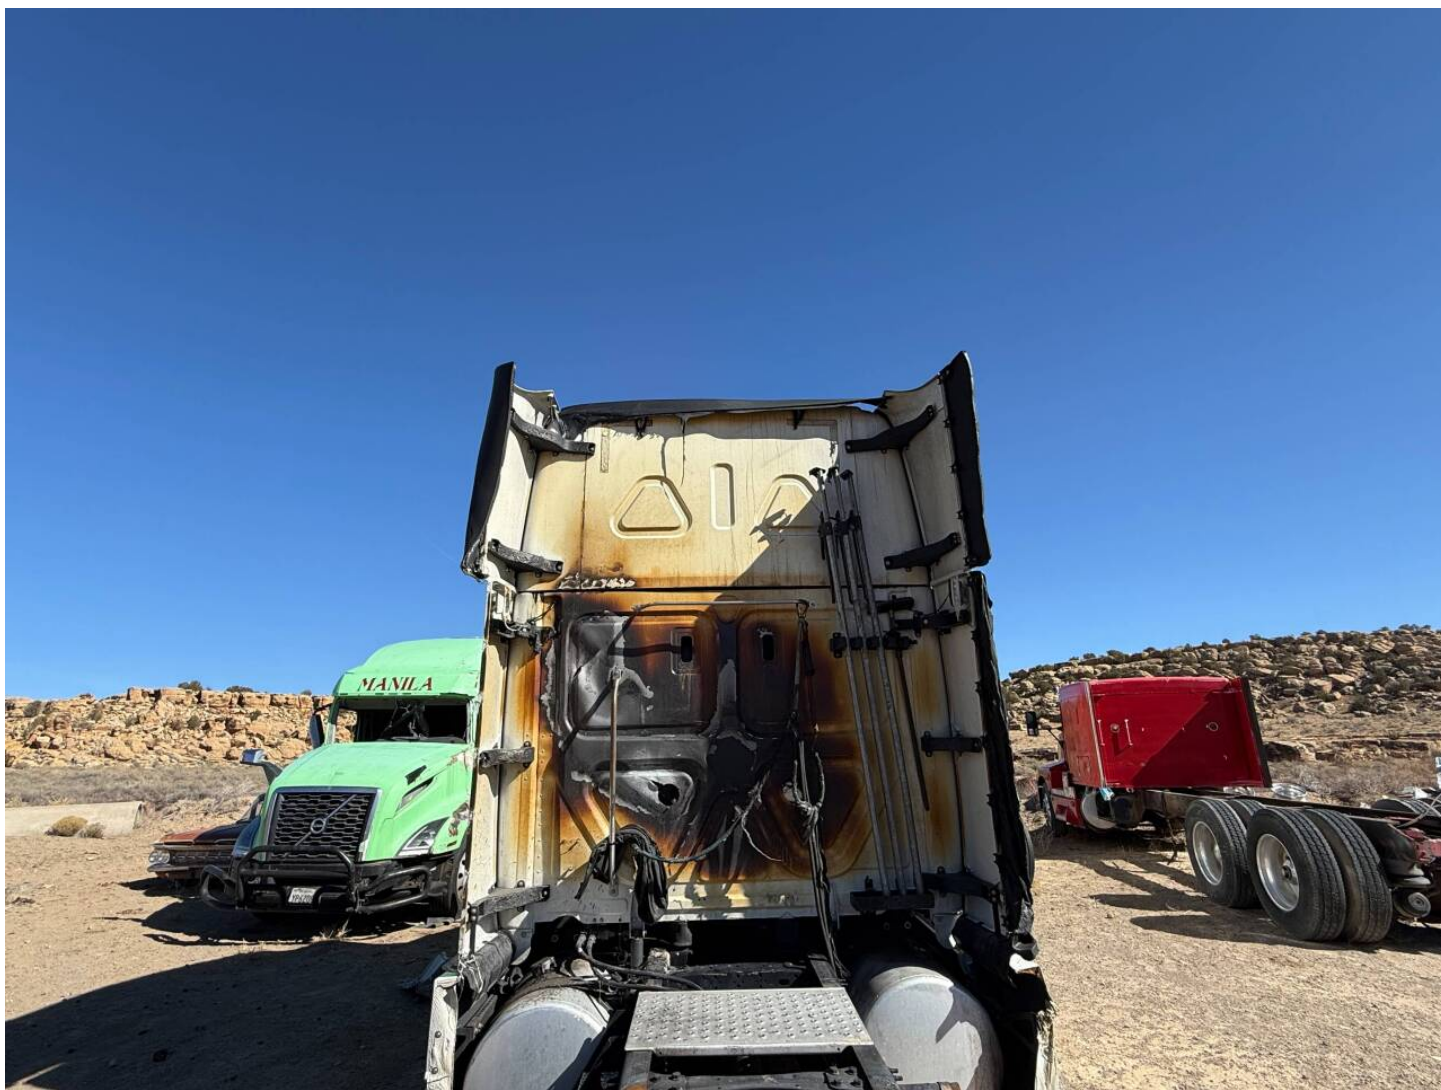
Damage noted to rear of vehicle of 2023 freightliner tractor VIN: 3AKJHHDR0PSUP4928.

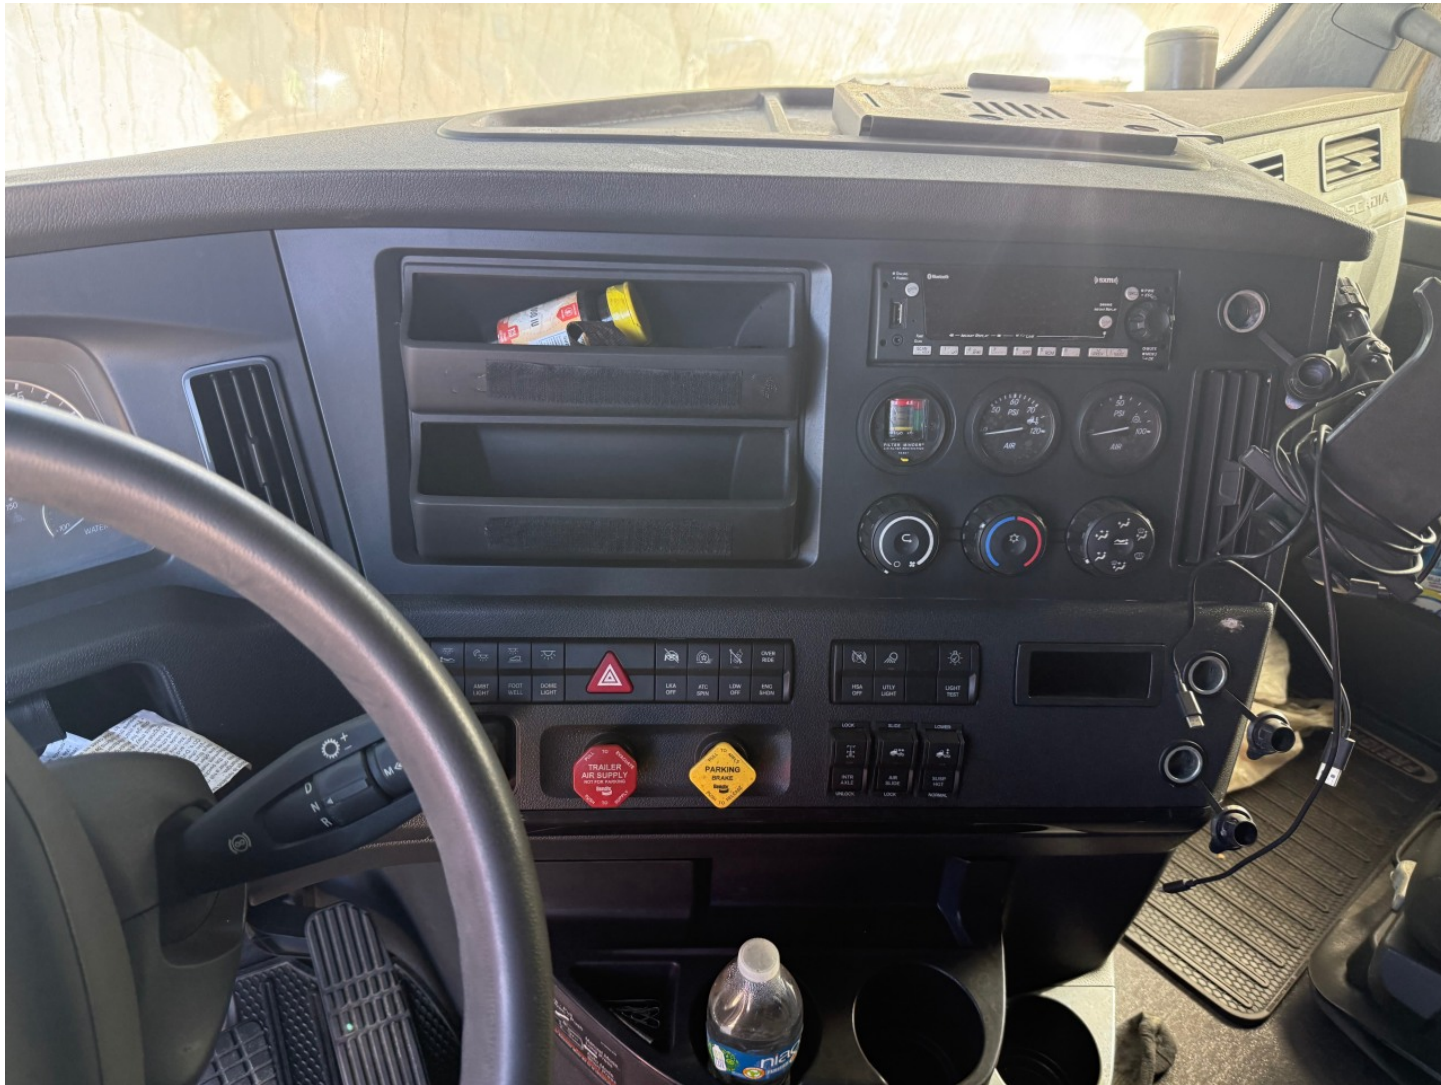
Dash.

Also, the unit did not start and there was no mileage sticker. There was no mileage reading.
