PHOTOS ONLY — APPRAISAL REPORT

The above referenced loss was received on 12/23/2025 at which time we were asked to inspect a vehicle described as: Year **2022** Make **Freightliner** Model **Cascadia** VIN **3AKJHHDR9NSMW7926**.

The assignment indicated damage to: Overturned tractor/trailer Trailer: 2023 Vanguard VIN 5V8VC5324PM301409.

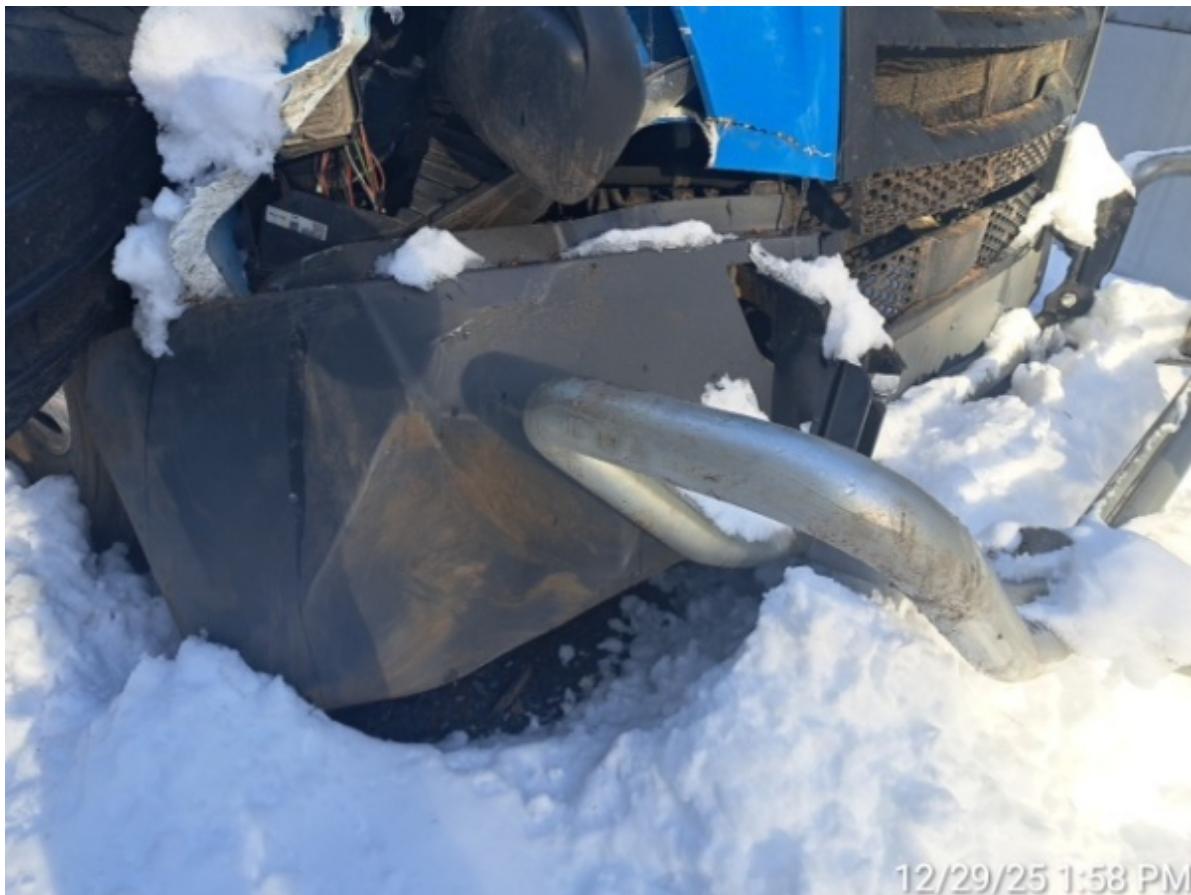
FR BUMPER DAMAGE

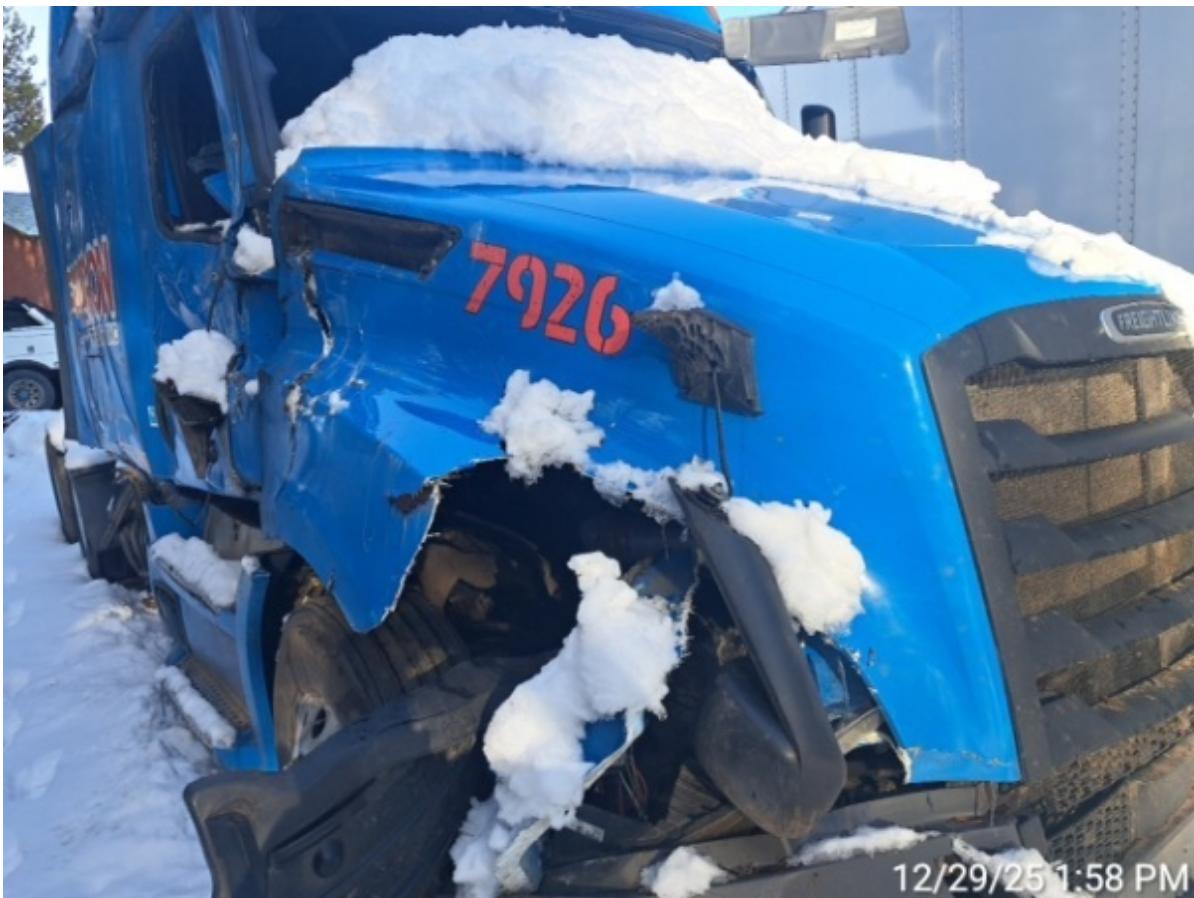
RT FENDER DAMAGE

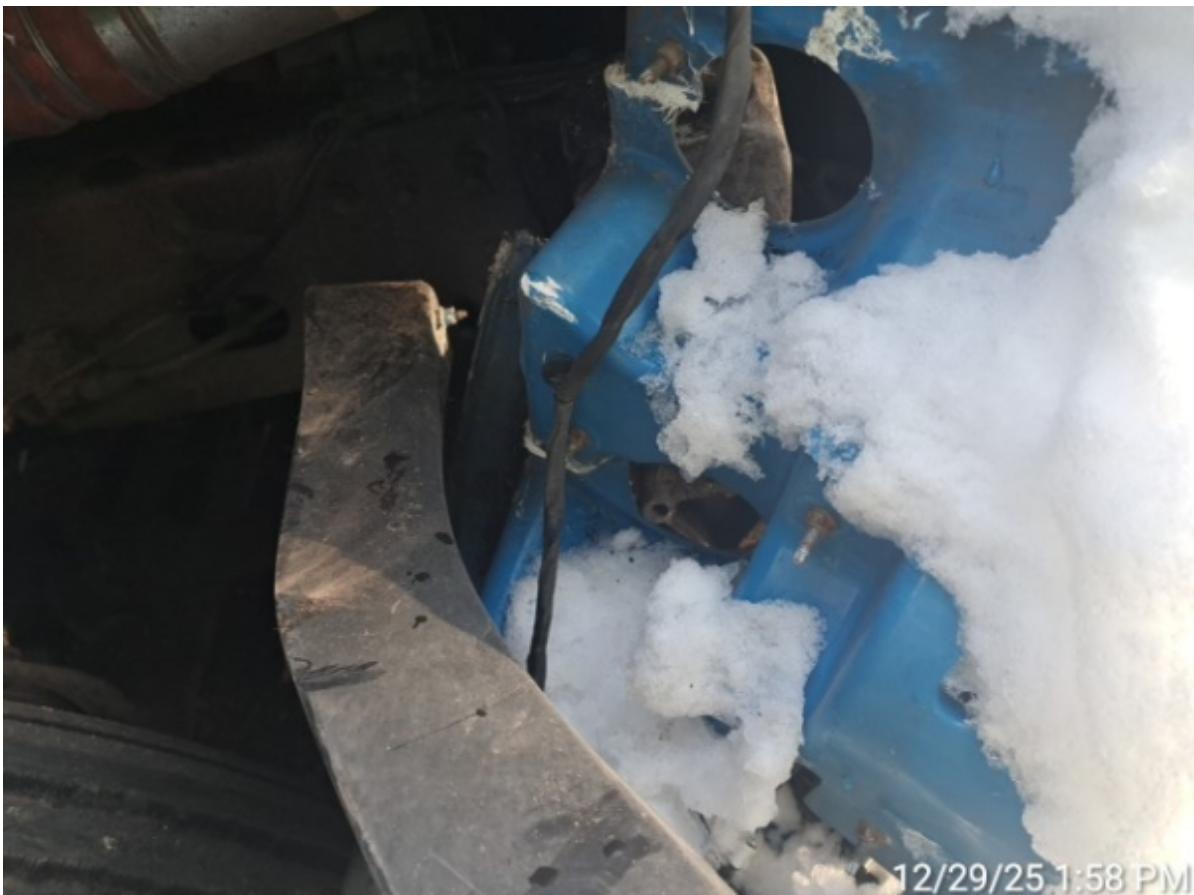
RT FENDER DAMAGE

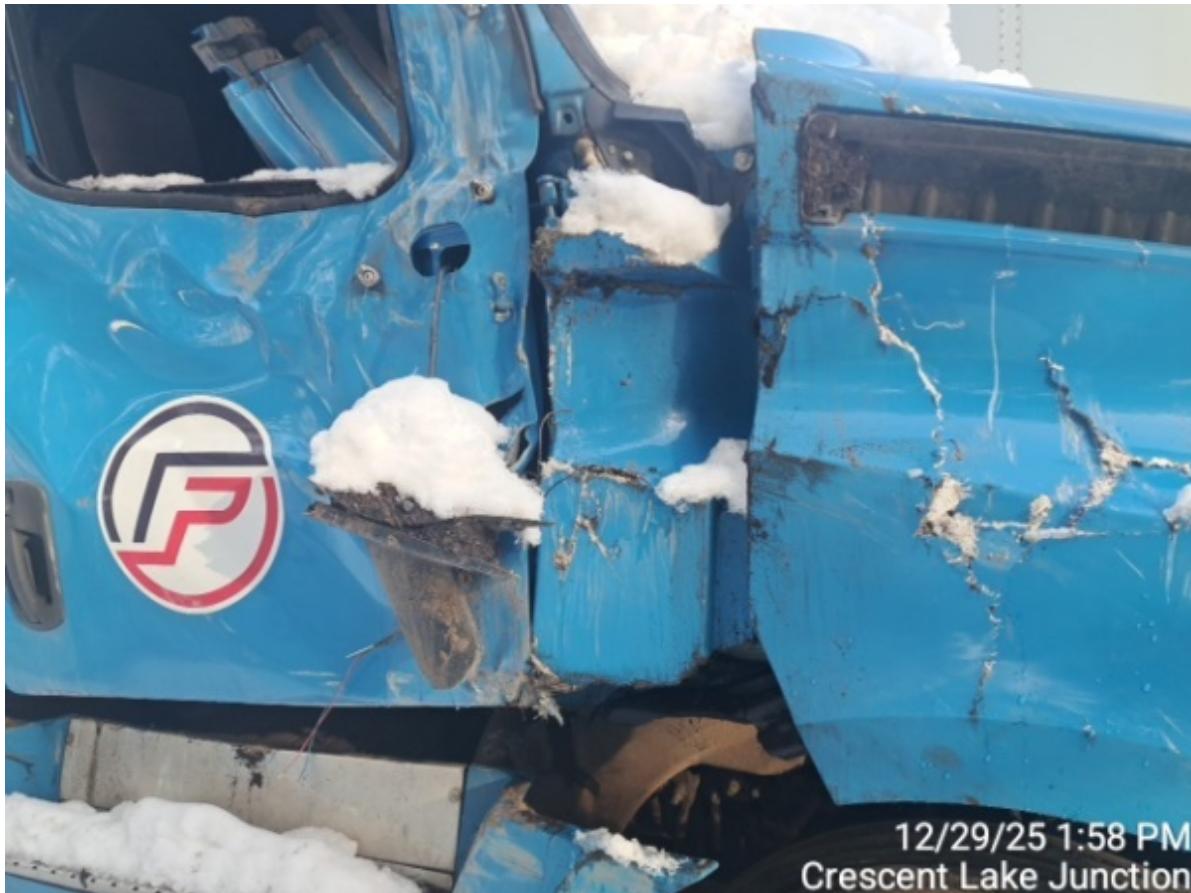
RT FR DOOR DAMAGE

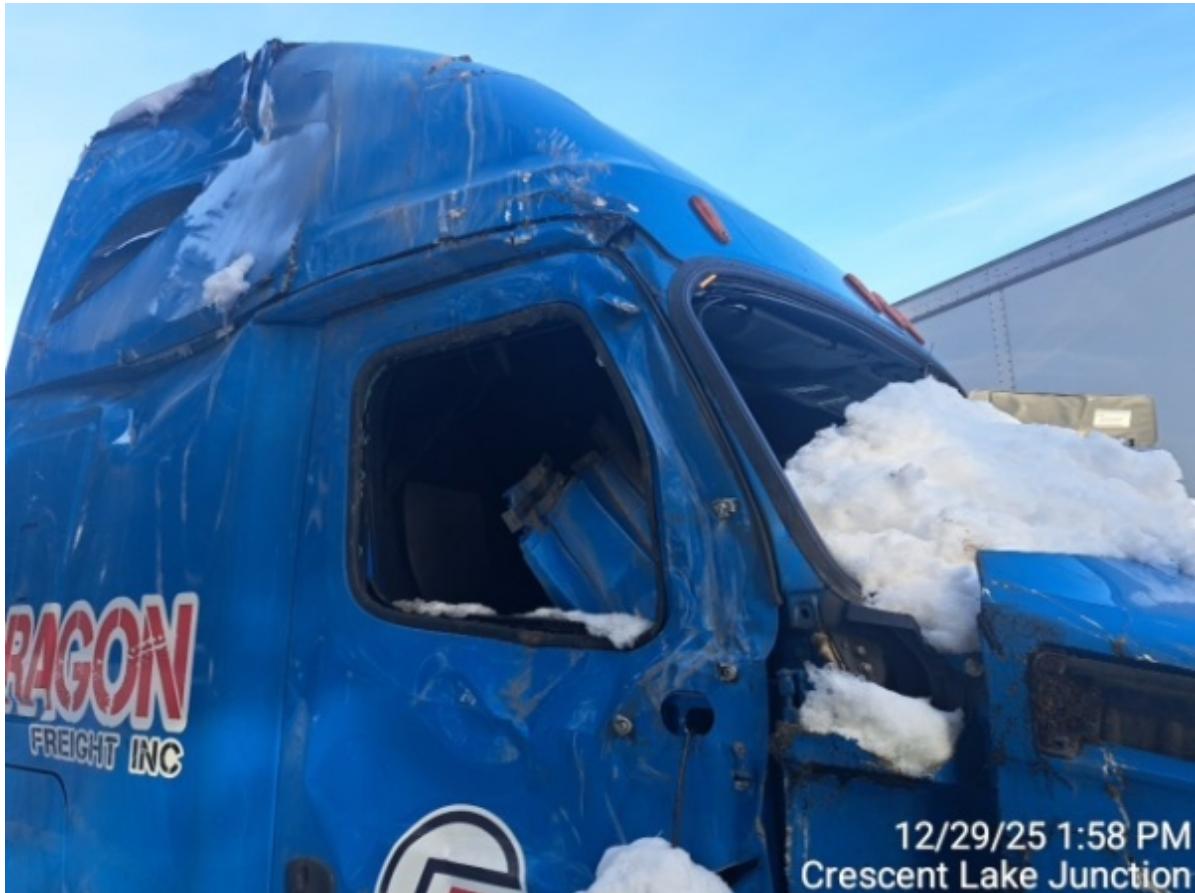
RT CAB CORNER DAMAGE

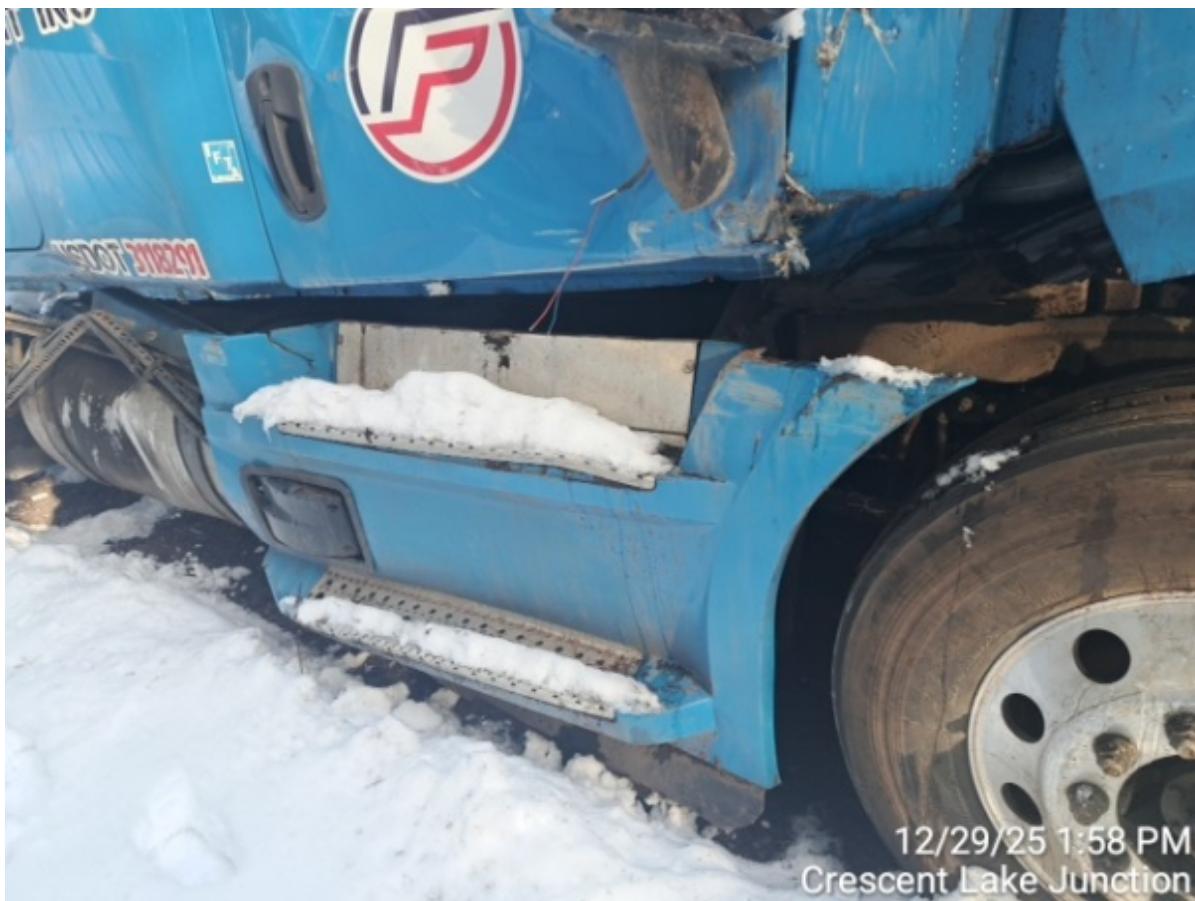
RT SIDE DAMAGE

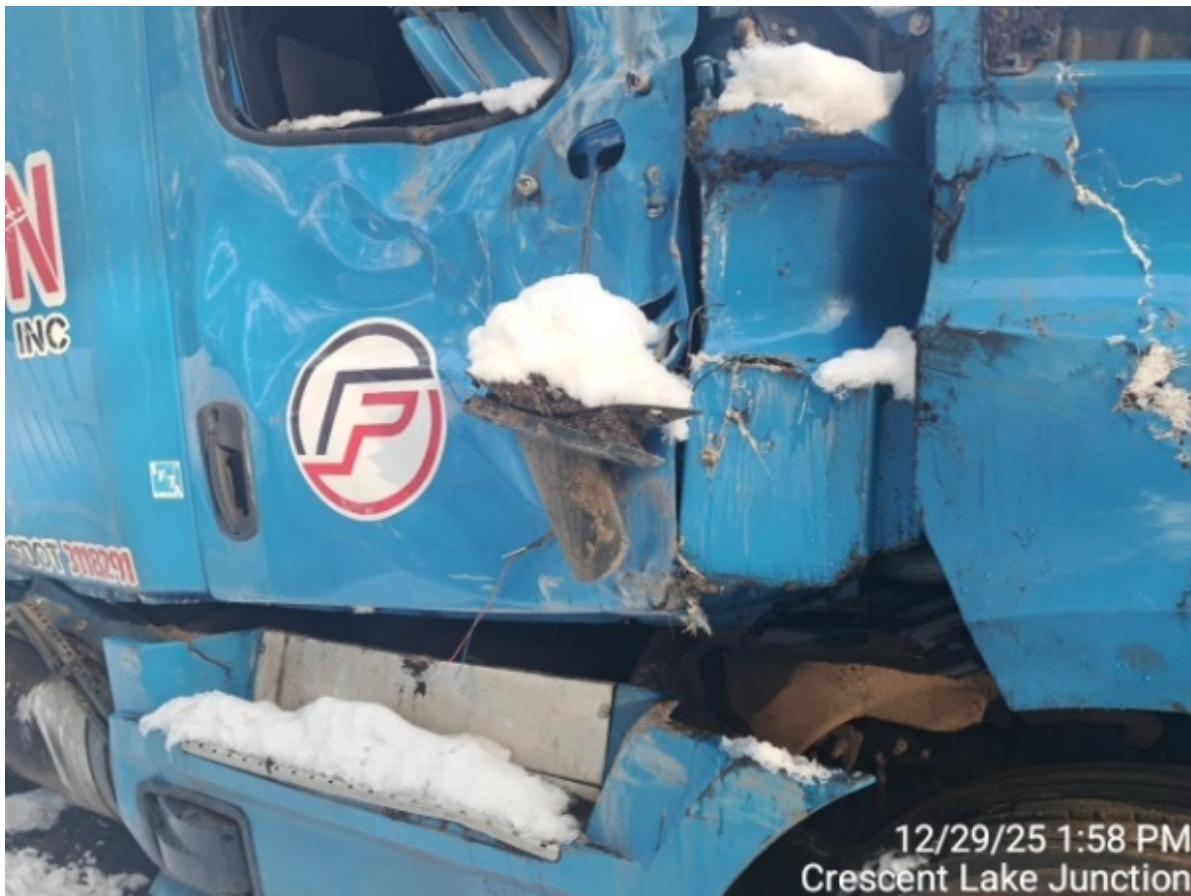
RT SIDE DAMAGE

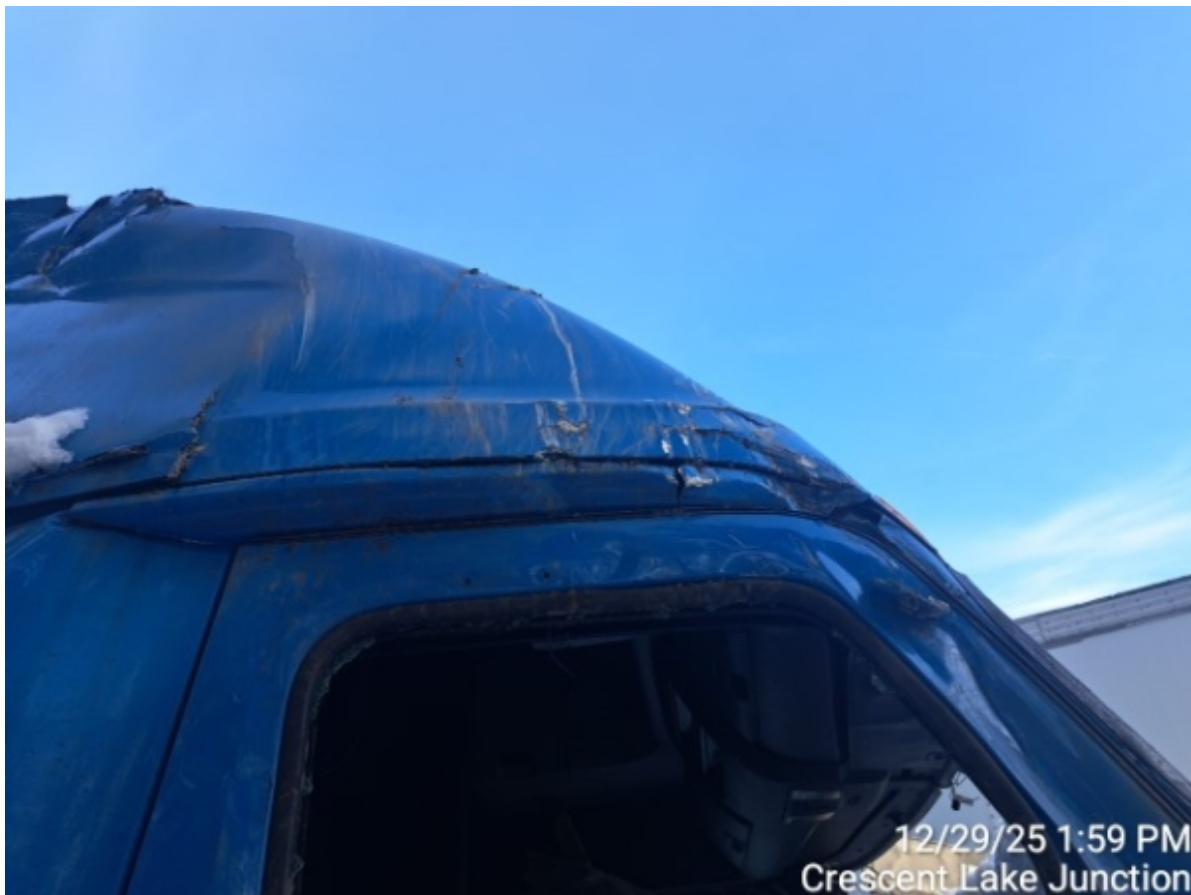
RT CAB DAMAGE

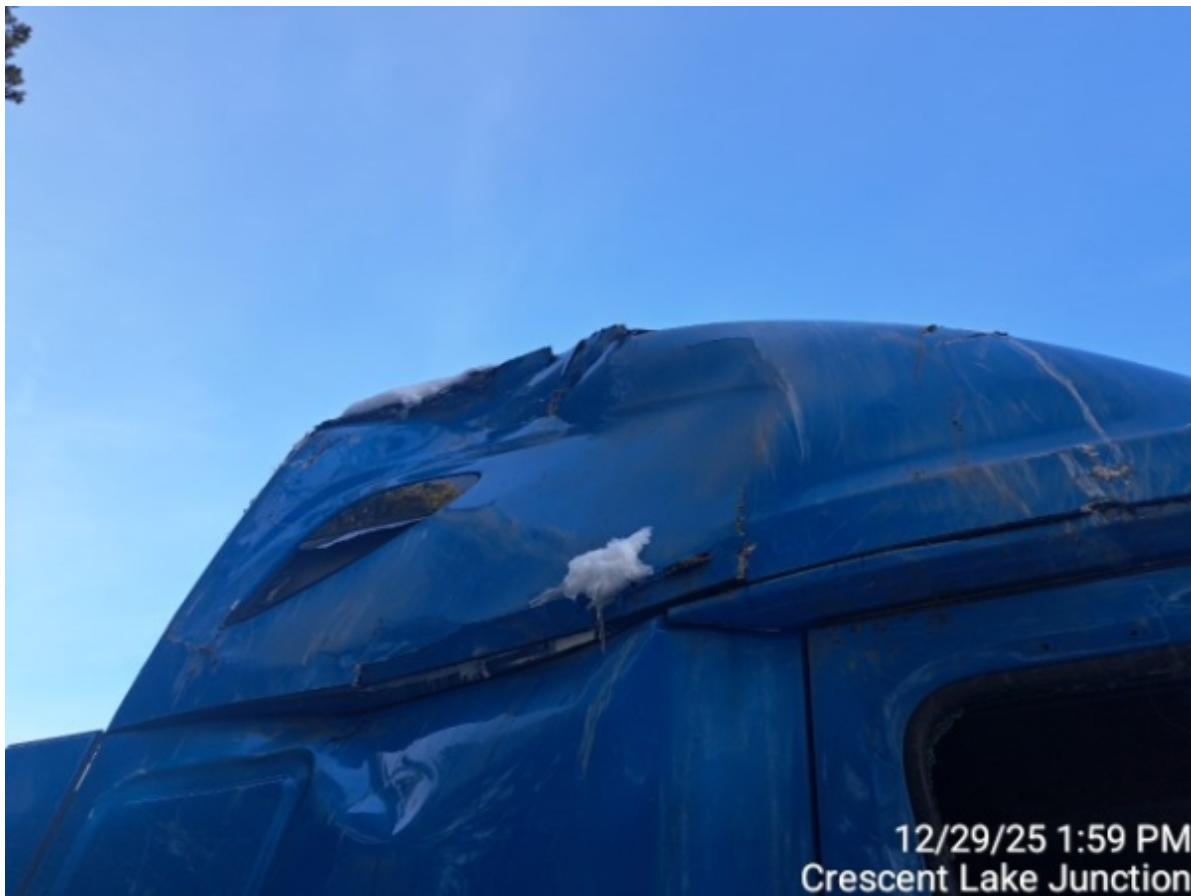
RT ROOF DAMAGE

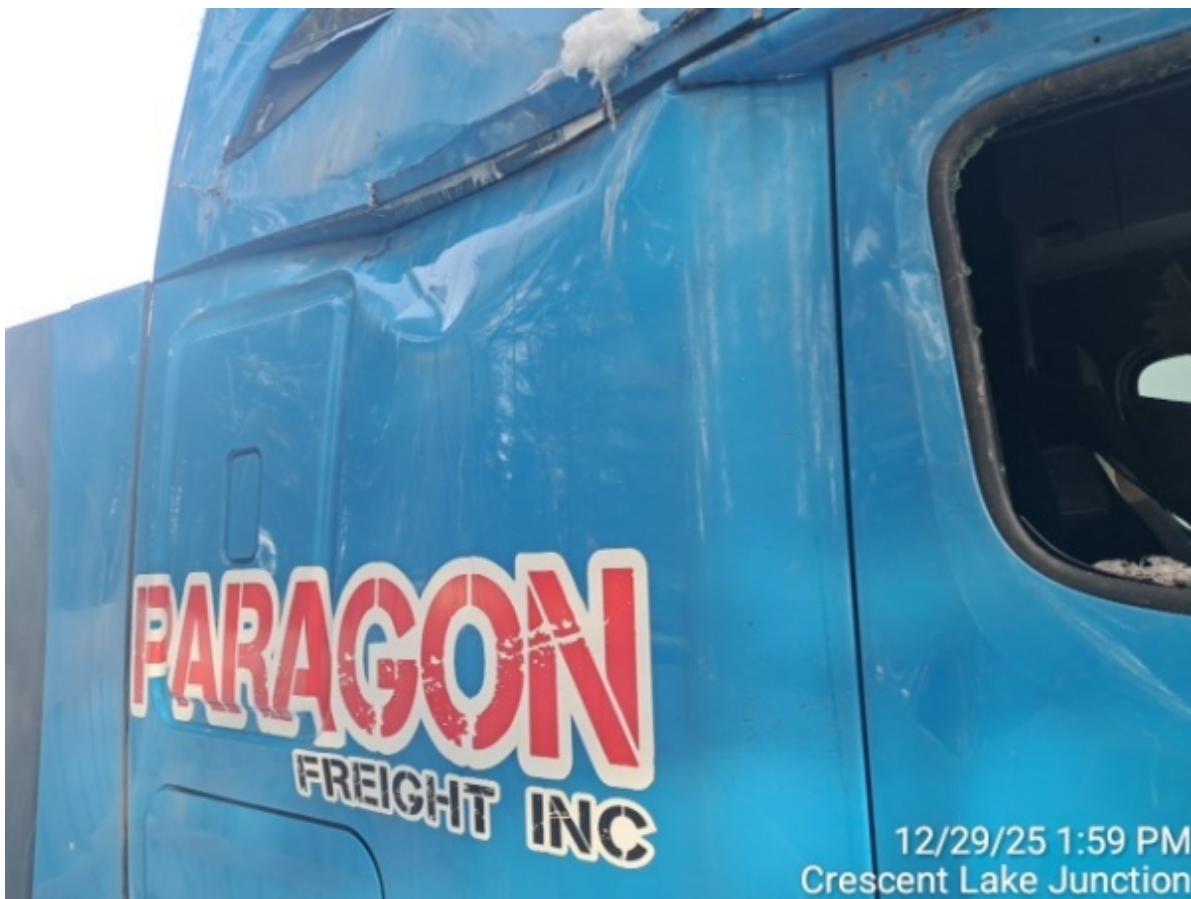
RT SIDE DAMAGE

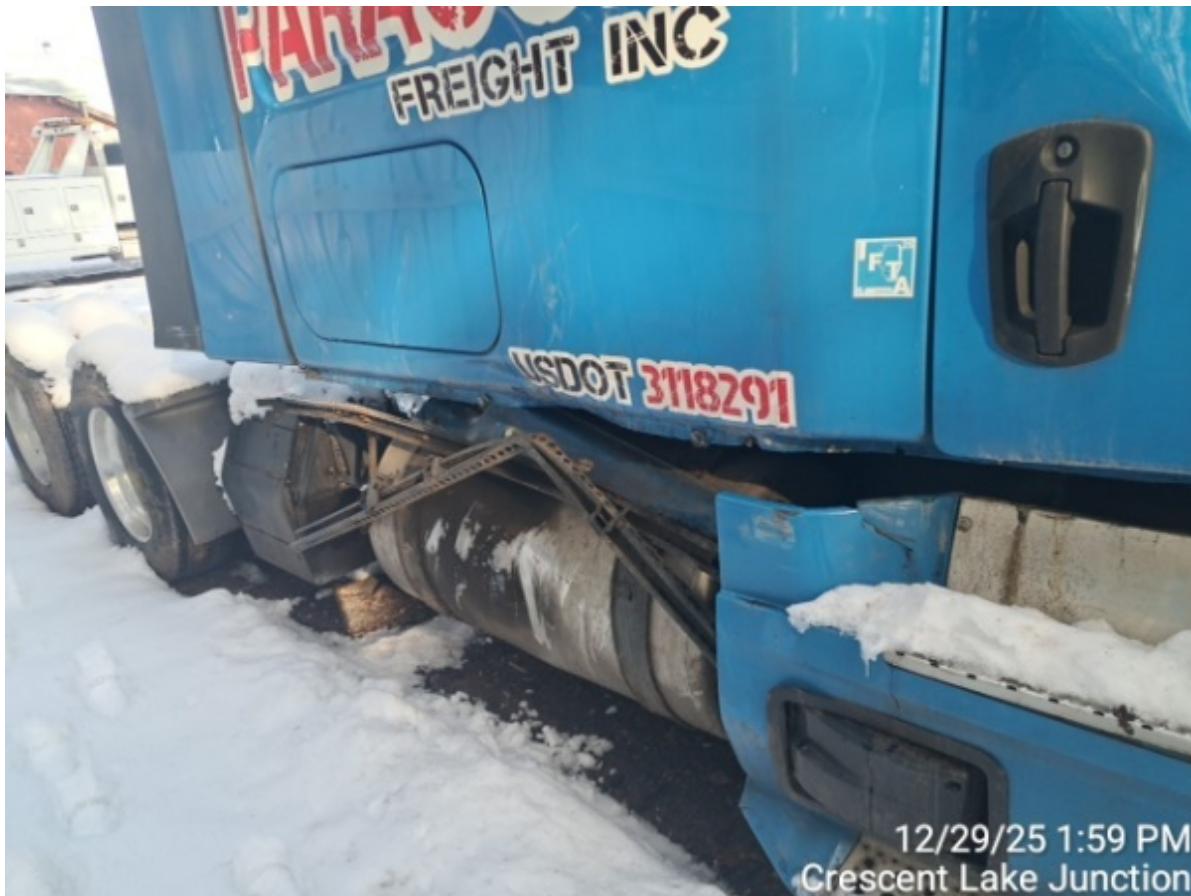
RT SIDE DAMAGE

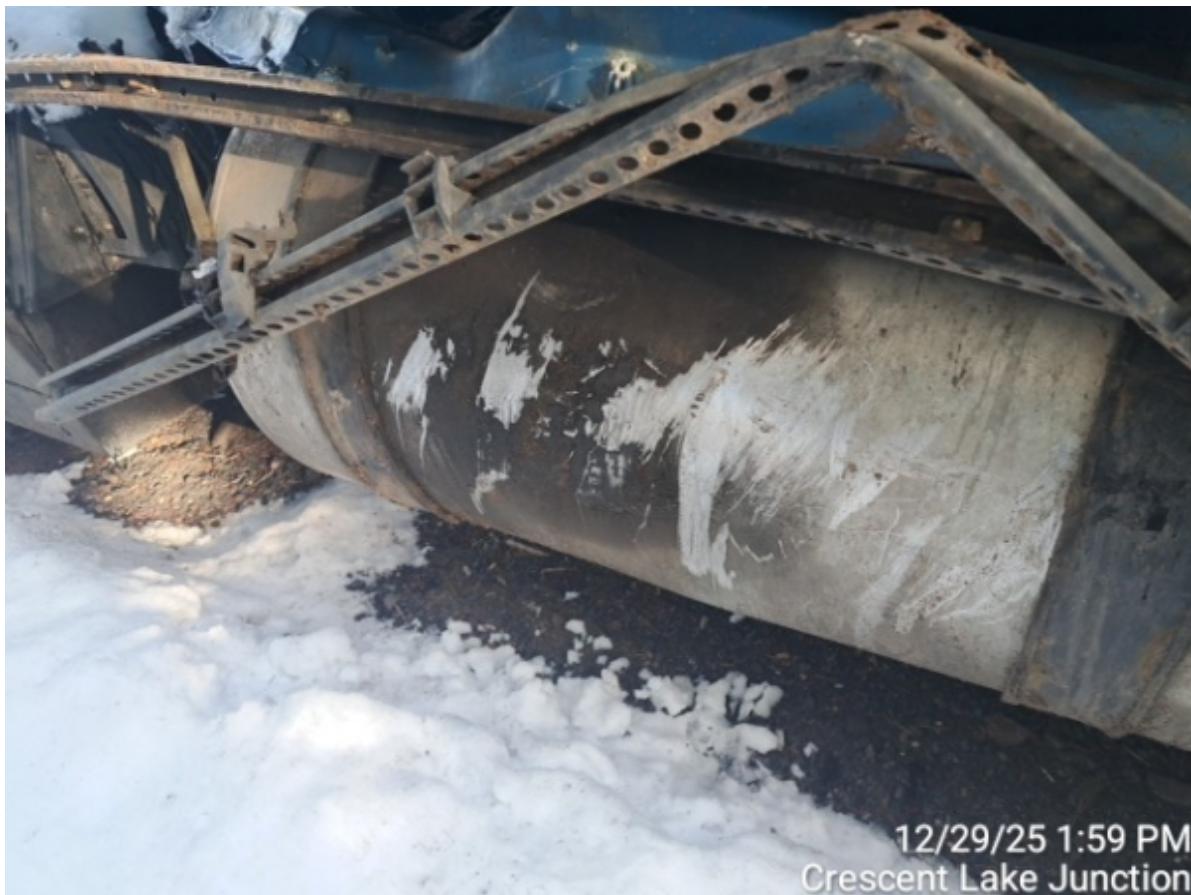
RT TANK DAMAGE

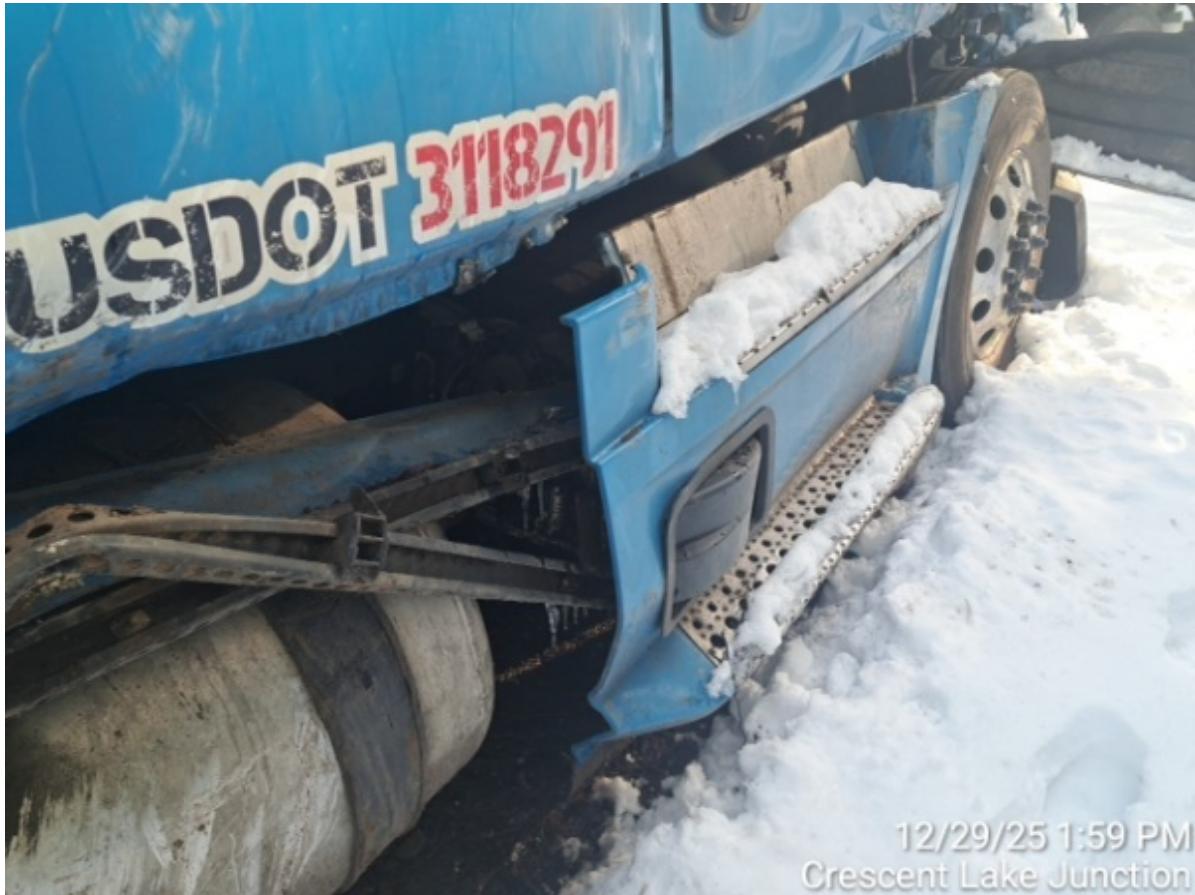
RT SIDE DAMAGE

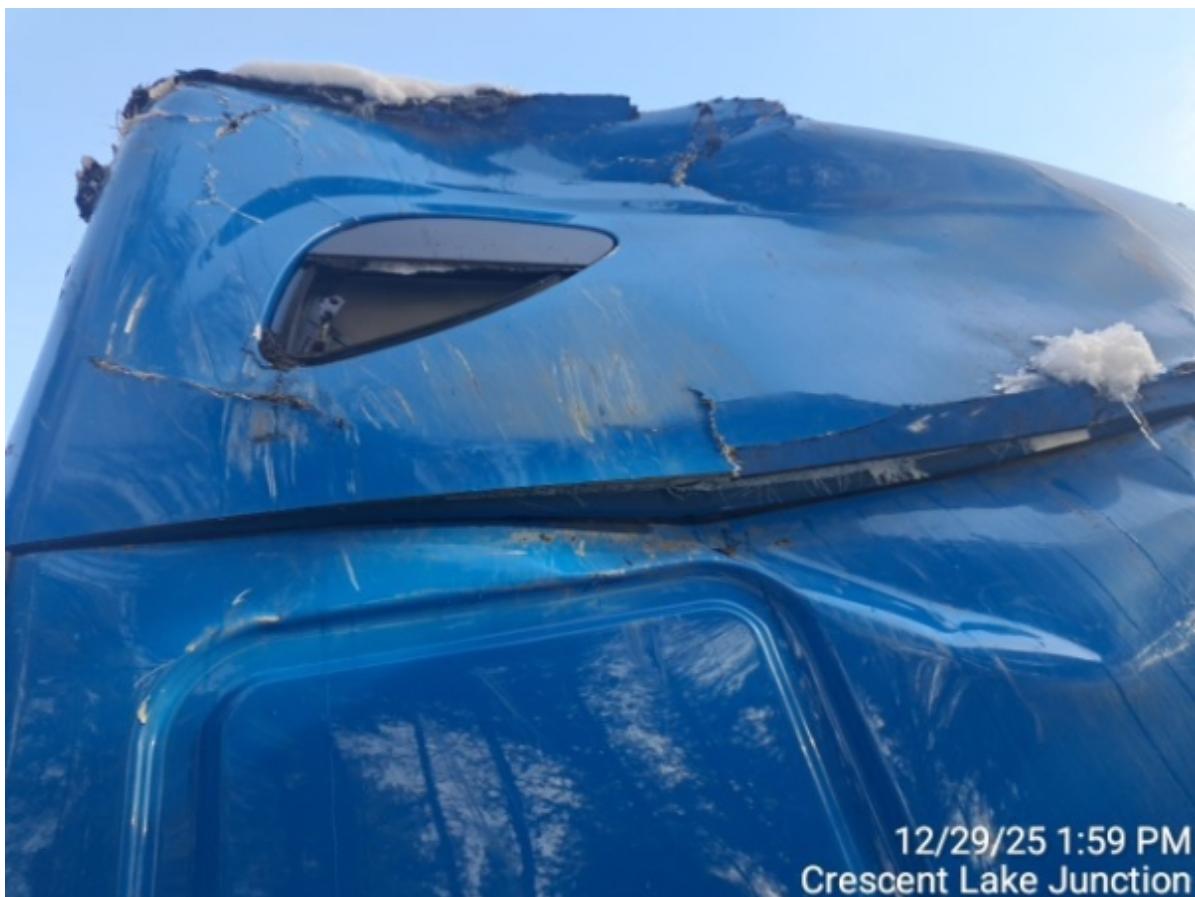
RT SIDE DAMAGE

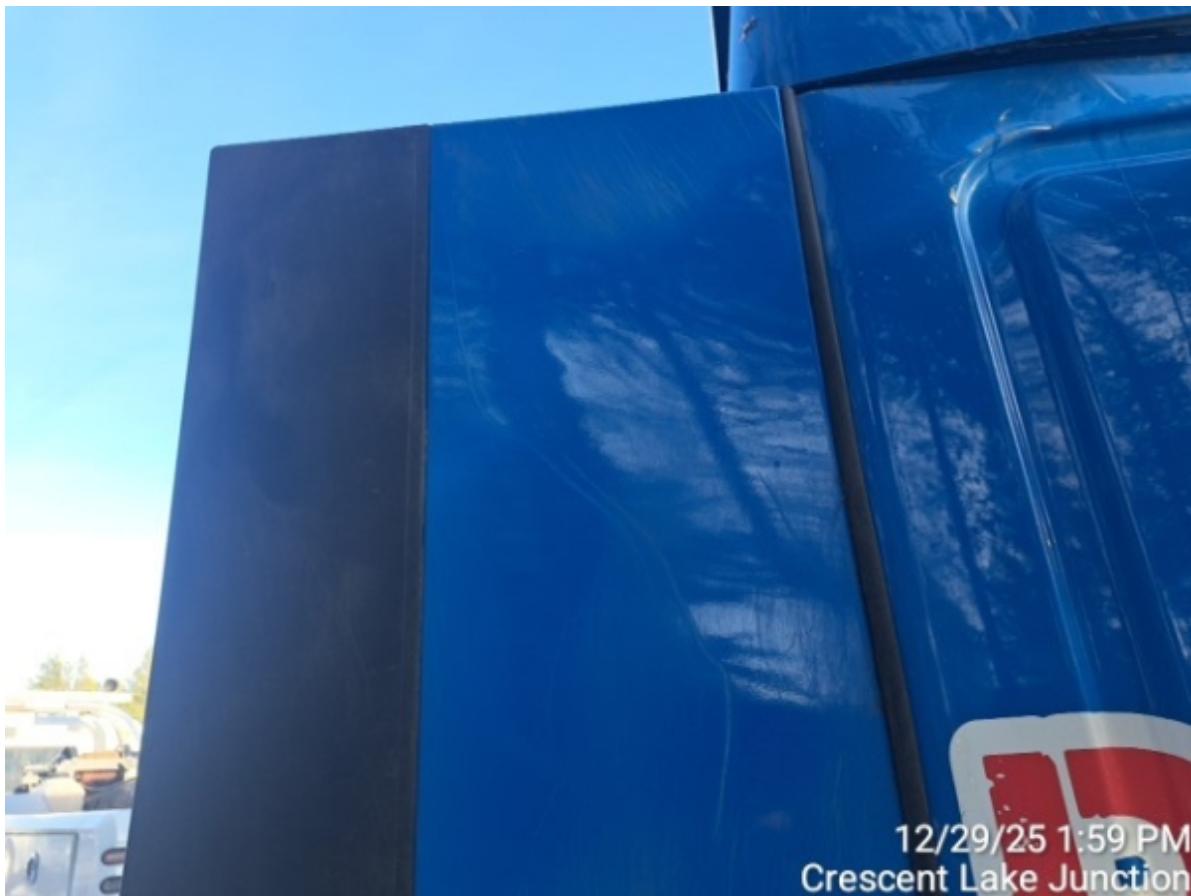
RT SIDE DAMAGE

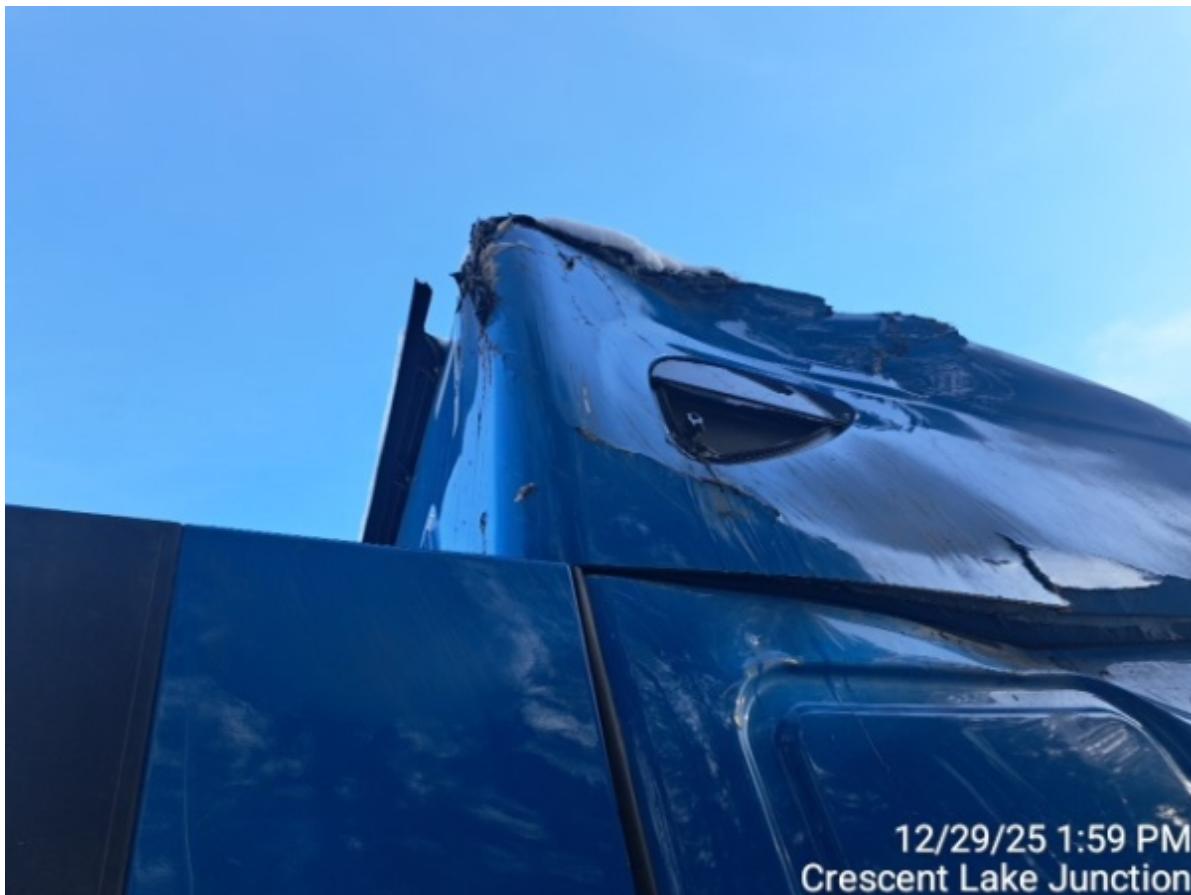
RT SIDE DAMAGE

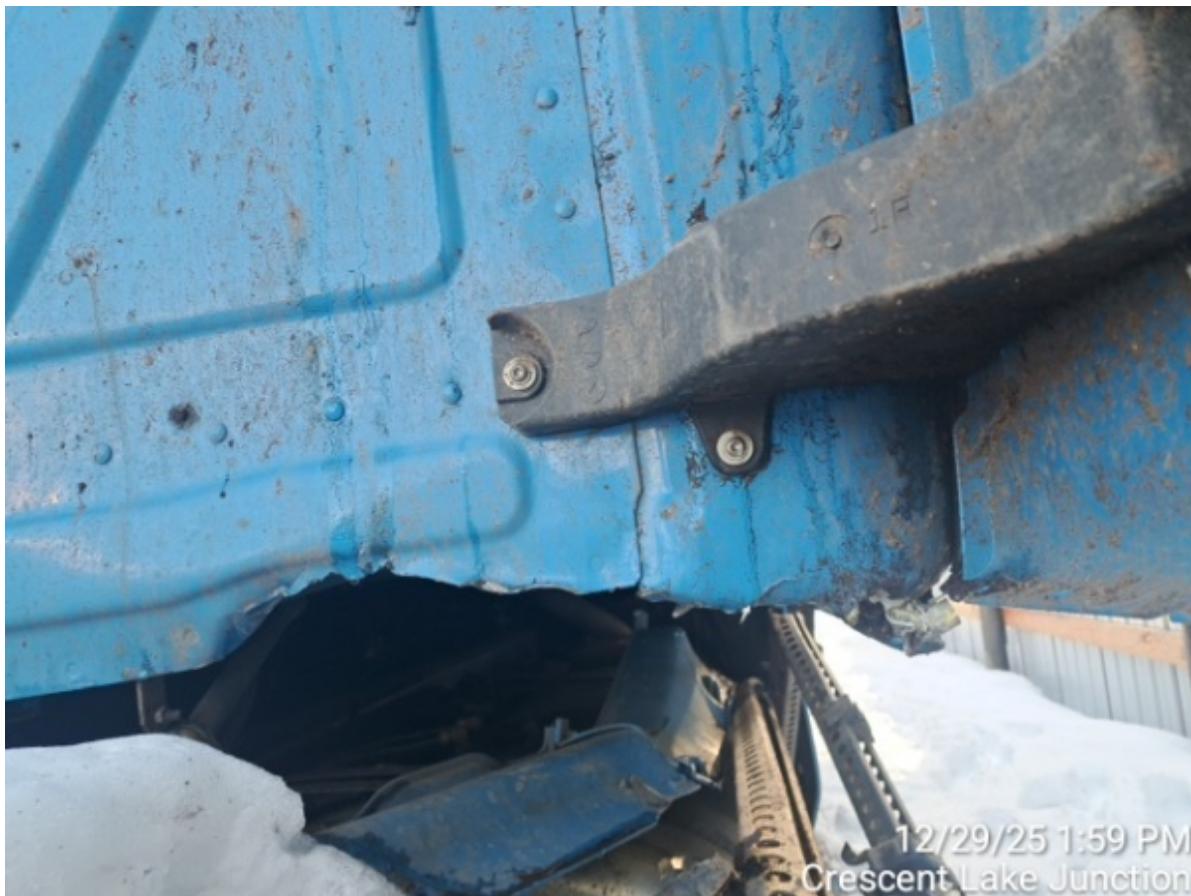
RR PANEL DAMAGE

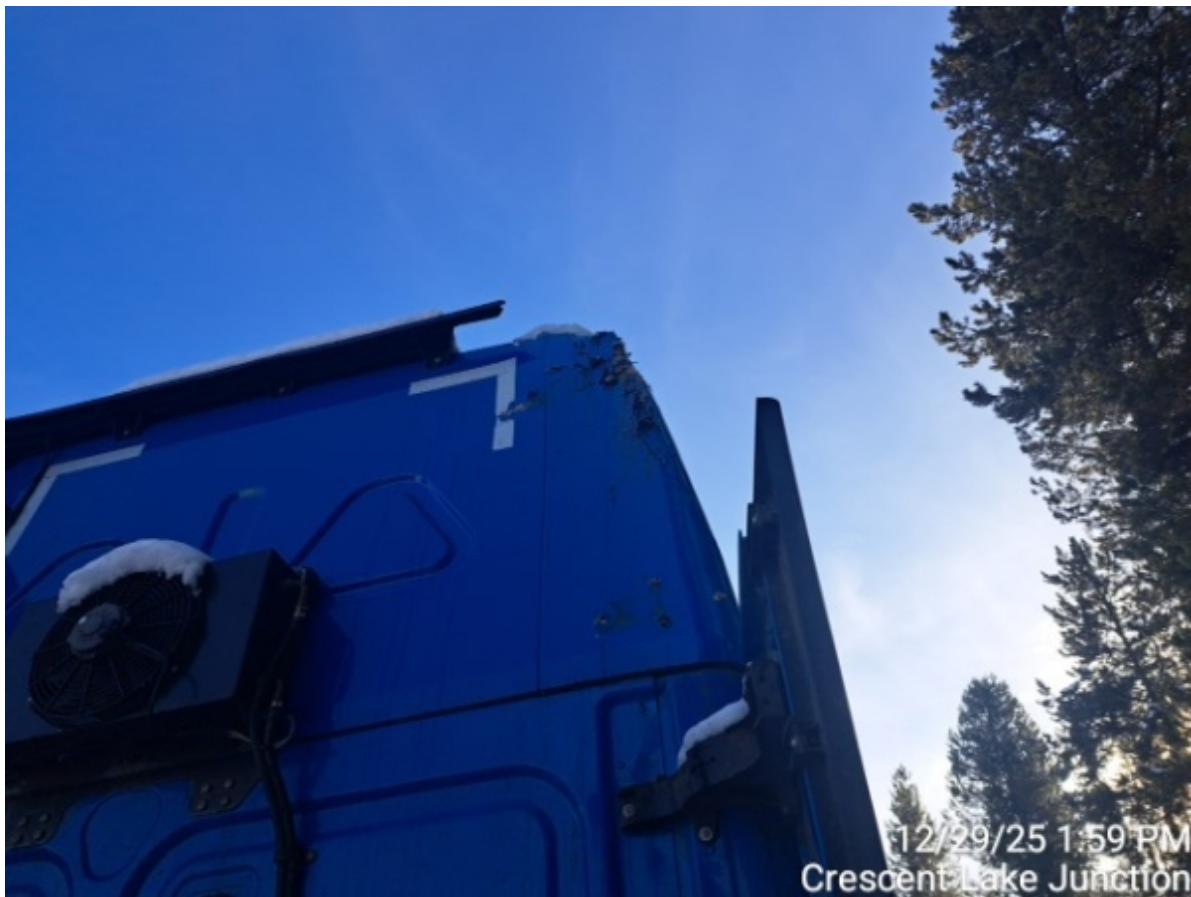
UPPER RR PANEL DAMAGE

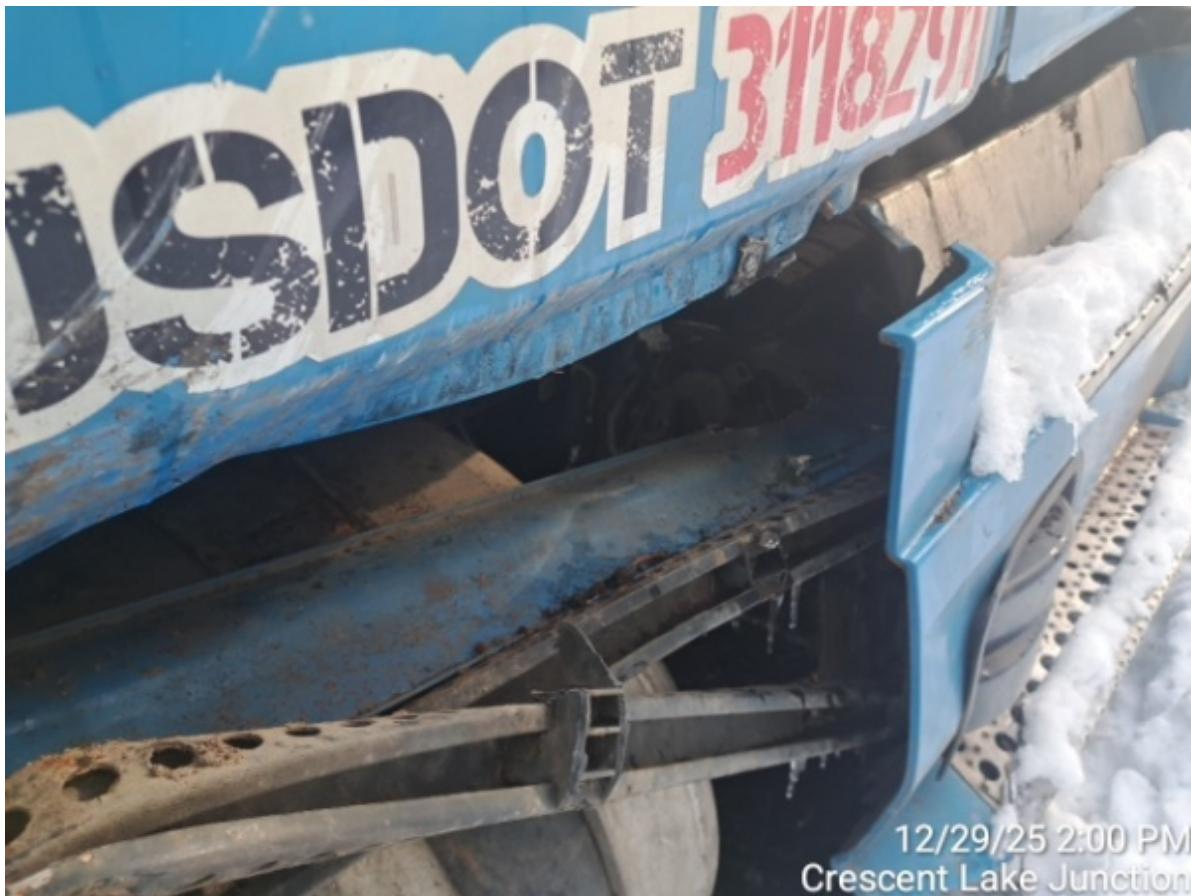
RT SIDE DAMAGE

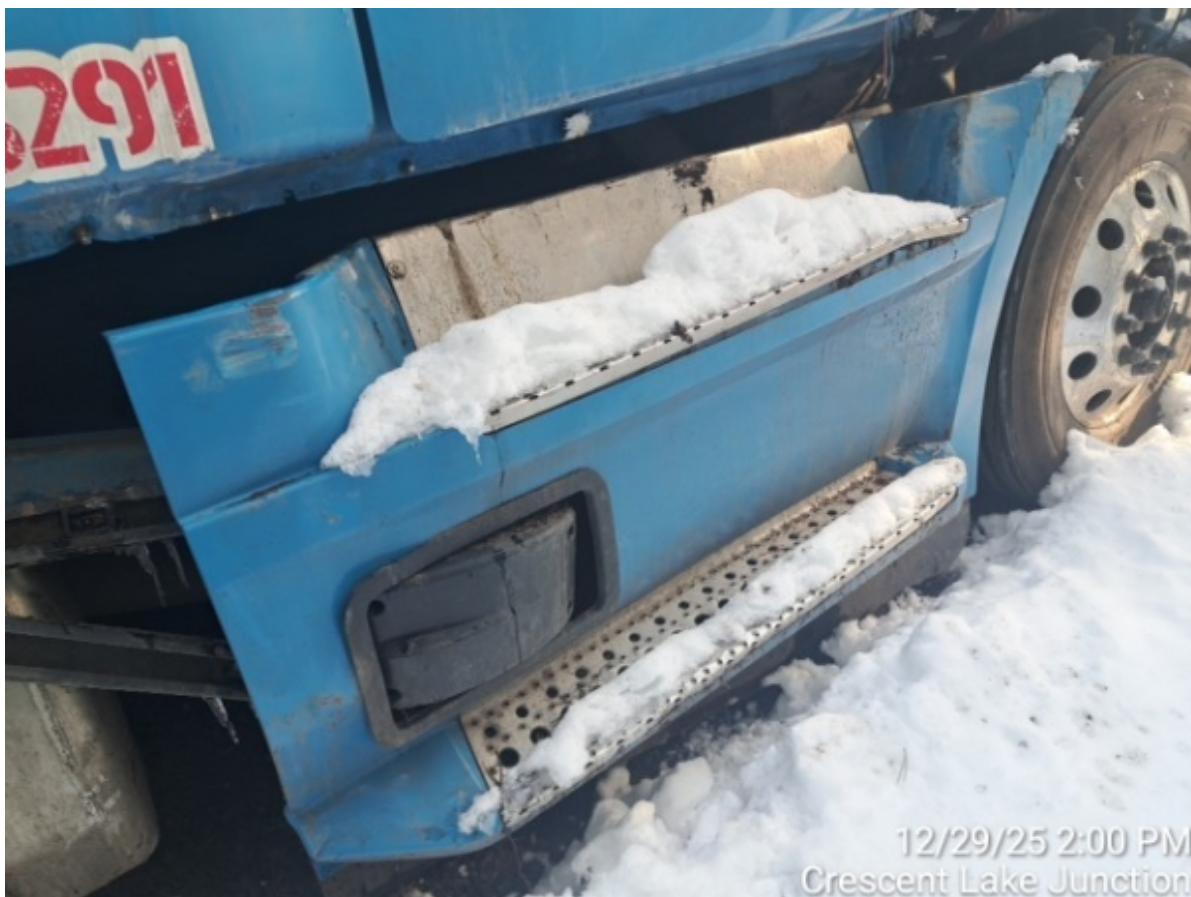
RT SIDE DAMAGE

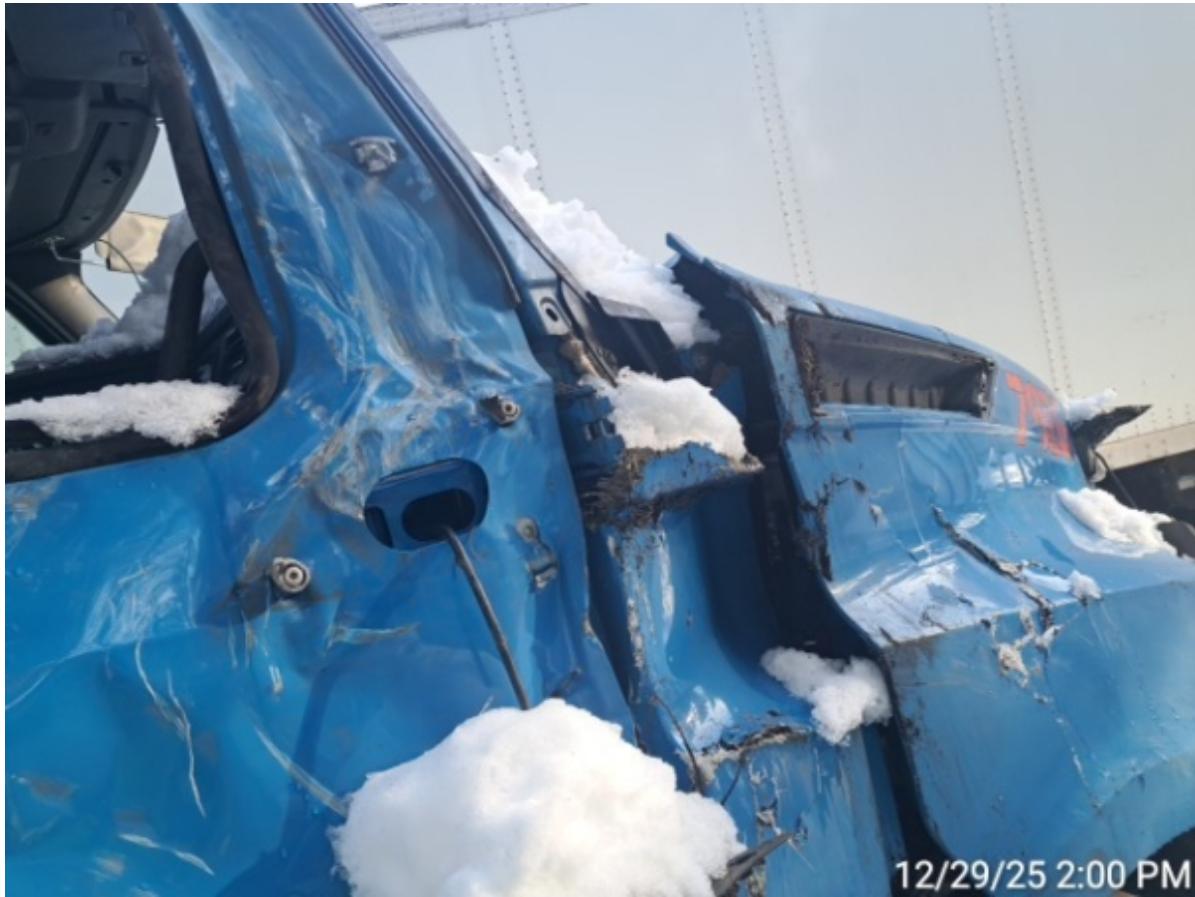
RT CAB CORNER DAMAGE
