PHOTOS ONLY — APPRAISAL REPORT

The above referenced loss was received on 12/23/2025 at which time we were asked to inspect a vehicle described as: Year **2022** Make **Freightliner** Model **Cascadia** VIN **3AKJHHDR9NSMW7926**.

The assignment indicated damage to: Overturned tractor/trailer Trailer: 2023 Vanguard VIN 5V8VC5324PM301409.

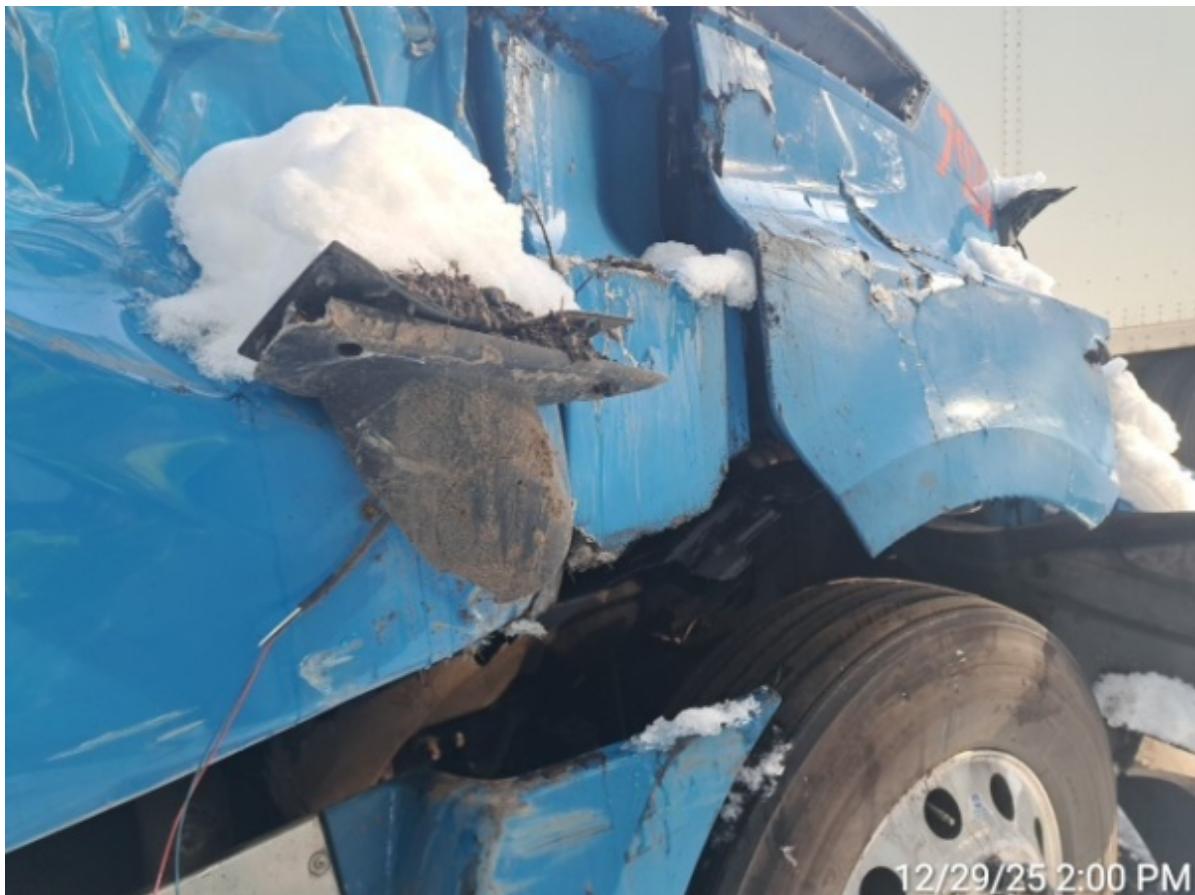
RT SIDE DAMAGE

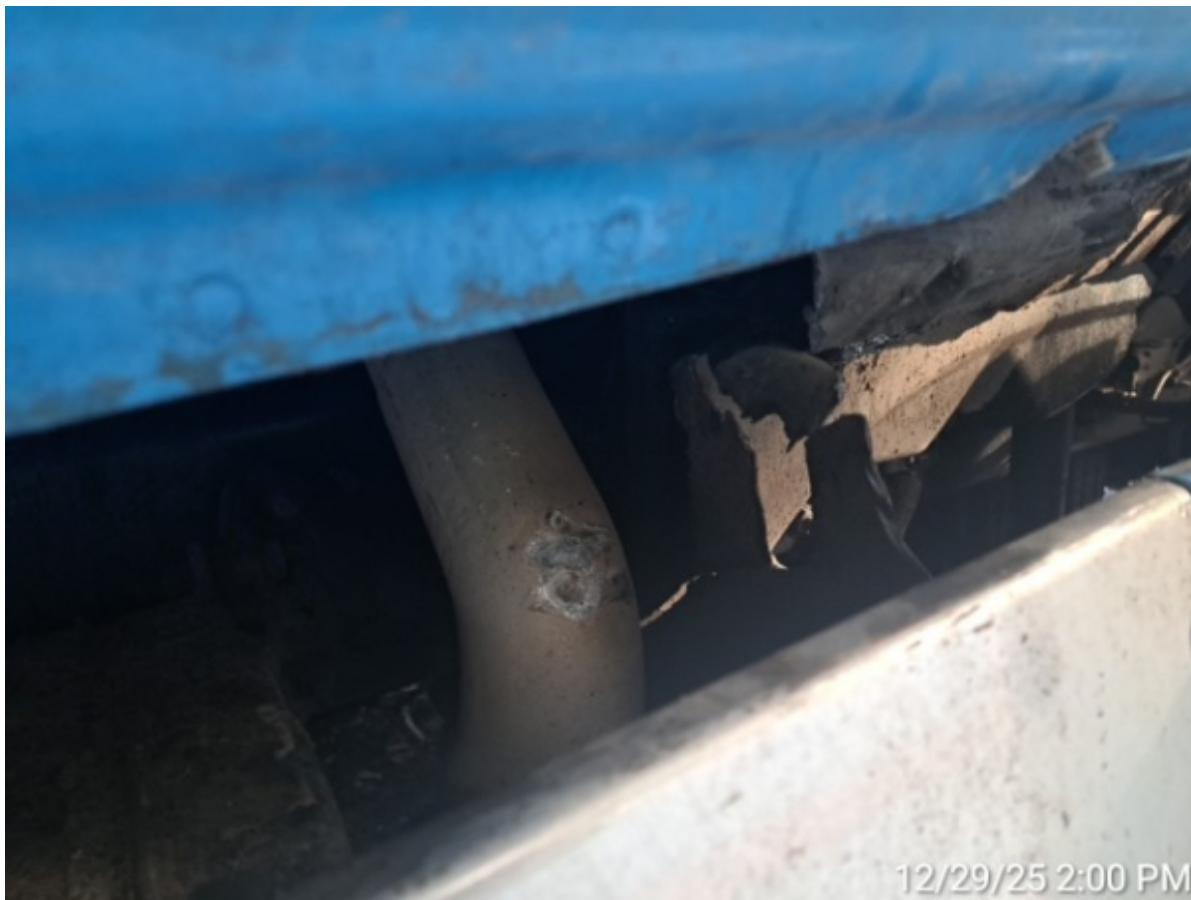
RT SIDE DAMAGE

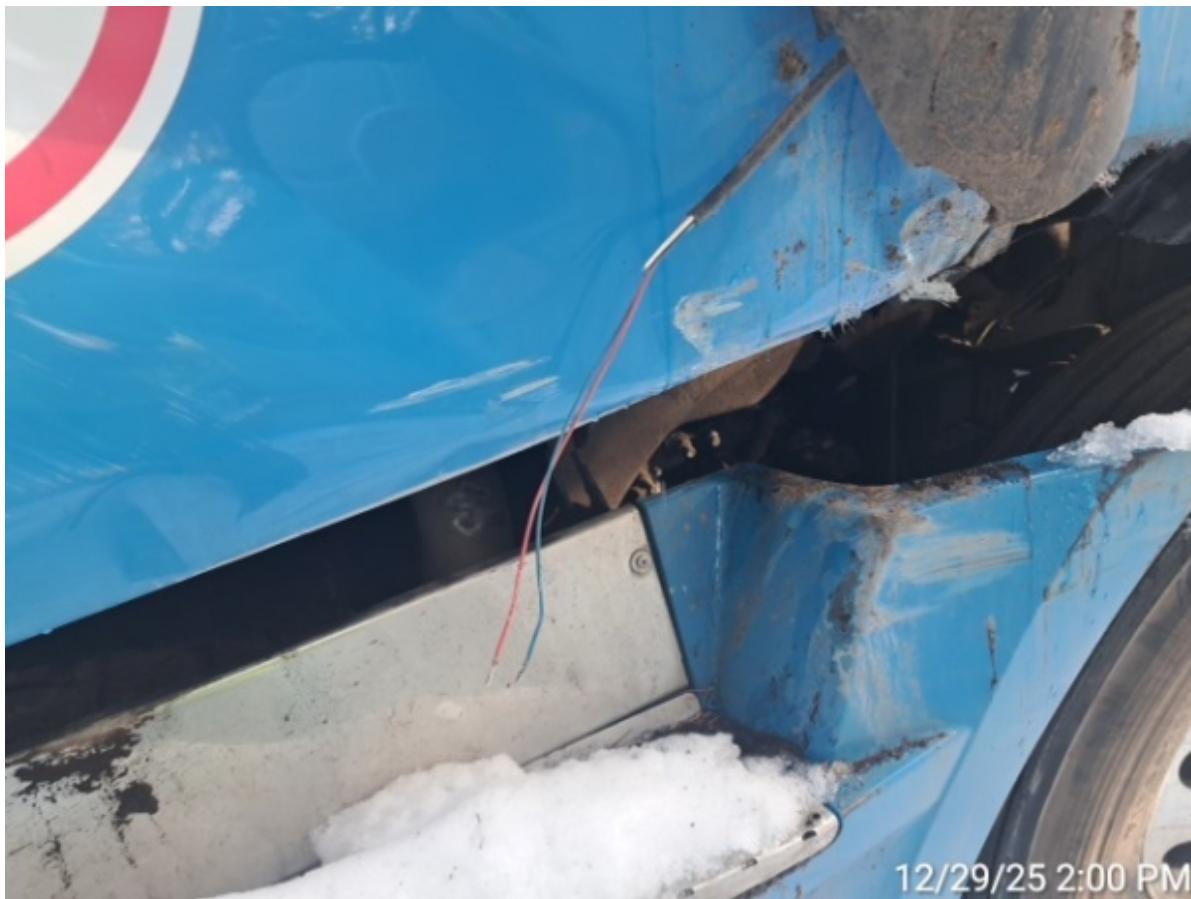
RT SIDE DAMAGE

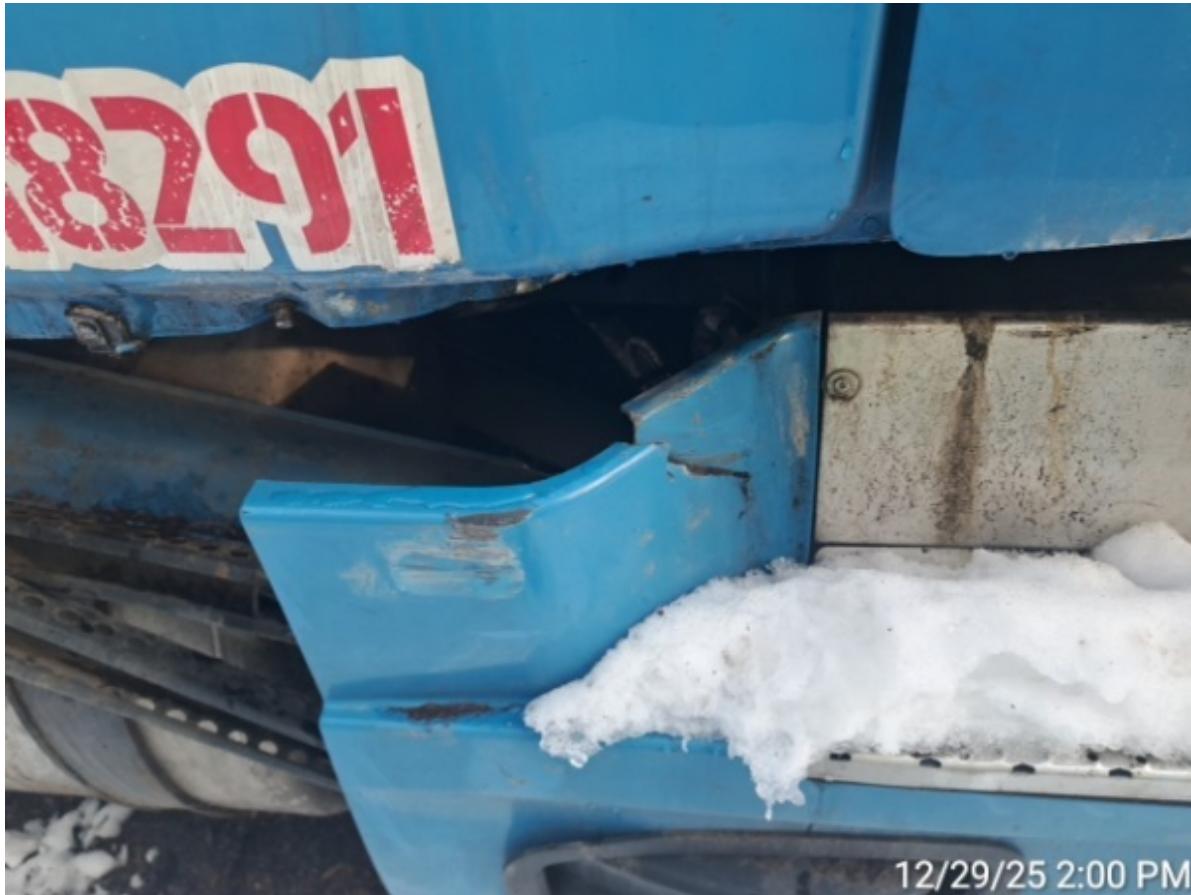
RT SIDE DAMAGE

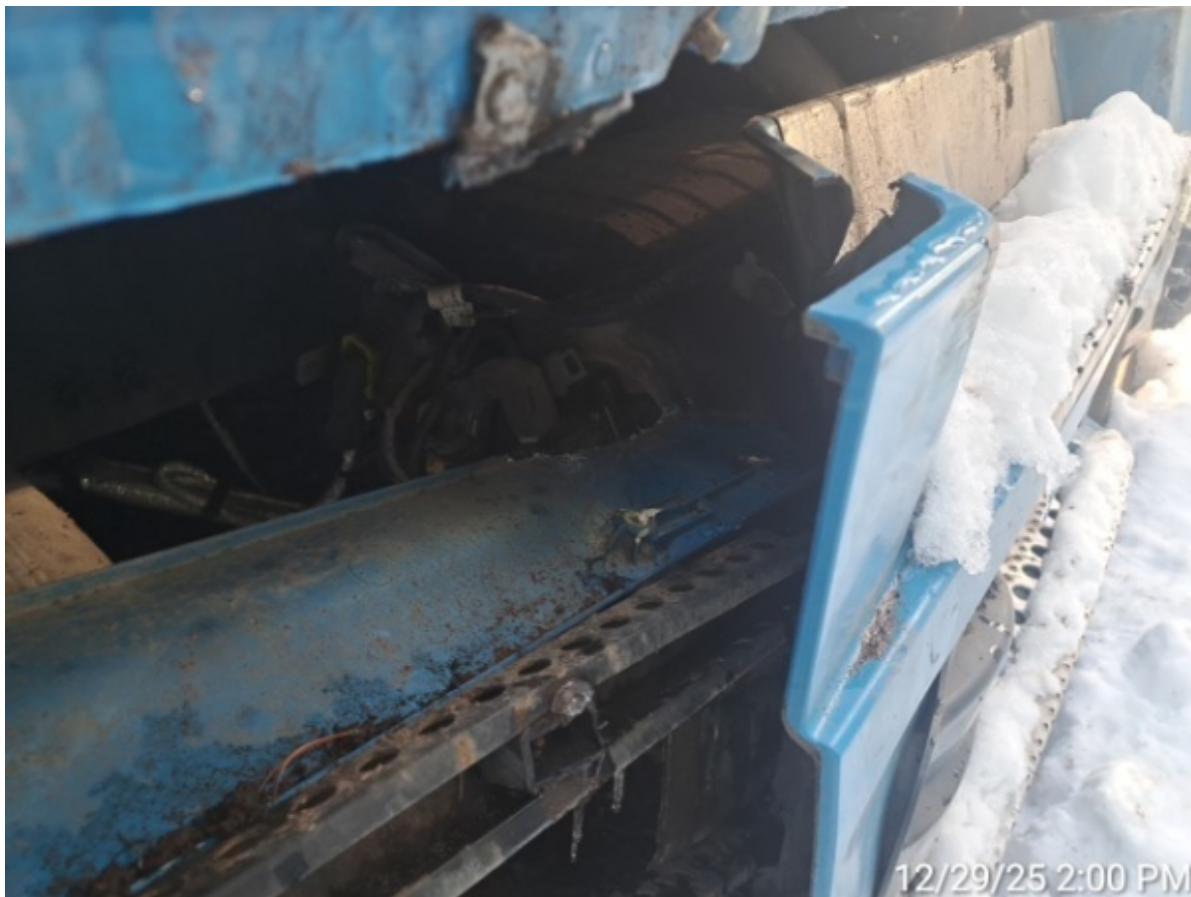
RT SIDE STEP DAMAGE

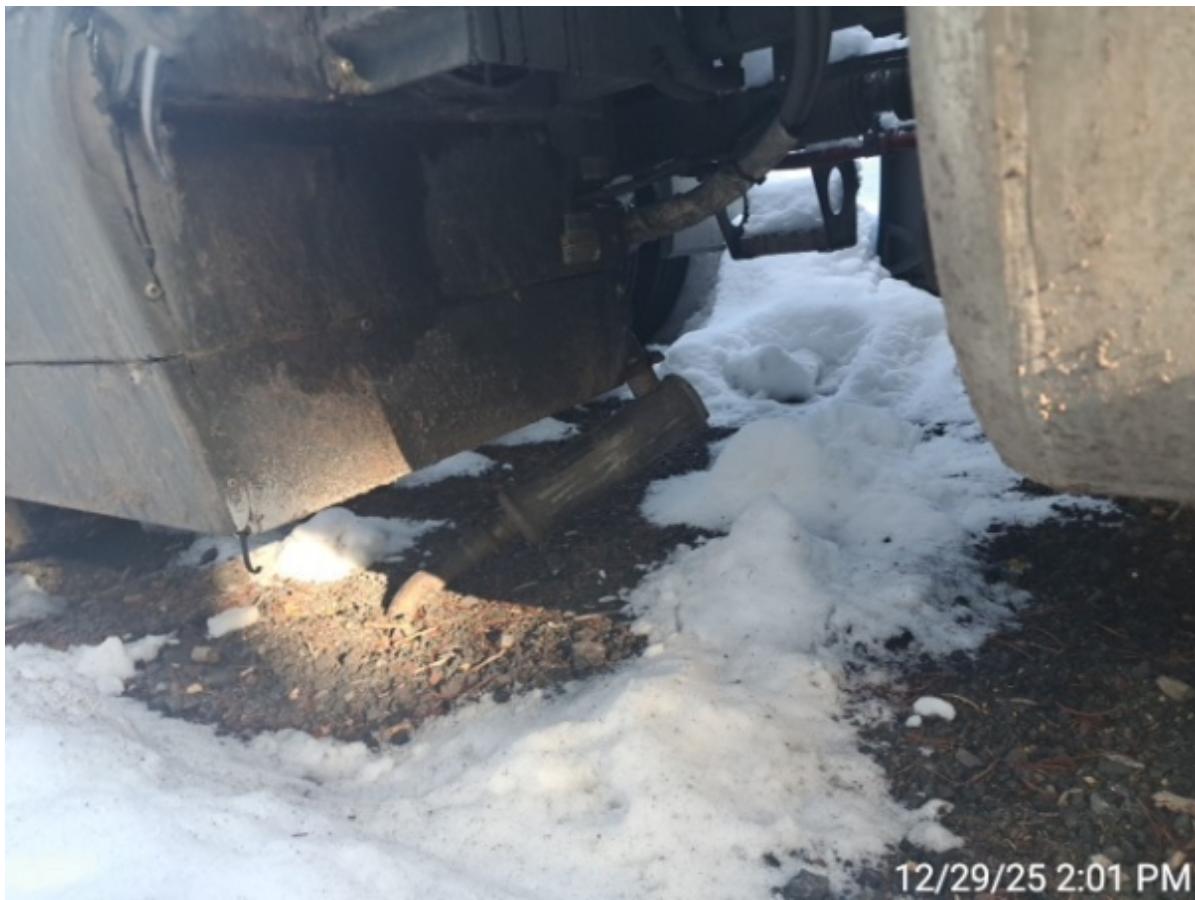
UNDERNEATH DAMAGE

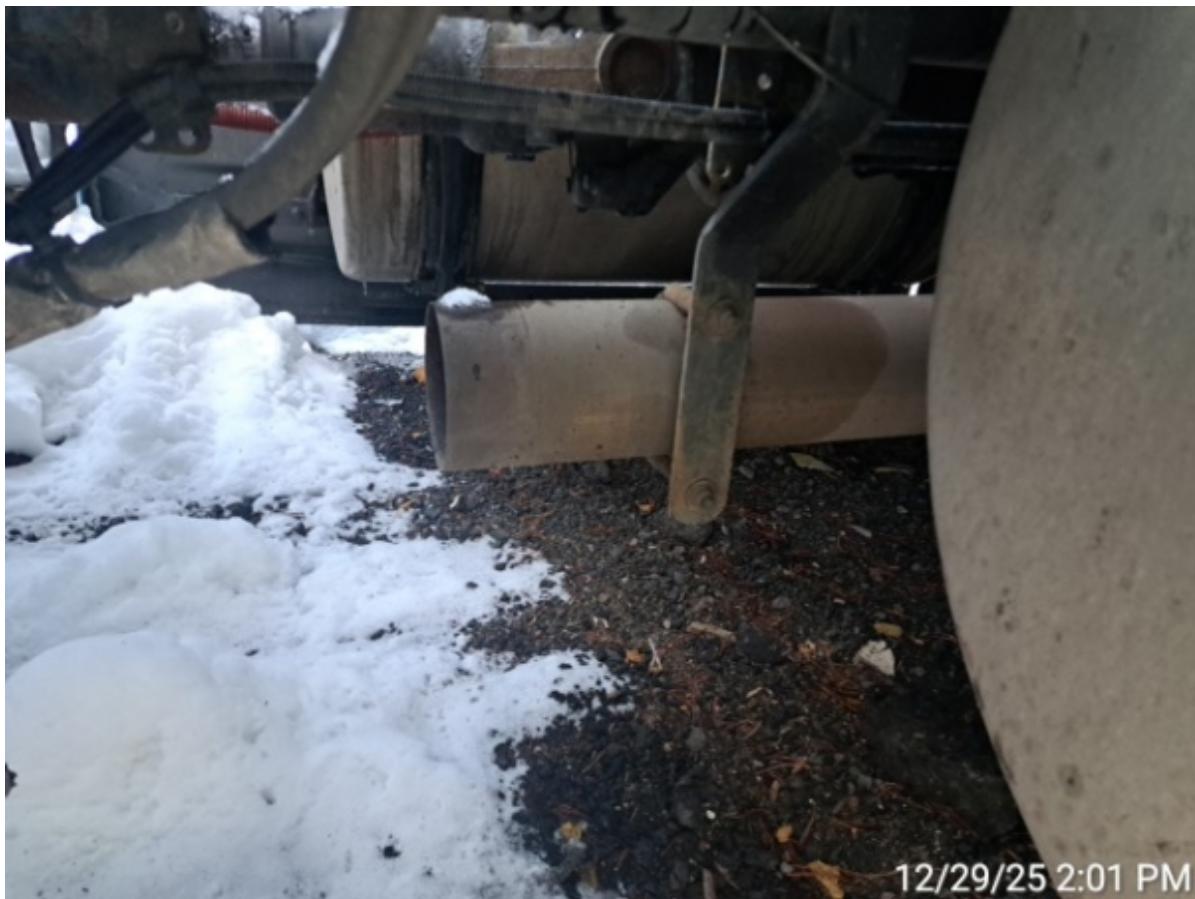
UNDERNEATH DAMAGE

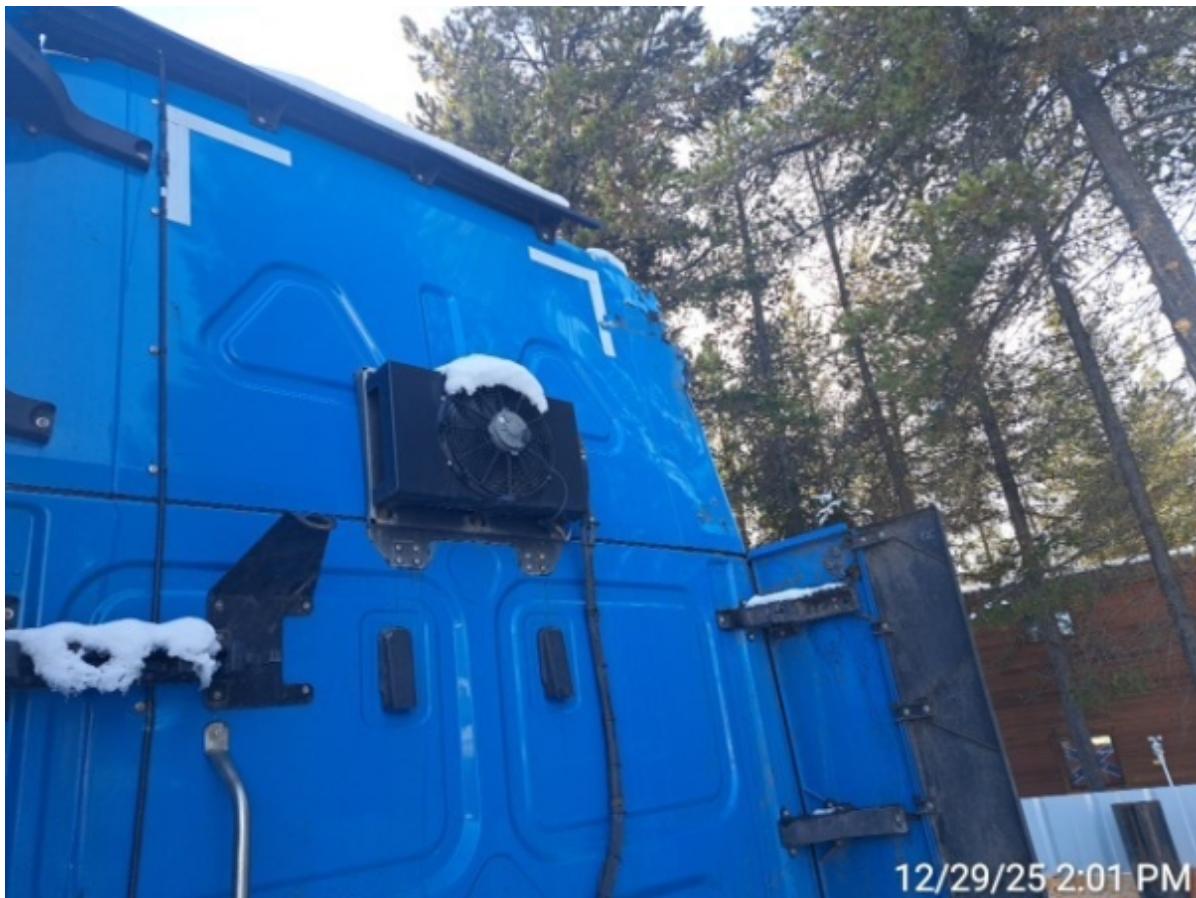
RR PANEL DAMAGE
