Report: FIRST & FINAL

RE: Insured: Jag Carrier
Claimant:
Claim #: 118.1607
Policy #: CUS062007037
Our File #: 046-602-0007
Loss Date: 1/1/1900
Risk: 2018 / Great dane trailers / Great Dane Trailers / Not Applicable
Serial #: 1GRAA0620JW113719

Appraisal
Equipment & Condition Report

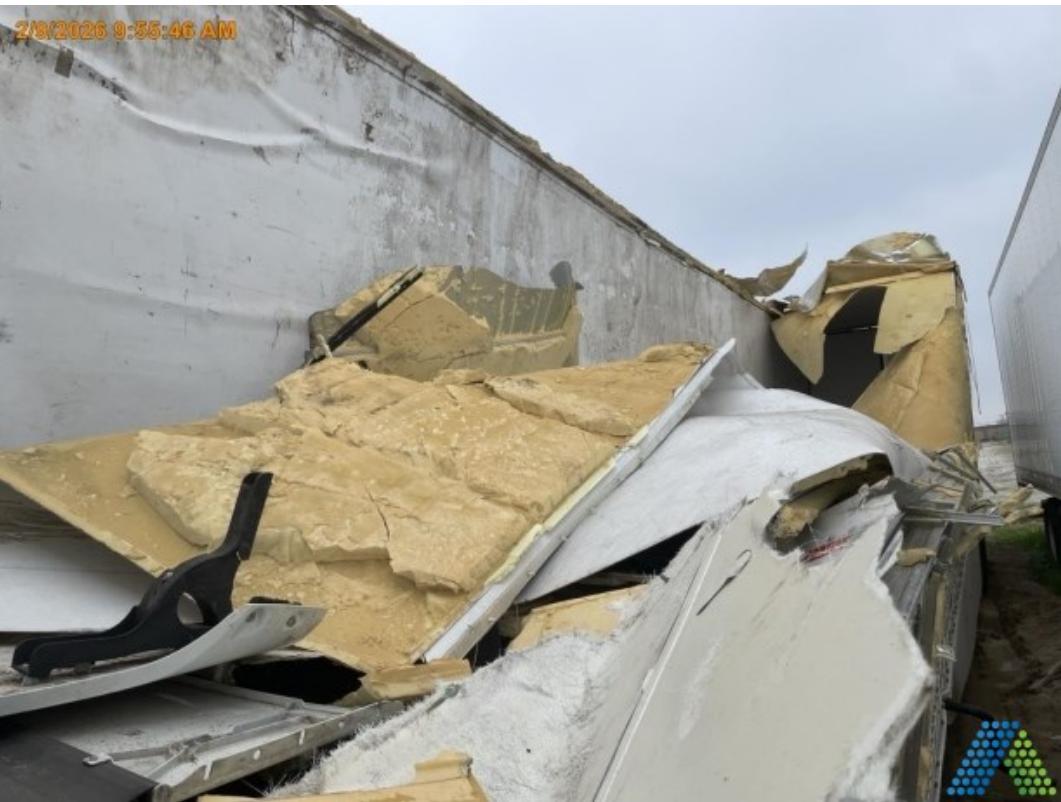
Document Name: INTERIOR.jpg

The unit was inspected on 2/9/2026 at Commercial Towing - Texas Street, 2609 Texas St Bakersfield, CA 93307. The trailer has sustained major damage. Damage is to both radius panels, both upper caps, left side panels, right side panel, left upper rail, right upper rail, left lower rail, roof, roof bows, liners, left side posts, crossmembers and both rear door skins. Possible supplement for hidden damage to the floor, additional rivets and parts price increases. Supplement could exceed \$8000.

Operation	Description	Part #	Type	Labor	Paint	Parts	Misc
19	Replace Plastic Liner (53')		New	4.50		1 @ \$903.18	\$903.18
----- Rear Door Swing (Left) -----							
20	Replace Stainless Door Skin (Left)		New	7.50		1 @ \$594.45	\$594.45
----- Rear Door Swing (Right) -----							
21	Replace Stainless Door Skin (Right)		New	7.50		1 @ \$582.09	\$582.09
----- Frame -----							
22 *	Replace Crossmember		New	M 10.50		3 @ \$150.36	\$451.08
----- Misc -----							
23 ^	Replace Rivets		New			1 @ \$750.00	\$750.00
----- Calculated Values -----							
24 ^	Shop Supplies		Mtrls				\$3,424.50

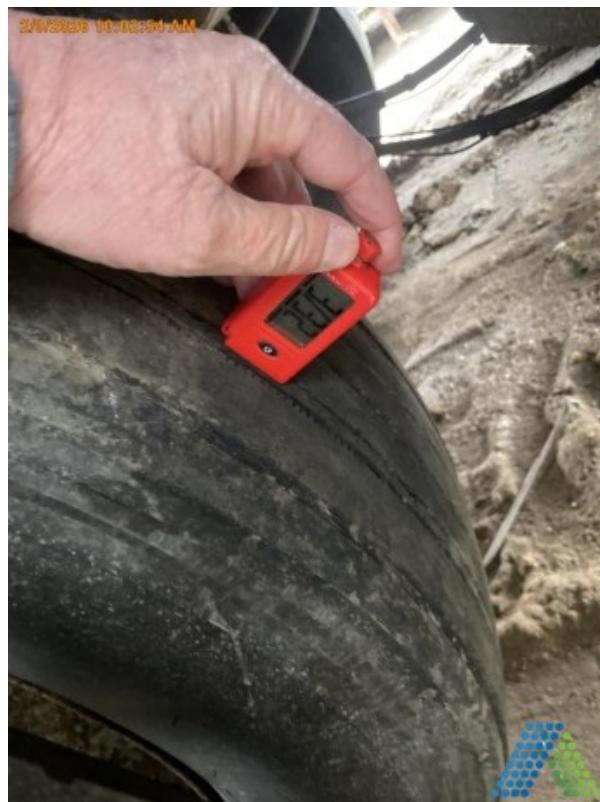
Document Name: Left front inner tire.jpg

Location	Tire Size	Recap	Tread Depth
1st Rear L/S Outer	295/75R22.5	False	3
1st Rear L/S Inner	295/75R22.5	False	3
1st Rear R/S Outer	295/75R22.5	False	7
1st Rear R/S Inner	295/75R22.5	False	6
2nd Rear L/S Outer	295/75R22.5	False	4
2nd Rear L/S Inner	295/75R22.5	False	4
2nd Rear R/S Outer	295/75R22.5	False	1
2nd Rear R/S Inner	295/75R22.5	False

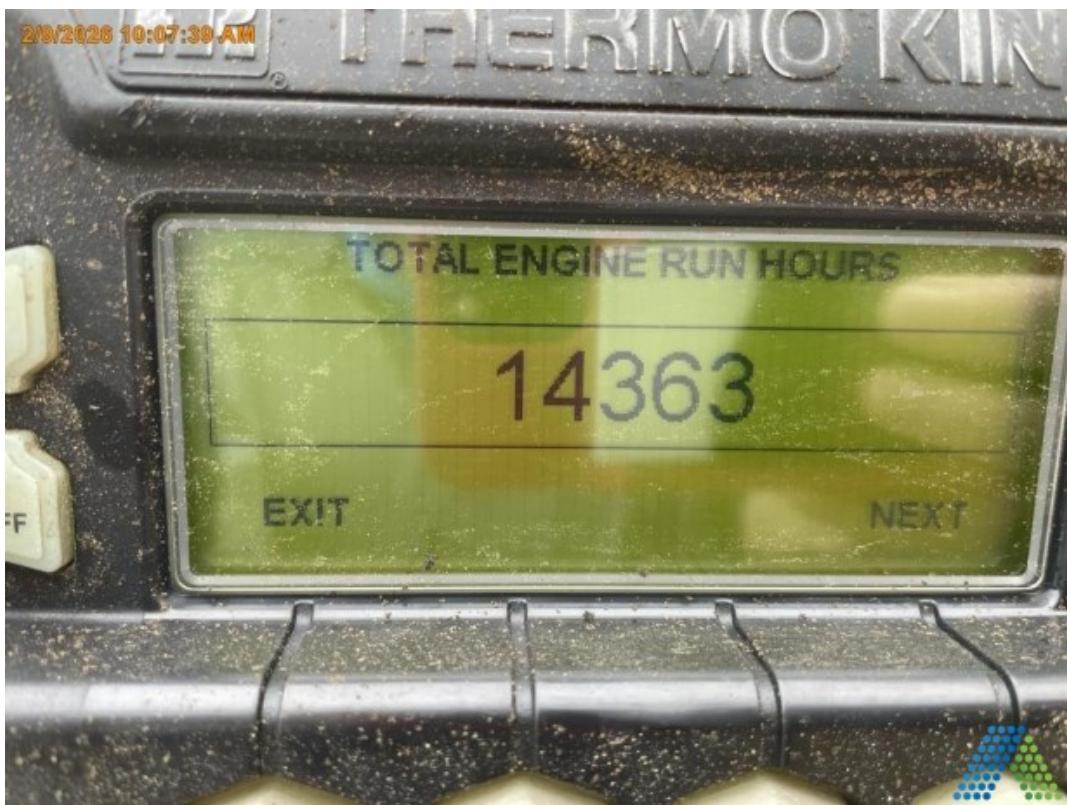
Document Name: Reefer hours.jpg

Make:	Thermo King	Hours:	14363
Model:	S-600	Fuel:	Diesel
HP:

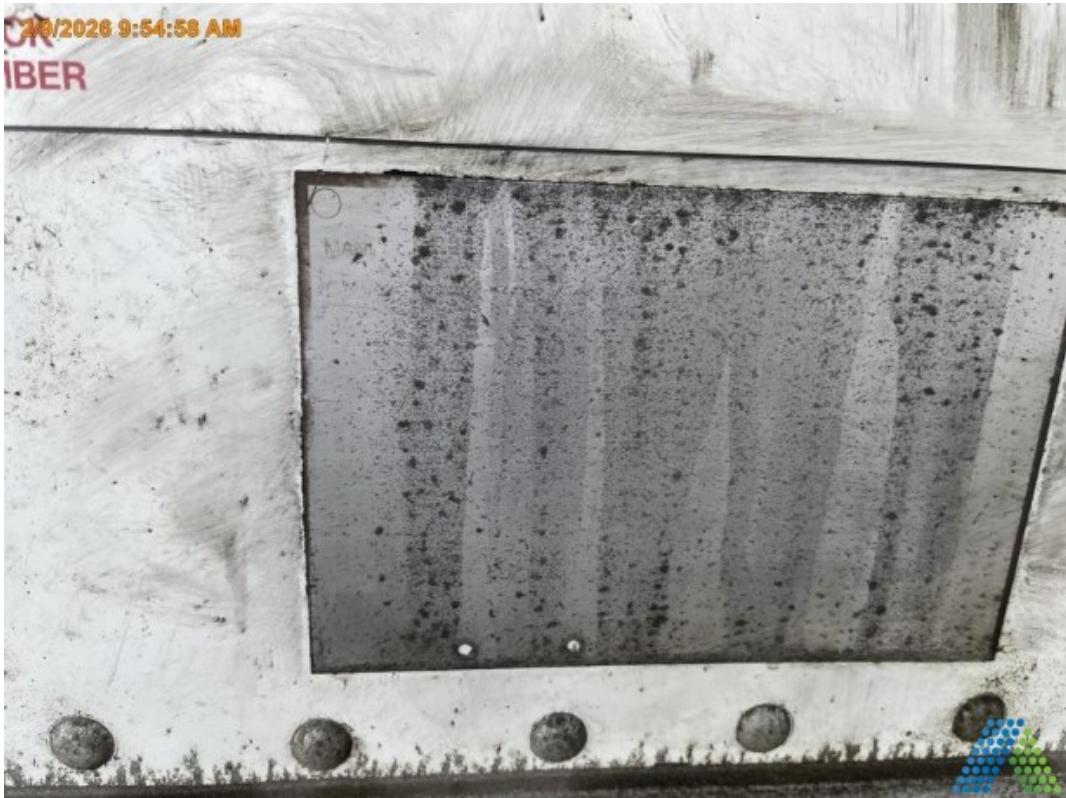
Document Name: VIN.jpg

The unit is a 2018 Great dane trailers Great Dane Trailers Not Applicable bearing the serial number 1GRAA0620JW113719. As part of our standard procedure, I analyzed the serial number and verified that it is a valid VIN. The overall condition of the unit is Good.
