VIN of 2023 freightliner tractor VIN: 3AKJHHDR0PSUP4928.

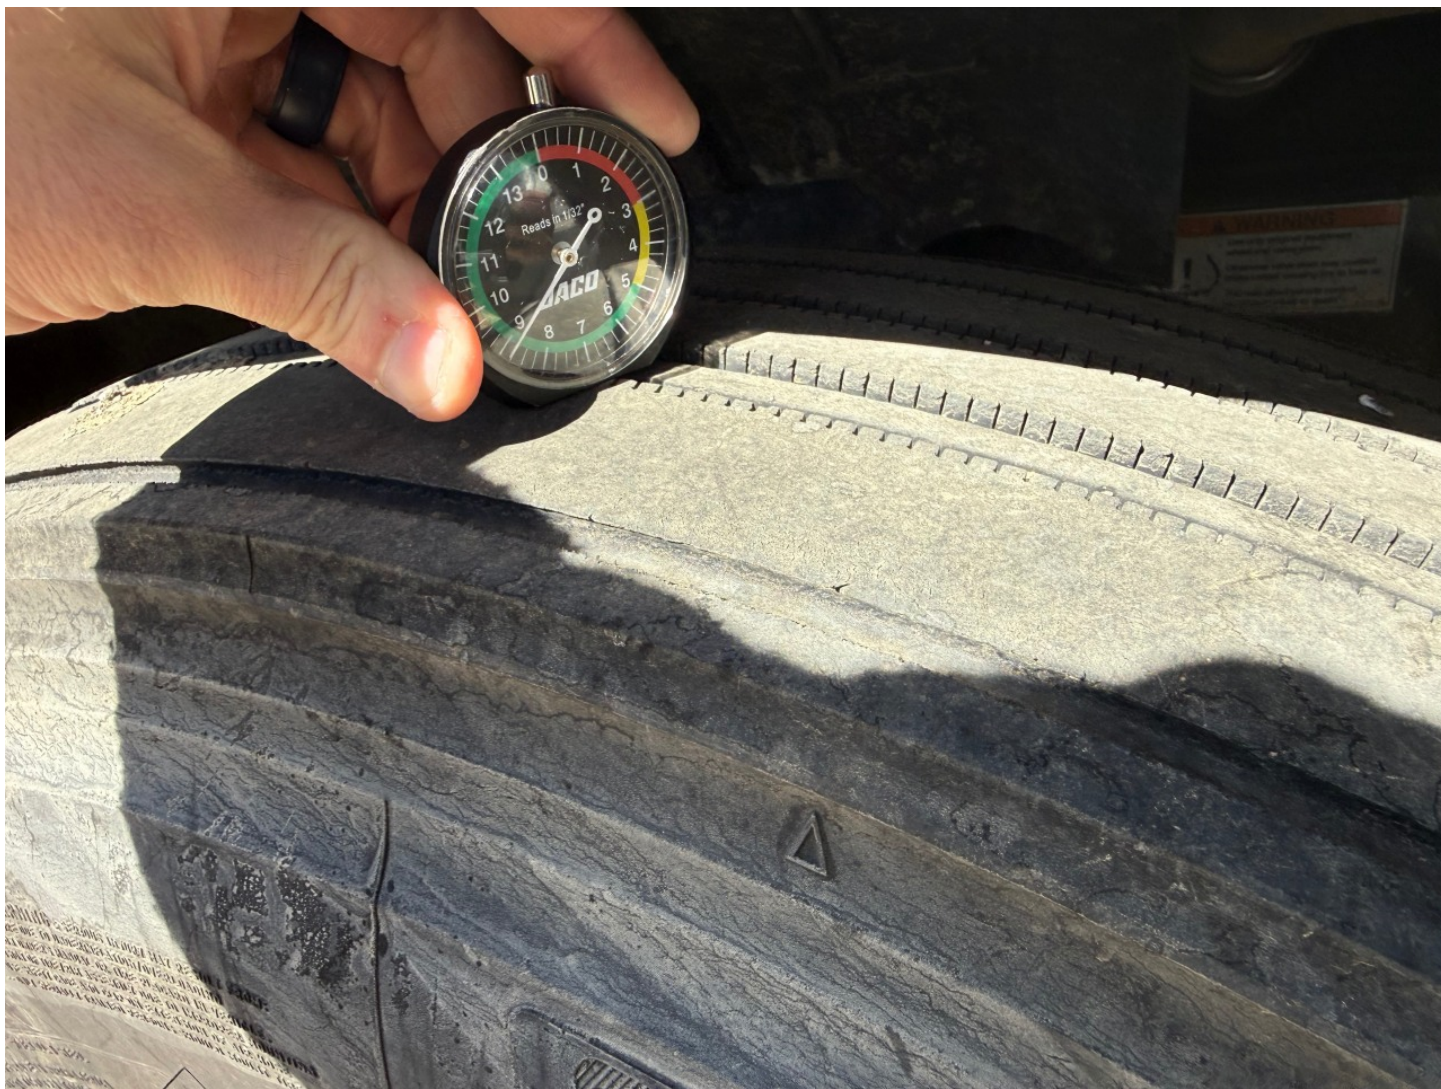
Tire tread depth of 2023 freightliner tractor VIN: 3AKJHHDR0PSUP4928.

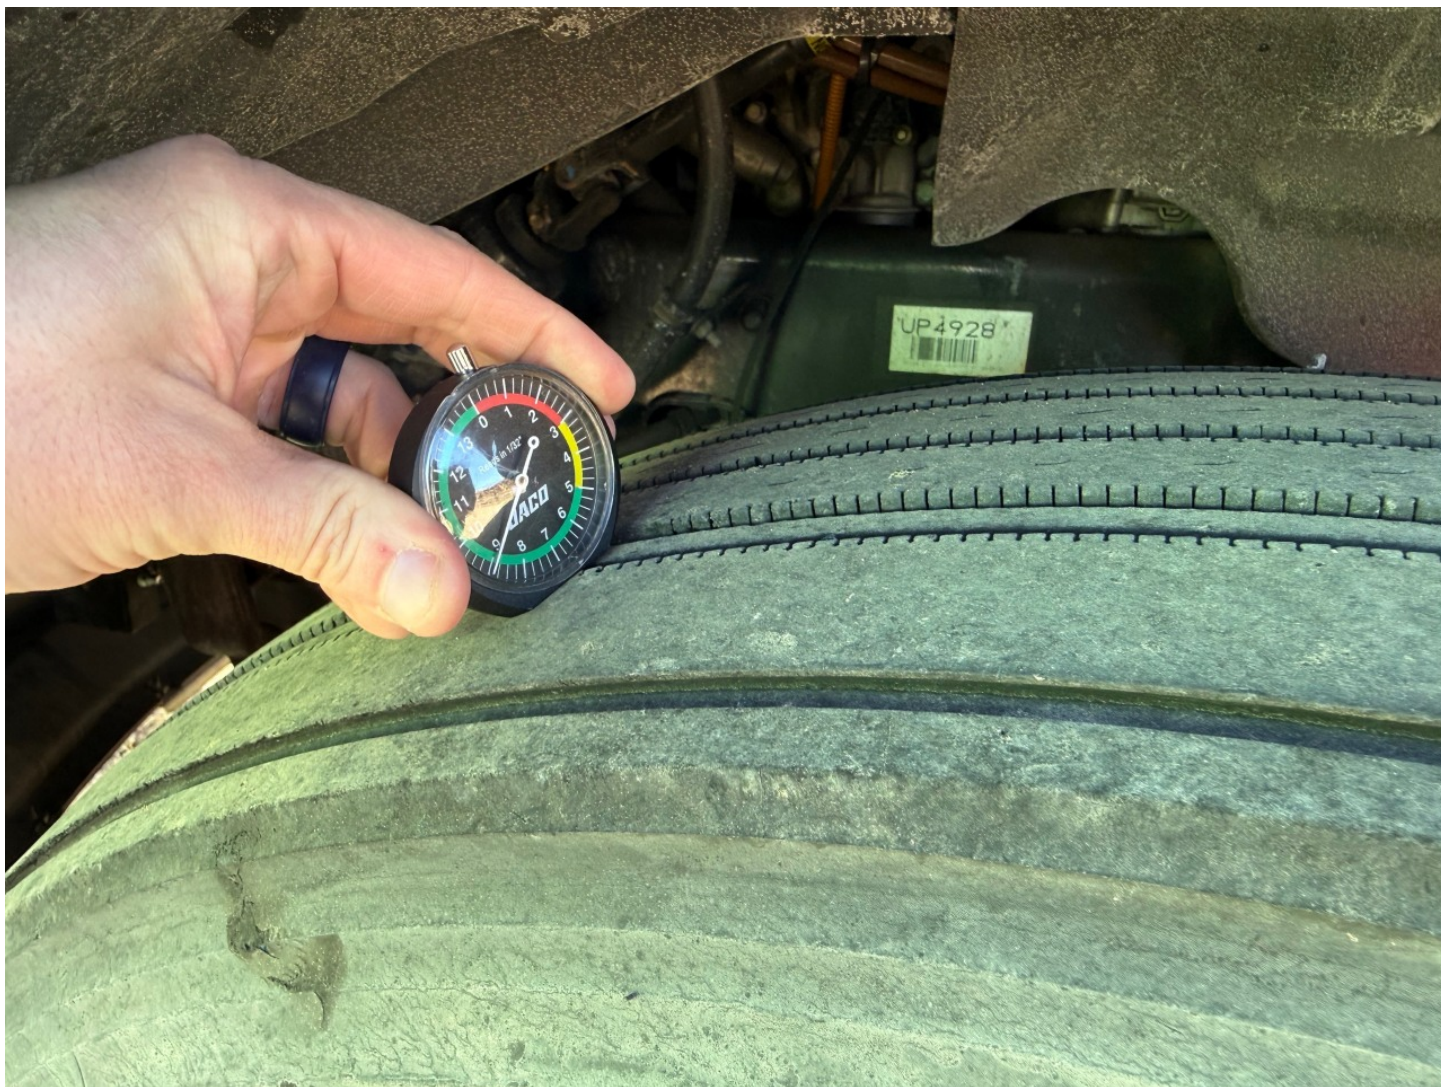
Tire tread depth of 2023 freightliner tractor VIN: 3AKJHHDR0PSUP4928.

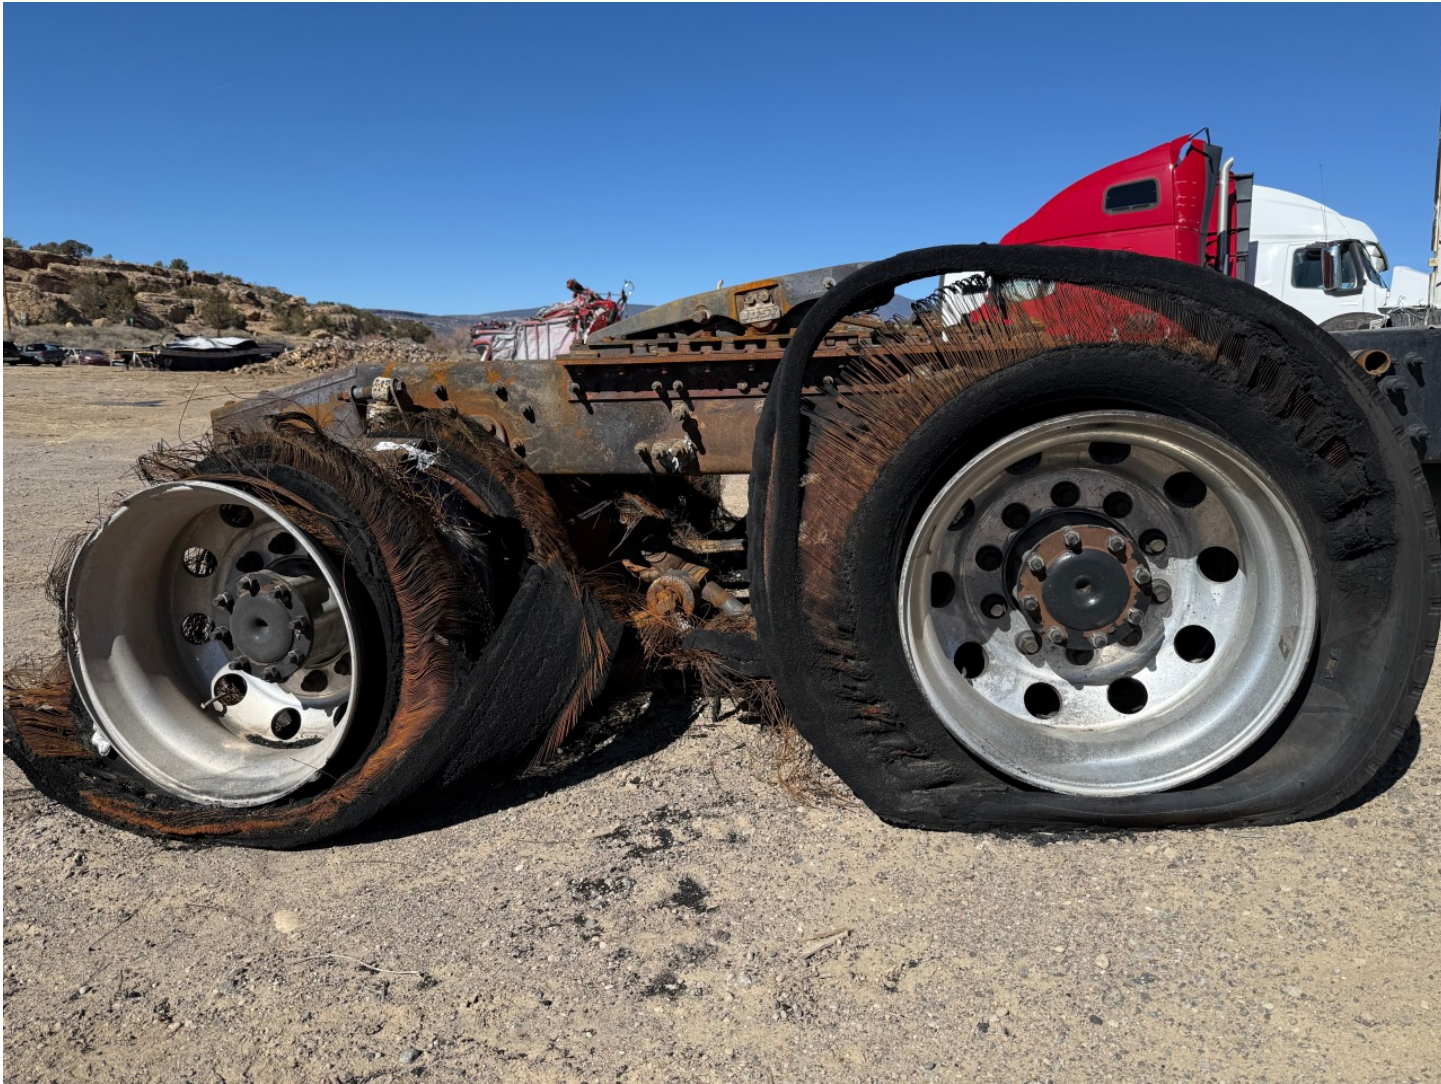
Wheels of 2023 freightliner tractor VIN: 3AKJHHDR0PSUP4928.

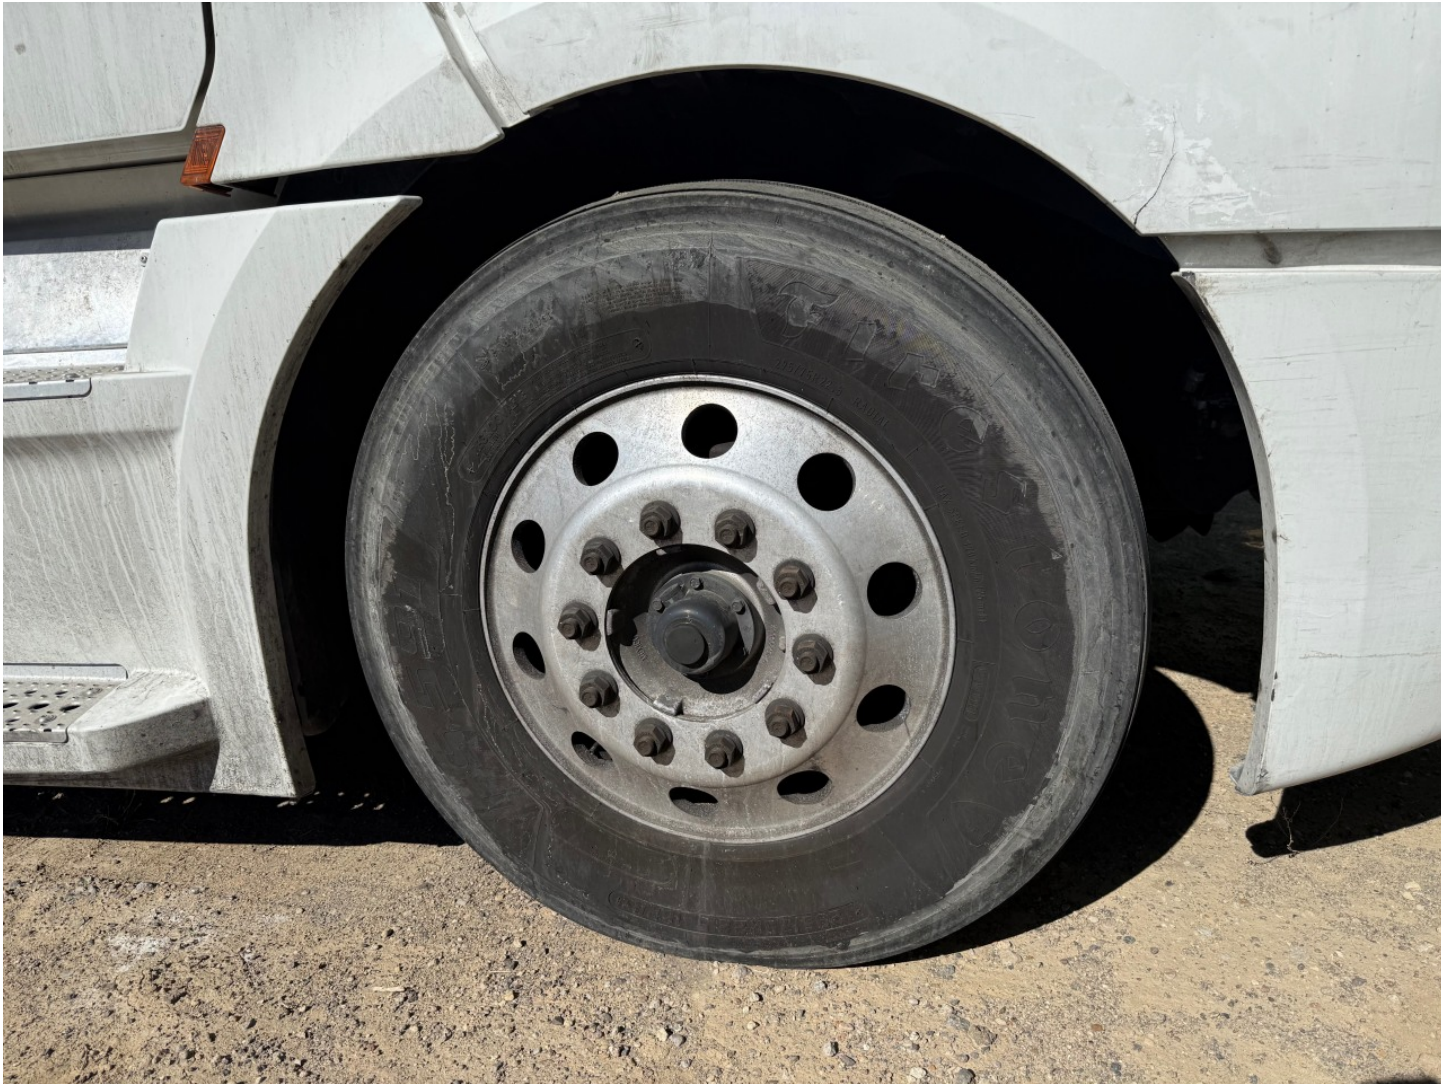
Wheels of 2023 freightliner tractor VIN: 3AKJHHDR0PSUP4928.

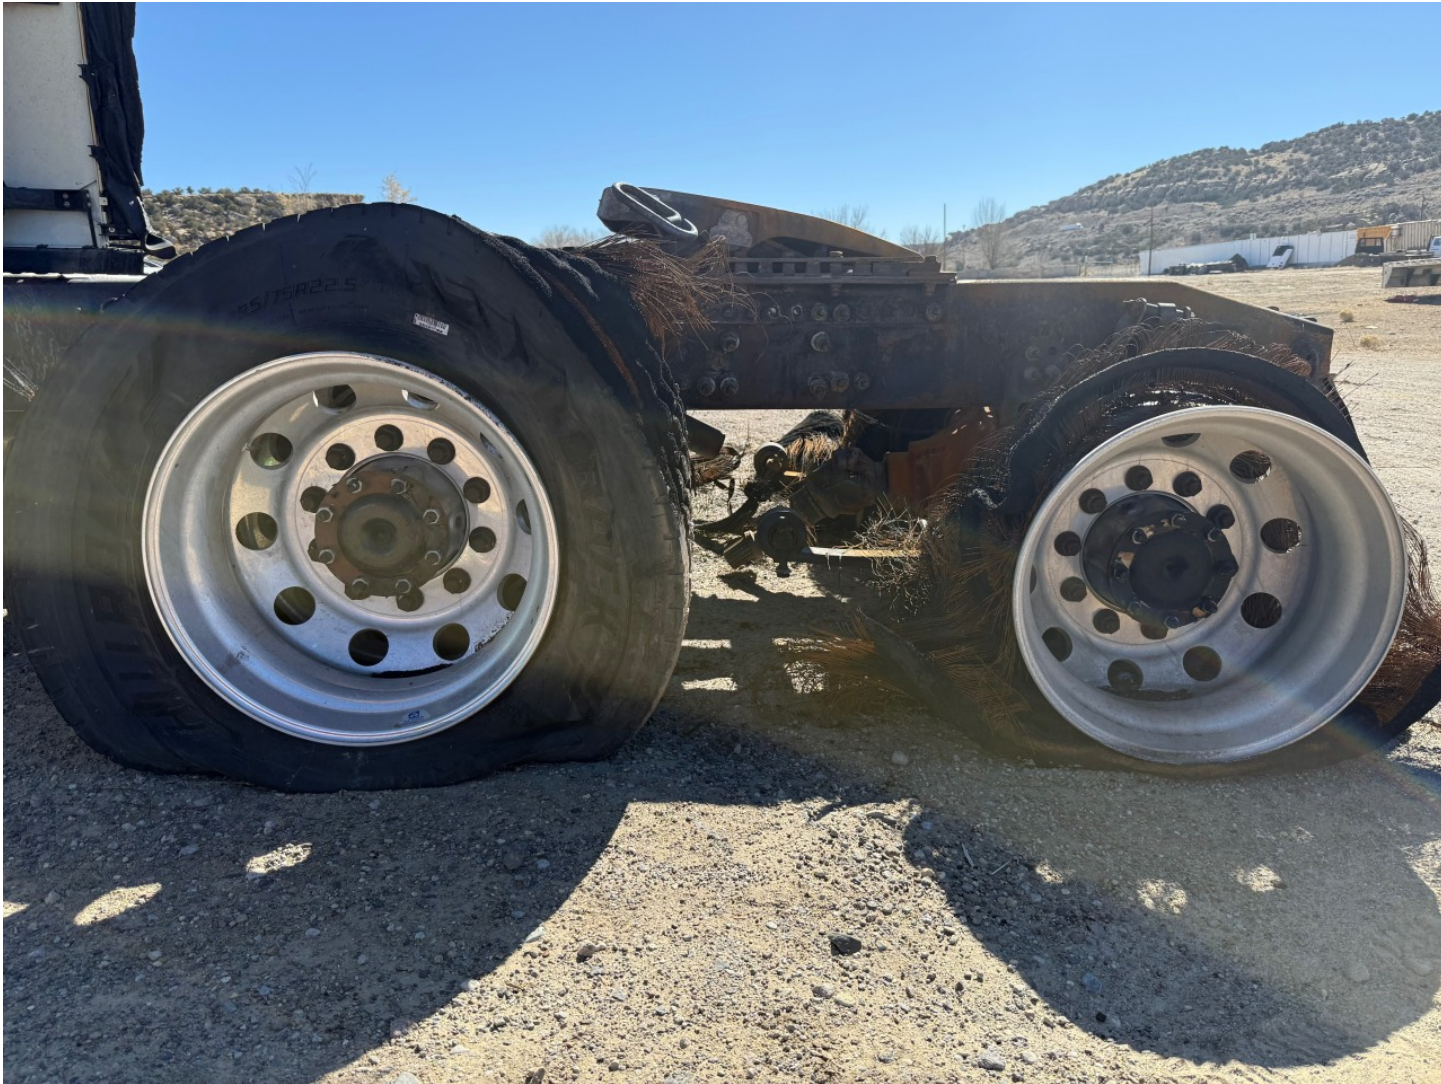
Wheels of 2023 freightliner tractor VIN: 3AKJHHDR0PSUP4928.

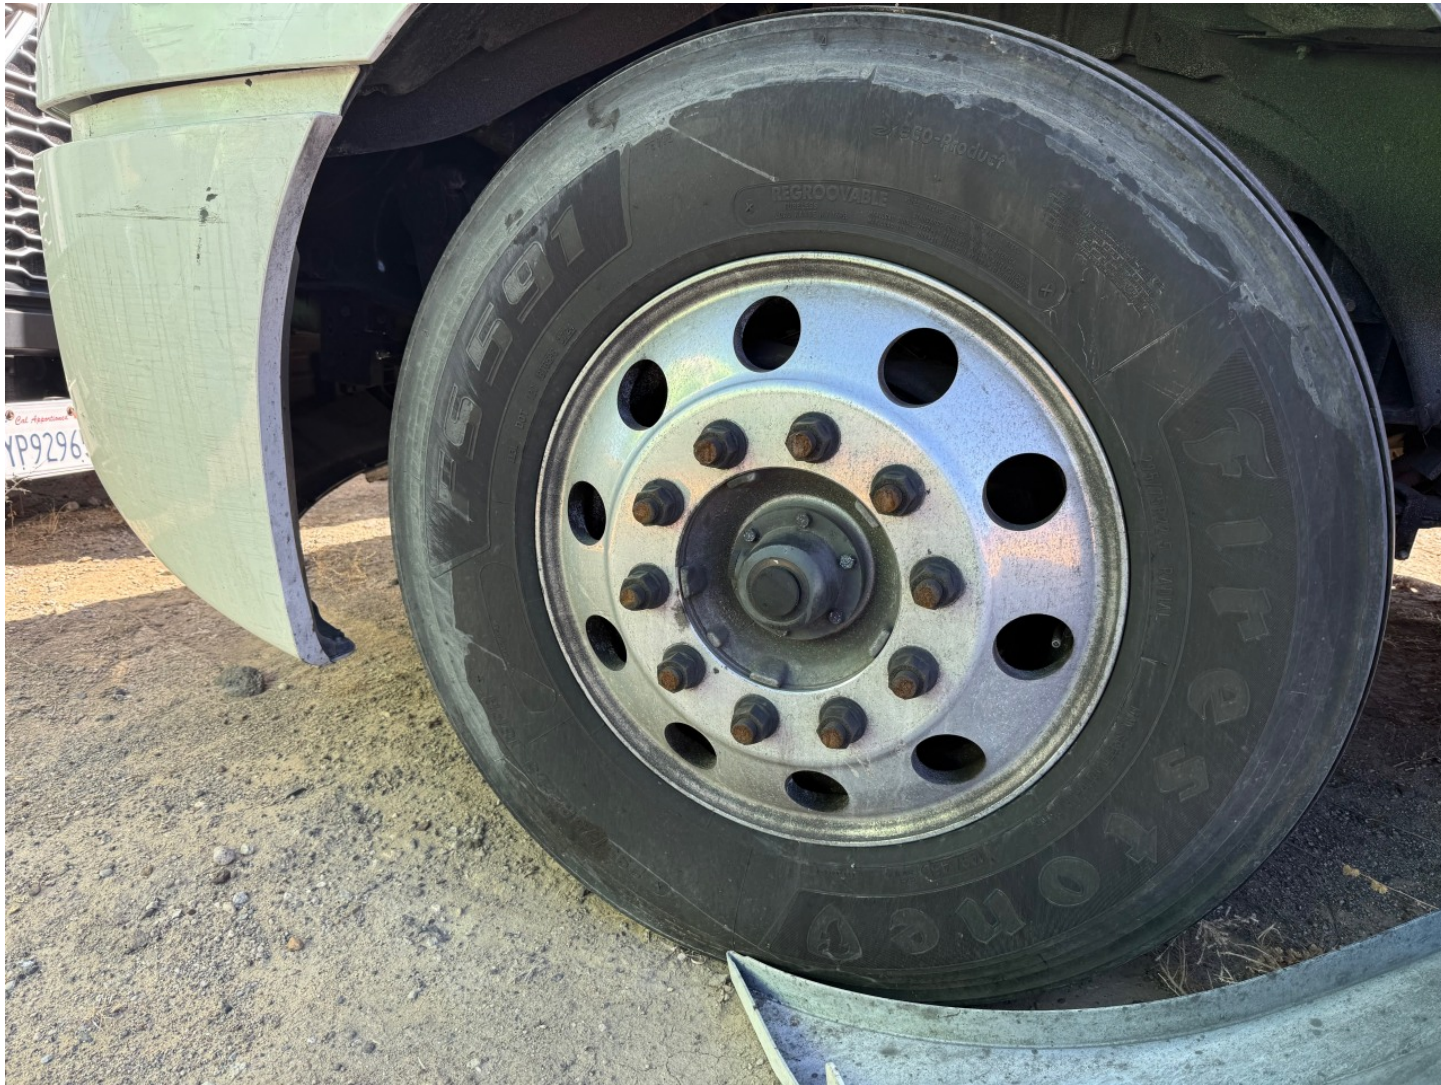
Wheels of 2023 freightliner tractor VIN: 3AKJHHDR0PSUP4928.
